Inquiry R0-2013-102: Passenger train travelled with doors open,
Wingate - Taita, 28 March 2013

Final Report

Rail inquiry RO-2013-102
Passenger train travelled with doors open Wingate - Taita
28 March 2013

Approved for publication: June 2014

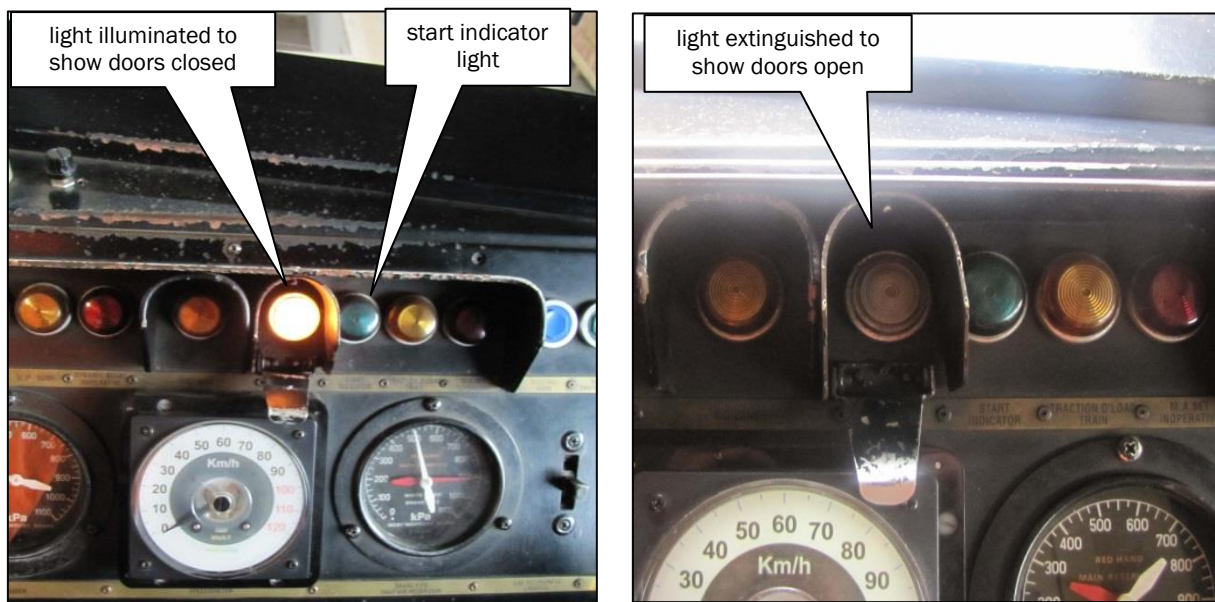
Figure 1
The “all-doors-closed” and “start indicator” warning light arrangements in the driver’s cab

- 3.1.4. The train event recorder showed that the train arrived at Wingate station five minutes late at 1741:40.
- 3.1.5. At 1742:03 the train manager pressed the door-open button at the local door control box in the third car to allow passengers to disembark. An “all-doors-closed” light on the driver’s control panel extinguished to show that the doors had opened (the light was normally illuminated when all the doors were closed – see Figure 1).

- 4.2.1. There is a convention, in almost all disciplines, where the colour red means “danger” or “stop” and green means “go” or “safe”. If the design of the passenger door-alert system had followed this convention, there would have been two lights for indicating the status of the doors. One would have been red and would have illuminated when the doors were open, and the other would have been green to indicate the doors had closed, or that it was safe to proceed. In this case the safe condition was represented by an illuminated white light and the unsafe condition by the light not being illuminated. In other words there was no light to draw a driver’s attention to an unsafe condition.

- 4.2.4. The concept of a single white light was considered to be failsafe. That is, if the bulb in the light was not working a driver would assume that the passenger doors were still open. Tranz Metro had an established procedure for checking if that were the case. However, a driver would first have to notice that the light was not illuminated. In this case the trainee failed to notice this.

- 5.1. The trainee powered up his train to depart Wingate station without having received the required right-away signal from the train manager.
- 5.2. The extinguished passenger door-status light on the driver's control panel failed to alert the trainee sufficiently that the doors were open when the train departed Wingate station. A door-status light in line with the more conventional system of separate green and red lights to indicate safe and unsafe conditions respectively would have been more appropriate.
- 5.3. Portable radios installed on trains to enable crews to converse with the drivers during emergency situations would be more effective if they were carried by the train managers. In this case a portable radio could have been used to stop the train.
