Report RO-2013-105: *Capital Connection* passenger train,  
departed Waikanae Station with mobility hoist deployed, 10 June 2013

## Final Report

Rail inquiry RO-2013-105  
Capital Connection passenger train, departed Waikanae Station  
with mobility hoist deployed, 10 June 2013

Approved for publication: April 2015

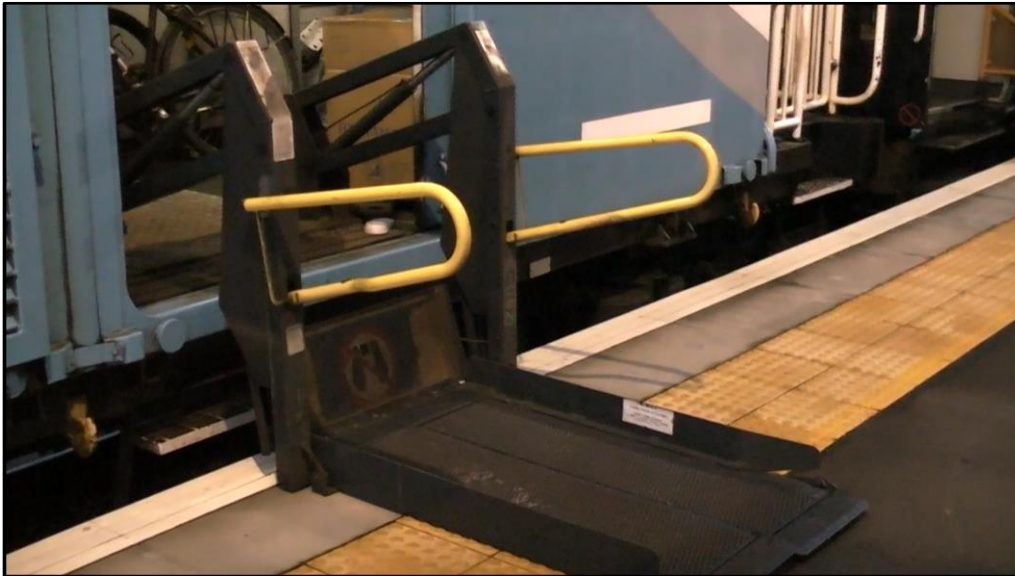
Figure 1  
Mobility hoist deployed from the luggage van at Waikanae Station

- 3.1.11. Meanwhile, the train attendant deployed the mobility hoist with the wheelchair-bound passenger and her support person onto the station platform at 0730:03<sup>6</sup>.
- 3.1.12. As the train attendant deployed the mobility hoist onto the platform, the train manager was radioing the driver and giving him “right of way” to depart. At 0730:09 the train driver moved the throttle to notch 2 and the train started to move, dragging the mobility hoist along the platform with the wheelchair and two passengers still on it.
- 3.1.13. Seeing the train begin to move, the train attendant raised the mobility hoist off the station platform and activated the emergency stop button located beside the hoist control holder.

- 4.8. This safety issue has since been resolved by KiwiRail. It has placed high-visibility reflective tape on the hand rails of the mobility hoist to improve its visibility. KiwiRail has also installed a light in the luggage van that shines out onto the platform when the luggage van doors are open.

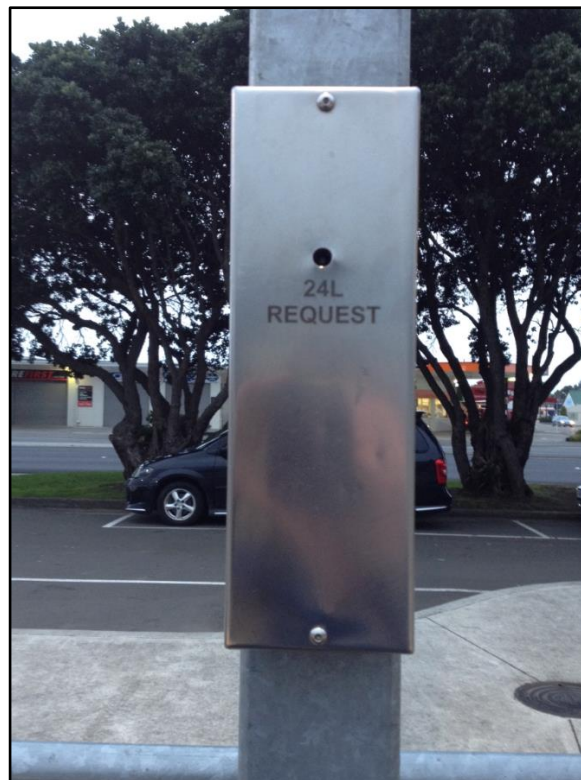
**Figure 2**  
**Request for signal mechanism**

- 3.1.9. The train manager stepped off the train to observe the boarding process. Once it looked as though everyone had boarded, he crossed to the “Request for Signal” pushbutton on the station platform. The purpose of pushing this button was to inform the train controller<sup>5</sup> that the southbound train was ready to depart from Waikanae. This was a special arrangement designed to reduce the time that the bells and barriers at the adjacent road level crossing were activated while passenger trains were stopped at the station platform (see Figure 2). The train had been stopped at the platform for about 40 seconds when he pressed the button.

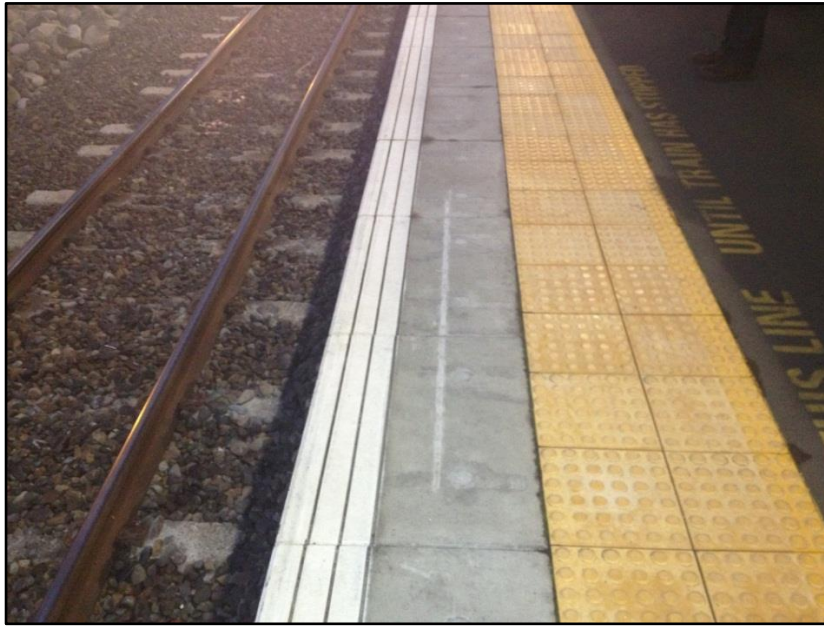
**Figure 3**  
Witness mark from the mobility hoist on Waikanae Station platform

The train movement lasted five seconds, during which time the mobility hoist was dragged 1.72 metres along the platform (see Figures 3 and 4).

- 3.1.14. Once the train had stopped the train attendant lowered the mobility hoist back onto the platform and the two passengers were disembarked. Neither was injured during the incident and no damage occurred other than the witness mark on the station platform.
