Inquiry RO-2013-107: express freight MP16 derailment,
Mercer, North Island Main Trunk, 3 September 2013

Final Report

Rail inquiry R0-2013-107
express freight MP16 derailment
Mercer, North Island Main Trunk

3 September 2013

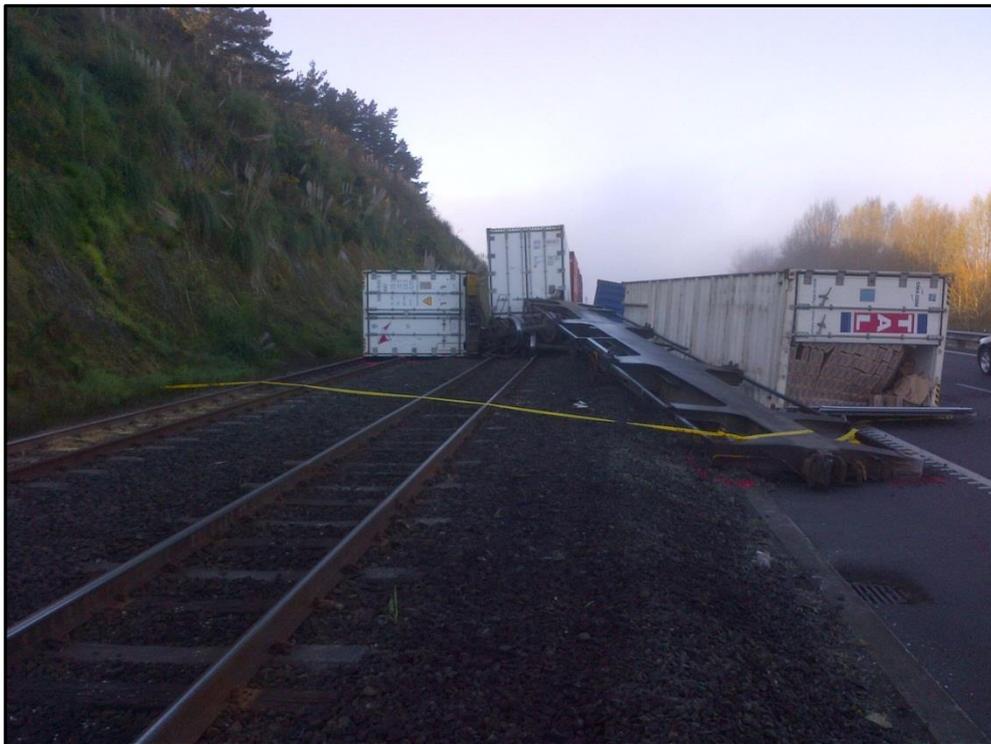
- 3.1.5. The 20th wagon behind the locomotive derailed within Mercer Station limits (Wagon PKK321). The derailed wagon was dragged about 600 metres to a set of “trailing points” for the crossover between the northbound and southbound tracks at the north end of Mercer. The derailed wagon and its container tipped towards the right side, obstructing the southbound track. The following two wagons also derailed at the crossover points. Containers separated from the second wagon to derail and spilt out onto southbound State Highway One Expressway, blocking one lane (see Figure 1).

Figure 1
Photograph of wagon and containers fouling State Highway One
(image provided by KiwiRail)

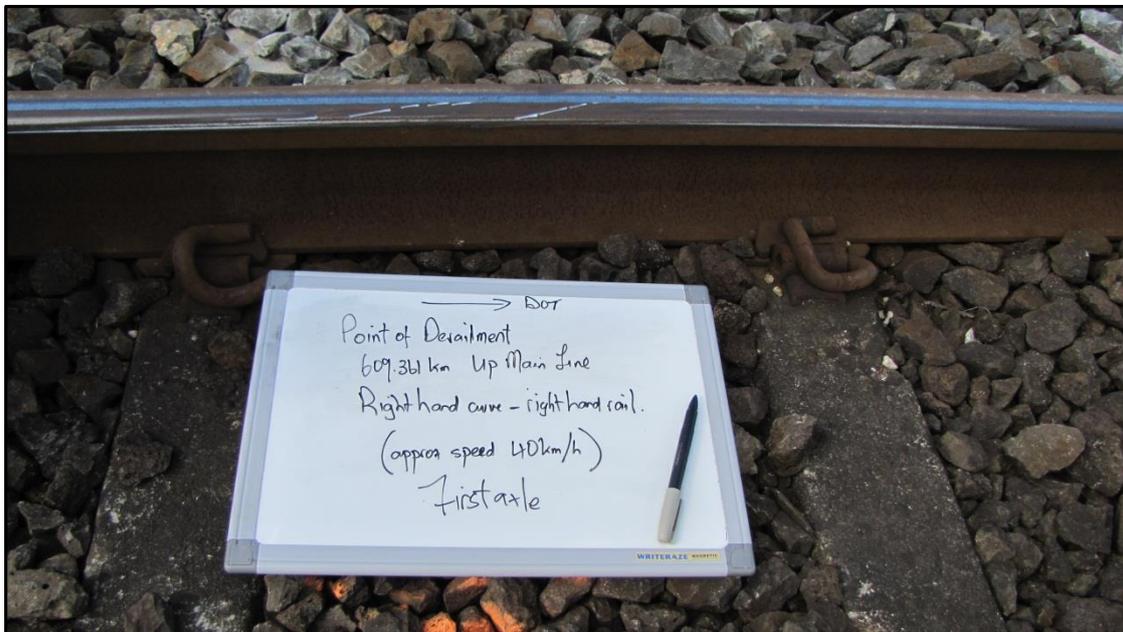
- 3.2.1. Marks on the head of running rail confirmed that the point of derailment was at 609.361 kilometres, North Island Main Trunk line, within station limits at Mercer (see Figure 2).

Figure 2
Railhead markings from the derailed wagon

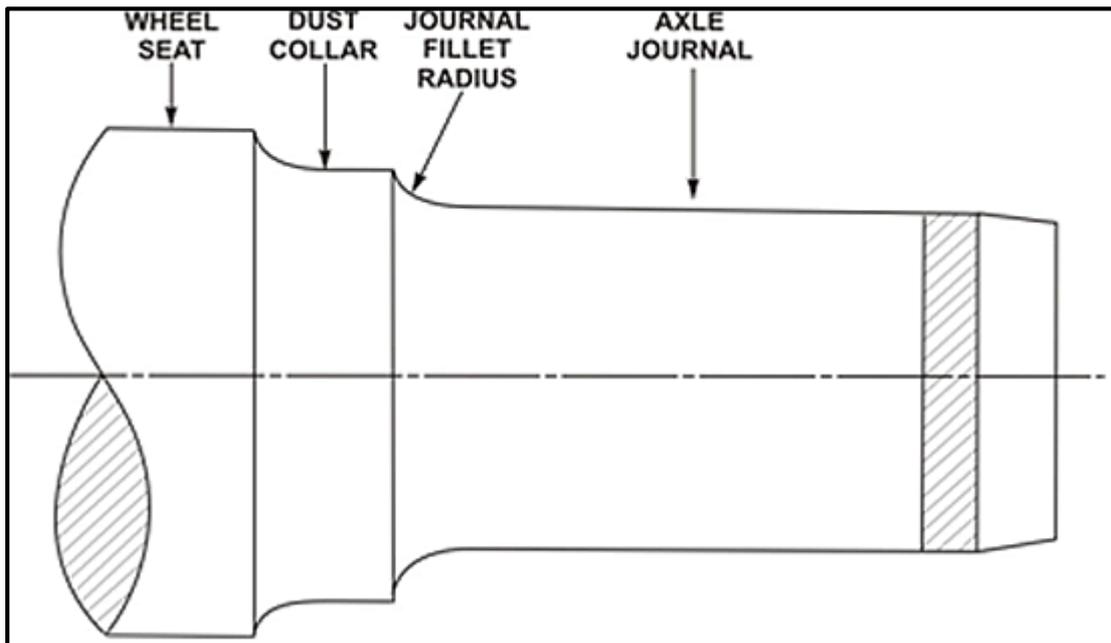
Figure 3
Axle journal

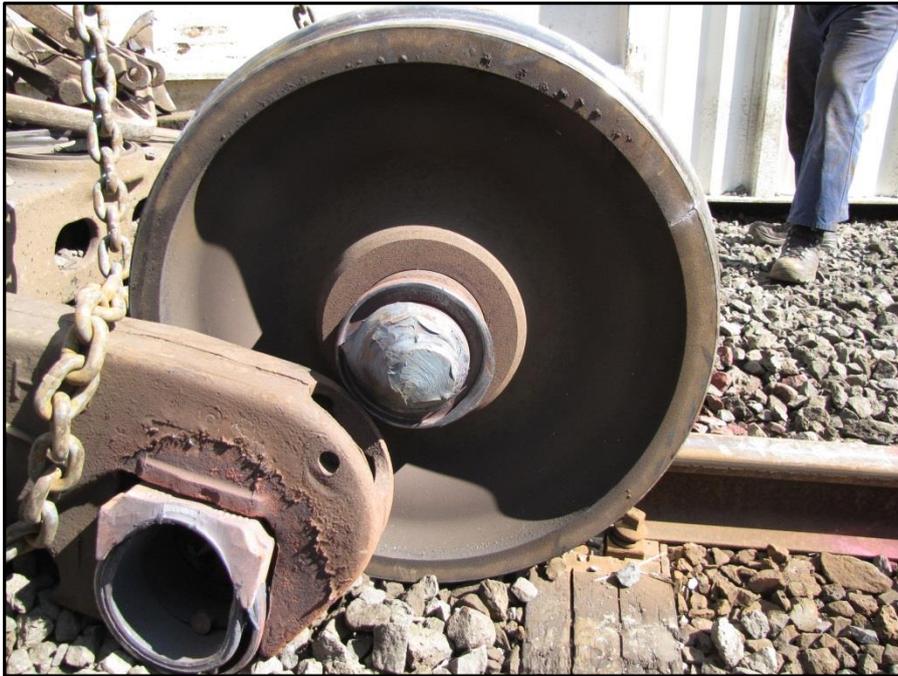
Figure 4
“Screwed” axle journal from the derailed wagon

- 4.1.4. The evidence points clearly to a wheel-bearing failure resulting in a “screwed” axle journal and the consequential dropping of the bogie side frame onto the rail. This sequence is described in more detail in the following analysis.

⁶ The term “screwed journal” is a rail industry term that describes the failure of a wheel-bearing and the consequential separation of the wheelset from the axle journal on which the bearing was fitted.

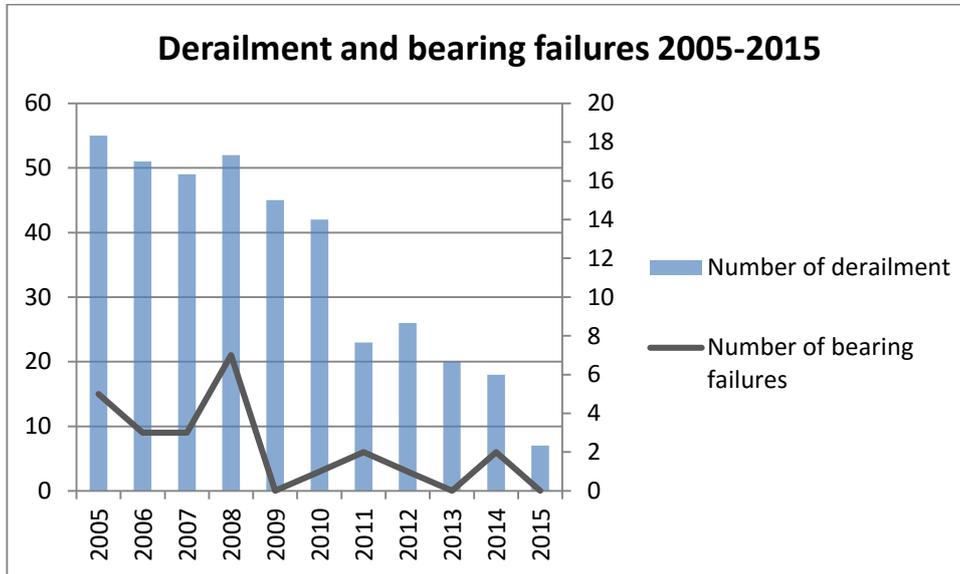
3.4.1. Fifty-five mainline derailments occurred on the rail network in the financial year ending 30 June 2005. Since then, there has been a downward trend in the number of mainline derailments recorded, with seven derailments recorded during the financial year ending 30 June 2015 (see Figure 6). On 3 July 2015 KiwiRail confirmed that since the RailBAM systems were commissioned there had been one other derailment attributed to a bearing failure, which had occurred on 14 February 2014 on the Main South Line.

Figure 6
History of mainline derailments

- 4.4.15. Also supporting the effectiveness of the bearing acoustic monitoring system is the number of mainline derailments recorded on the national rail network which has trended downward from 55 to seven over a 10-year period, a reduction of 87%. While not all wagons pass over a RailBAM unit on a regular basis, more than 90% of the fleet does. More importantly, the "high use" wagons on unit trains such as the MetroPort fleet that shuttle between Tauranga and Auckland pass over the RailBAM daily in both directions, providing valuable information on bearing condition that enables scheduling of preventative maintenance.

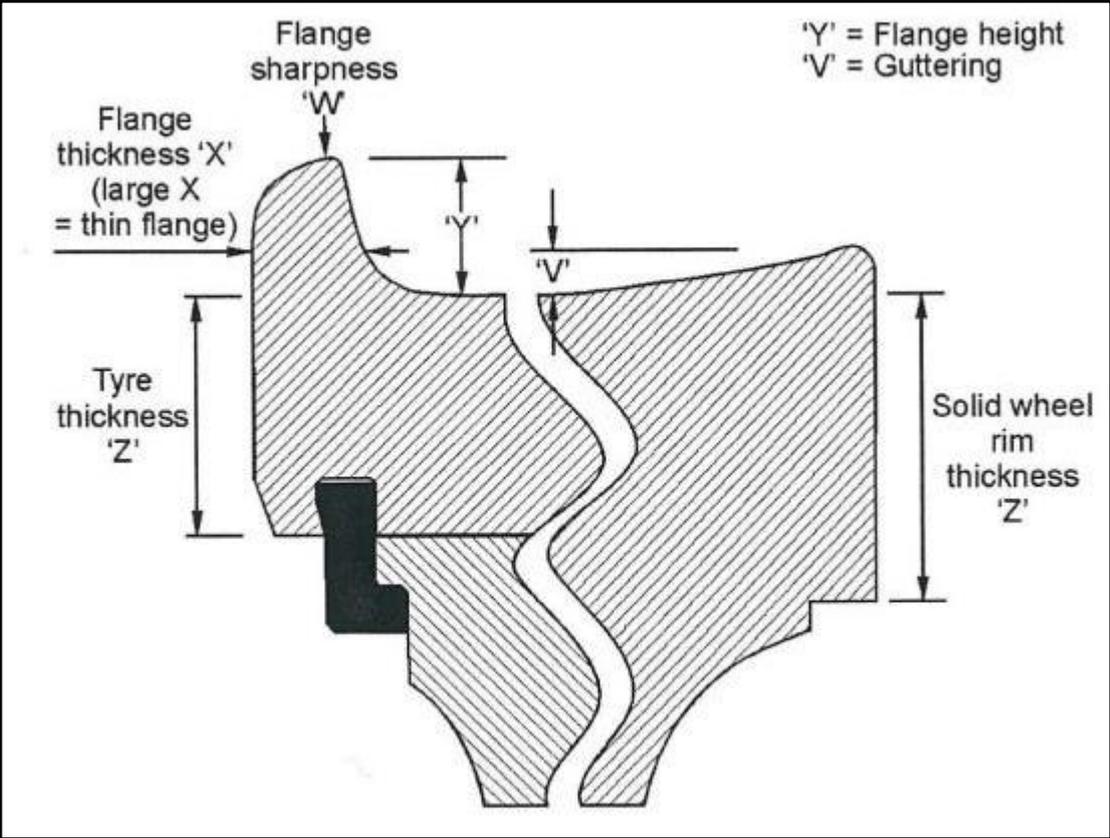
2. The flange wear limits set out in KiwiRail's Wheelset Manual M6000 Mechanical Code states in part that:
- the wheel is programmed for attention at 24 millimetres
 - attention must be given at 30 millimetres
 - the maximum limit allowed after wheel profiling is 40 millimetres.
3. The solid wheel rim limits set out in the Wheelset Manual requires that:
- a new solid wheel fitted to a Type 14 bogie has a Z reading of 57 millimetres
 - the diameters of two wheels on the same axle must not differ by more than one millimetre (Z gauges are not to be used for this purpose)
 - the diameters of wheels on the same bogie must not differ by more than 20 millimetres
 - the condemning limit for a solid wheel on a Type 14 bogie is a Z reading of 16 millimetres.

Figure 8
Profile of rail wheel
(provided by KiwiRail)
