Inquiry 13-201: Accommodation fire on board the log-carrier,
Taokas Wisdom, Nelson, 11 July 2013

Marine inquiry RO-2013-201

Accommodation fire on board the log-carrier, *Taokas Wisdom*,
Nelson, 11 July 2013

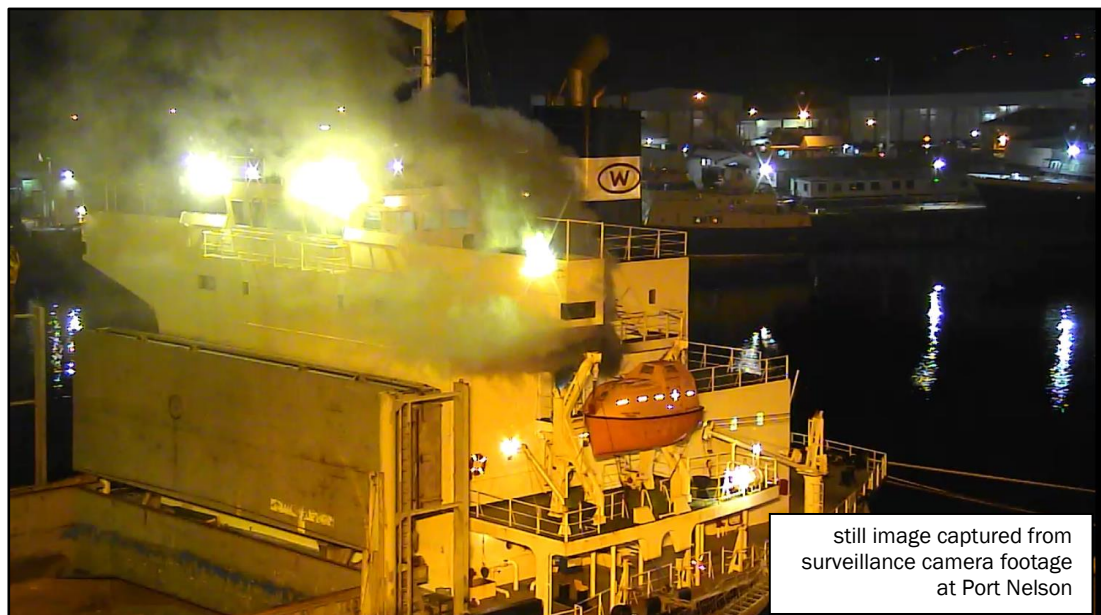
Figure 4
Smoke billowing from the port-side emergency exit door on the B-deck

- 3.1.10. Some crew members retreated down the internal stairwell to the A-deck, and others retreated outside via the B-deck emergency exit door located on the port side, leaving this door open as they did so (see location of door in Figure 3). Figure 4 shows smoke billowing out from this door.

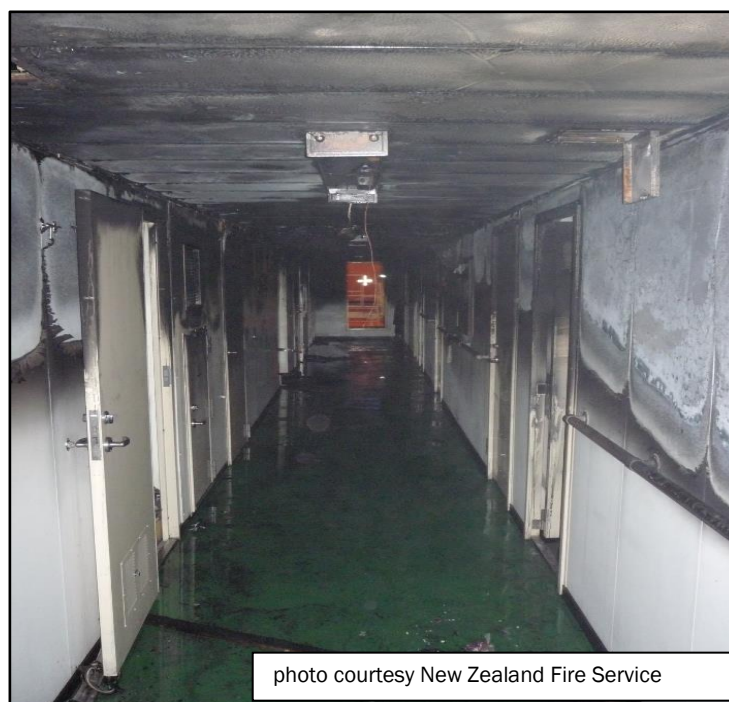
Figure 6
Smoke damage to the B-deck alleyway

- 4.2.6. The fire damage was restricted to AB-3's cabin, the B-deck alleyway and the common bulkhead between AB-3's cabin and the adjacent cabin. There was extensive smoke damage to the alleyway and to other cabins where their doors had been left open.
- 4.2.7. The corner of the bed, closest to the centre of the cabin, showed extensive fire damage (see Figure 7). The mattress, duvet and pillow were all severely burnt. The day bed showed signs of fire damage, particularly at the end closest to the centre of the cabin.
- 4.2.8. AB-3's cabin bulkhead had suffered significant heat damage, resulting in the buckling of the bulkhead lining. The buckling was greatest at the centre of the cabin. The common bulkhead of the adjoining cabin also showed signs of surface damage (see Figure 8).

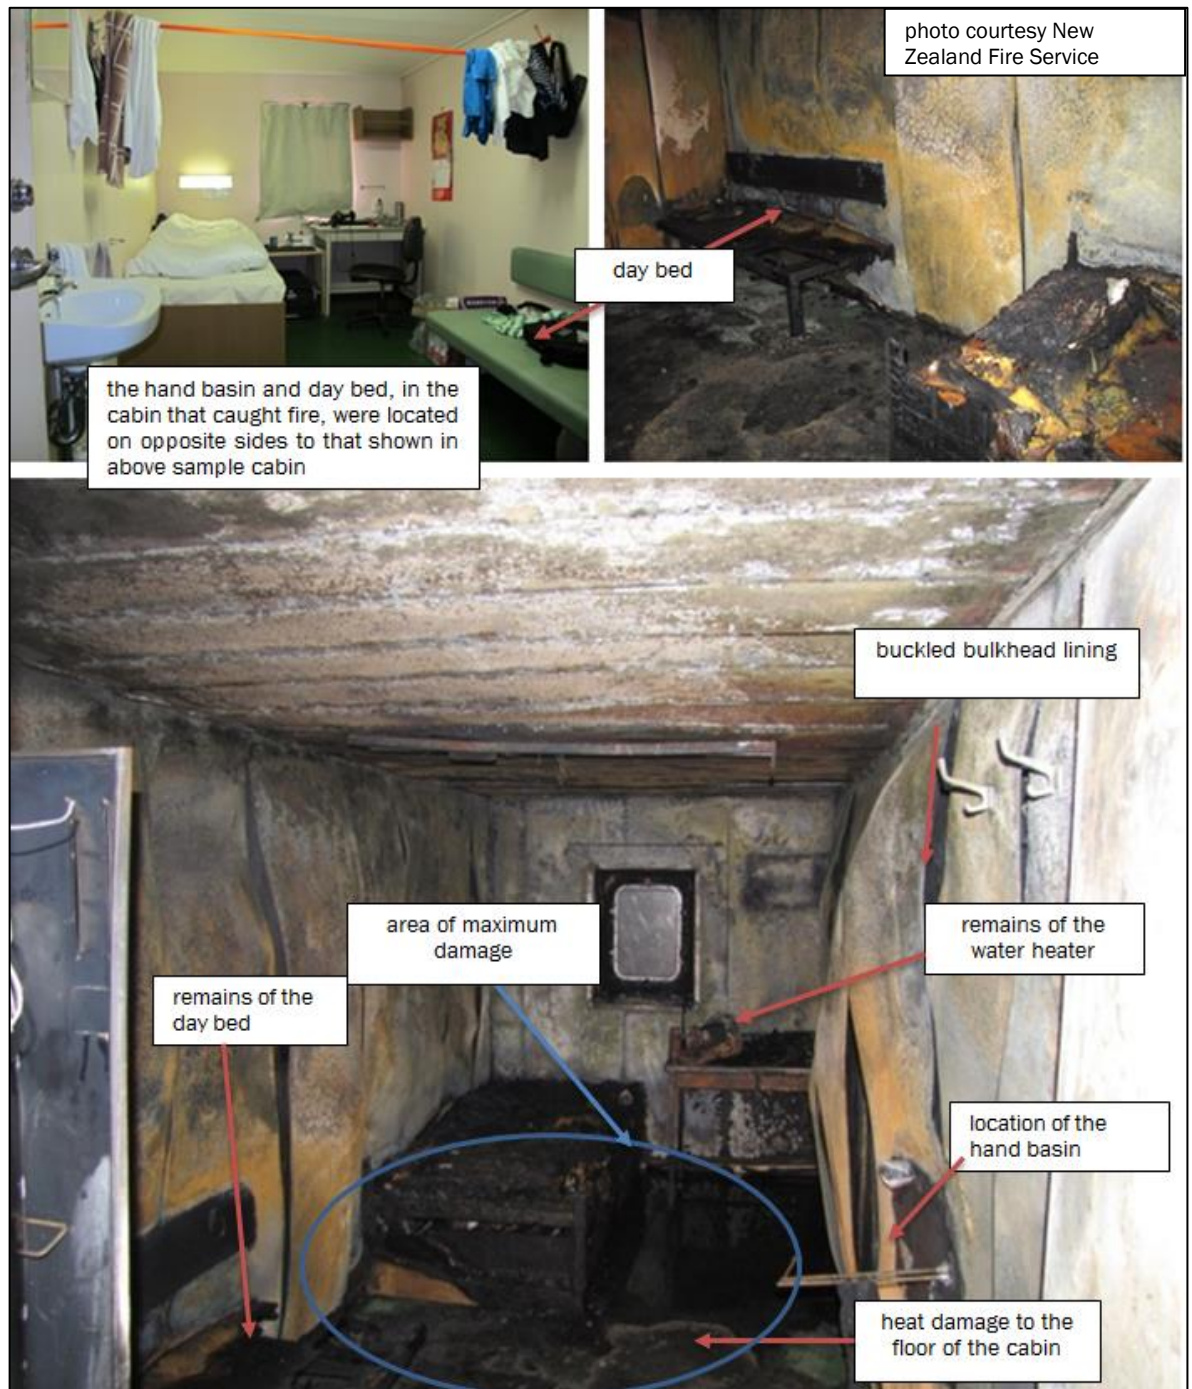
Figure 7
An undamaged cabin and the fire-damaged cabin on the B-deck

- 4.2.9. Heat damage to the floor in the centre of the cabin had lifted the floor coating, revealing the sheet-steel floor beneath.
- 4.2.10. The metal cabin desk situated in the aft corner of the cabin (see Figure 7) was heat damaged and the charred remains of a water heater and some books were found on top of the desk. An electric socket was located on the aft wall and the remains of a book shelf containing books and various papers were present. The remains of a hand basin were found on the port bulkhead of the cabin. The light fittings in the cabin were damaged and only the bare frame of the central overhead fluorescent lamp remained.

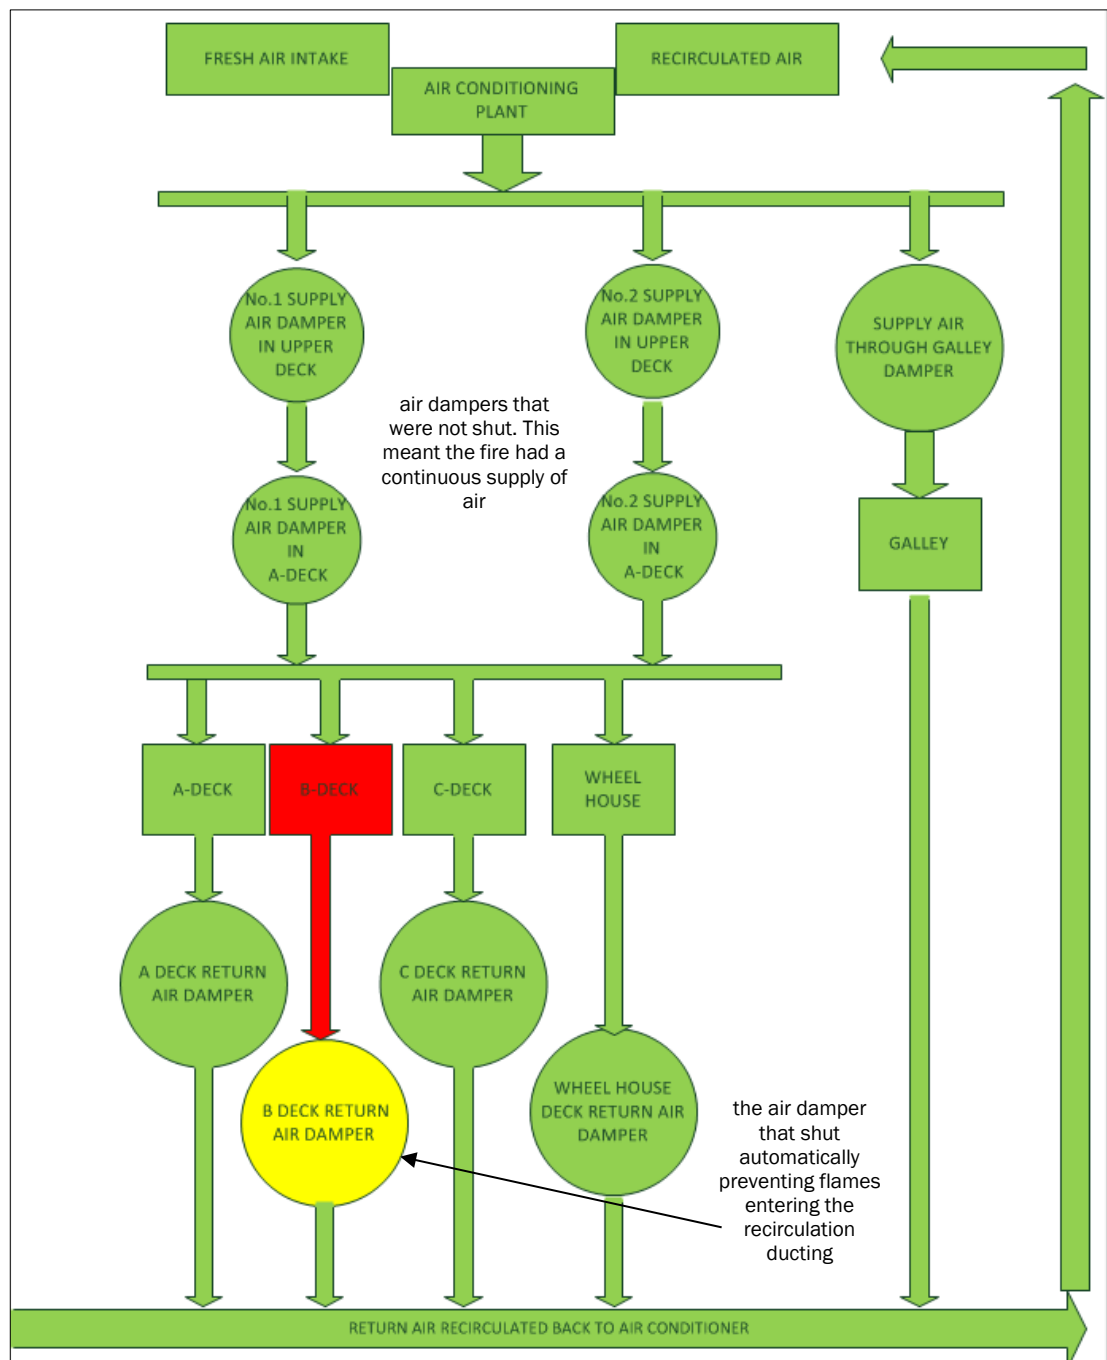
Figure 9
Air circulation flow chart showing locations of automatic dampers

- 4.3.12. Figure 9 is an air circulation flow chart showing the direction of airflow (green arrows) from the air-conditioning plant, through the accommodation spaces and back to the air-conditioning unit through the recirculation ducting. The air ducts had 9 automatic fire dampers, each fitted with fuses that would trigger a damper-closing mechanism once the temperature of the fuses reached 72 degrees Celsius. It was also possible to close these automatic fire dampers manually.
- 4.3.13. On the day of the incident, the heat from the fire caused the fuse on the B-deck return-air damper to break. The damper automatically closed, isolating the fire from the return-air ducting (see the yellow circle in Figure 9). However, the nearest supply-air damper was located on the A-deck, where the temperature rise was not sufficient to close the damper automatically.

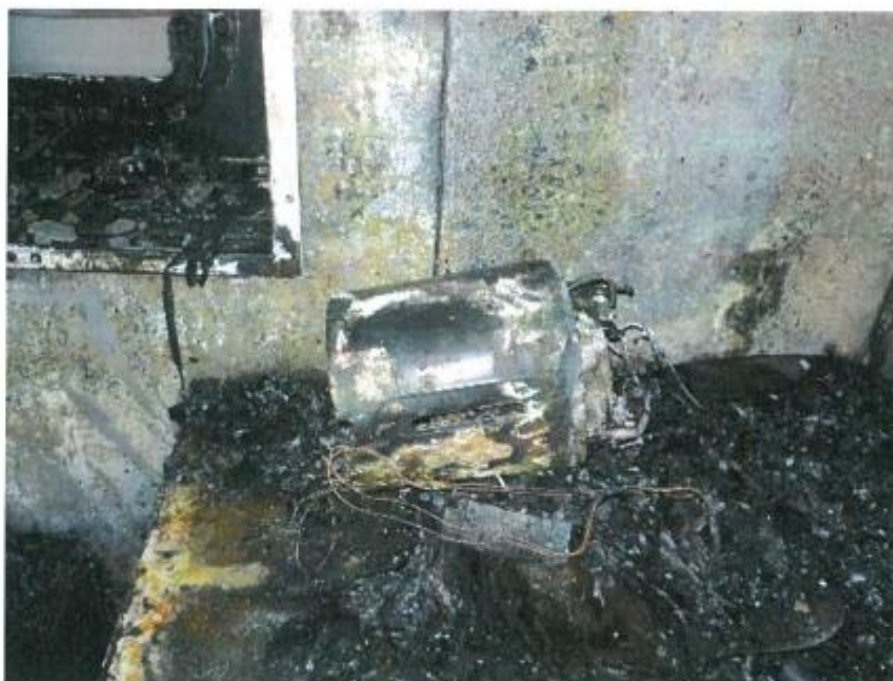
Water heater.

The water heater was situated on the metal desk and Witness 1 advised that it was plugged in to the power source and operating at the time he left the cabin. Witness 1 advised he topped up the water heater the previous night. The remains of the water heater were found on the desk, lying on its side. It was not possible to confirm that the water heater was plugged in to the power socket due to the extensive fire damage to the wiring and wall socket. The fire damage to the rest of the cabin is not consistent with the fire starting in the water heater on the metal desk and spreading to the rest of the contents of the cabin.

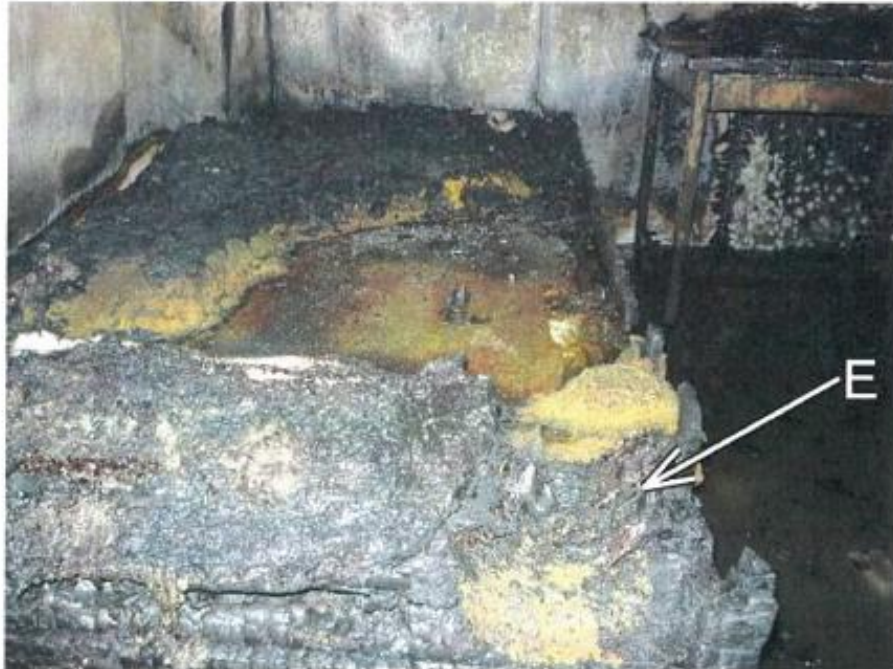
Witness 1 advised that he left his MP4 player on the bed when he left the cabin to start his shift and that the charger for the MP4 player was plugged into the wall socket above the metal desk. The MP4 player was not plugged into the charger as the charging cable was not long enough to reach the bed. The remains of what was thought to be the MP4 player were found next to the pillow at the head of the bed on the side closest to the centre of the room.

There was no evidence to suggest that the MP4 player played any part in the cause of this fire.

E: Remains of what is thought to be the MP4 player.

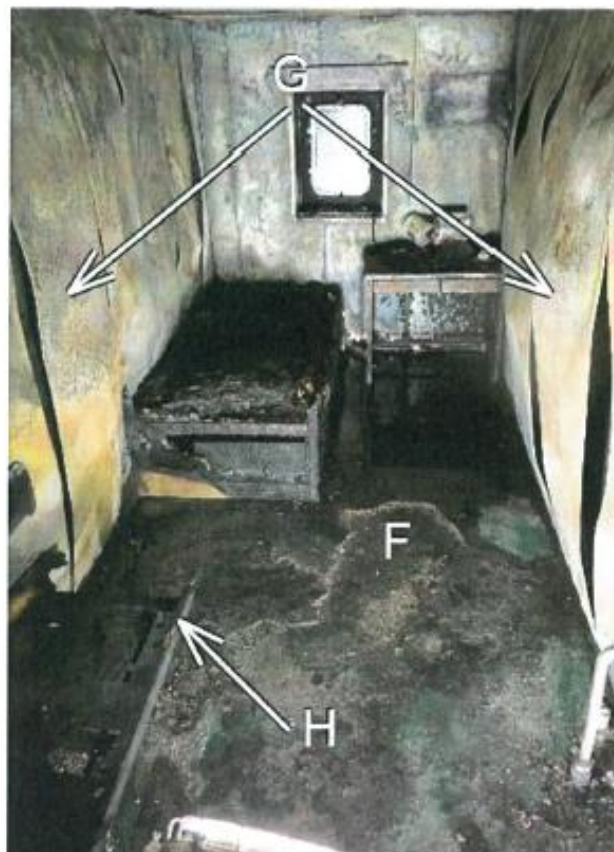
When Witness 1 left his cabin, the door was closed but not locked. The fire damage to the room indicated extensive heat damage to the centre area of the cabin. This was indicated by spalling damage to the plaster flooring, the buckling to the metal cabin walls, damage to the bench seat and corner of the bed.

The heat damage on the floor had separated the floor coating from the steel deck. The resulting irregular shaped pattern on the floor indicates that this area of the deck has been subjected to a greater heat source. As there was a lack of any combustible materials in this area which could produce this kind of damage, the possibility of the use of a flammable liquid creating the heat required to cause this kind of damage cannot be discounted.

The corner of the bench seat closest to the centre of the room had almost burnt away indicating the fire had been concentrated in this area.

F: Area of spalling on the cabin floor. G: Buckling to the metal walls. H: Bench seat showing fire damage to the corner.

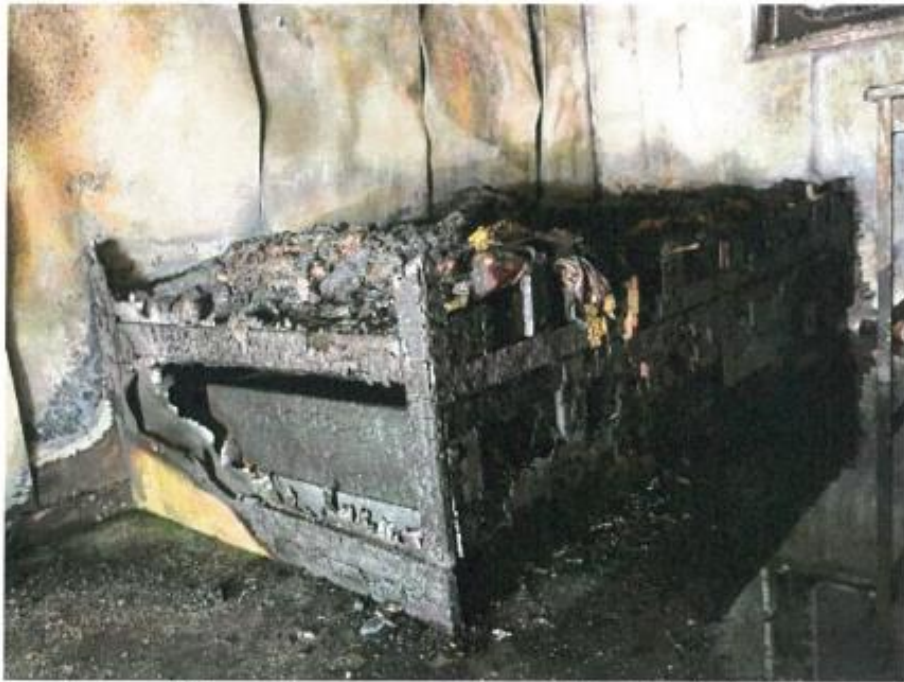
A "V" burn pattern to the corner of the bed pointed towards the centre of the room possibly indicating the point of fire origin.

V burn pattern damage to corner of the cabin bed.

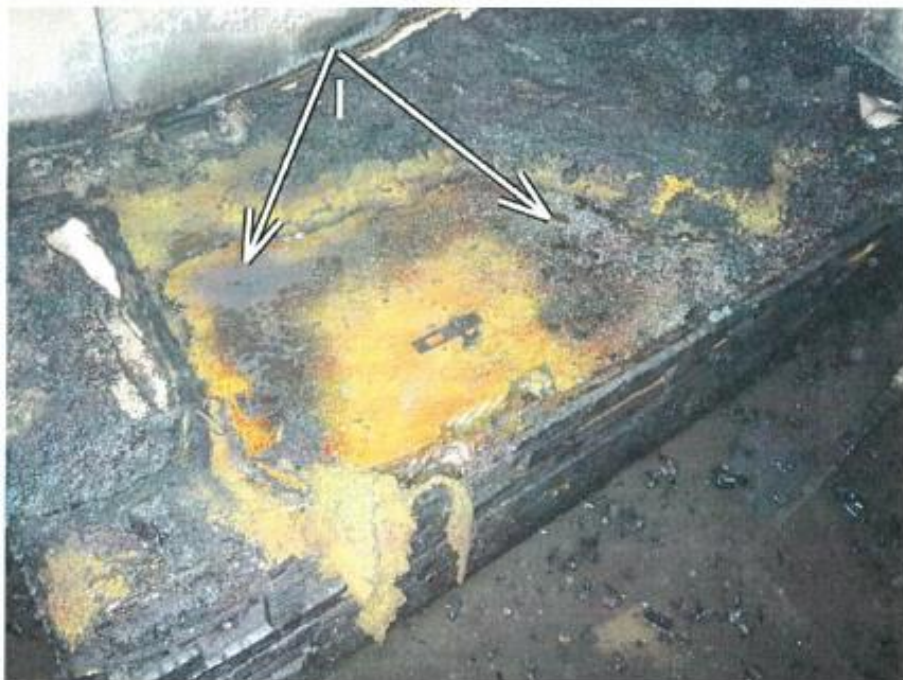
The mattress on the bed was a polyurethane foam squab. A portion in the centre of the mattress had burnt through to the wooden base although there was a section of the base that had been protected by an unknown object which had been removed prior to the fire investigators attendance. This was indicated by a clean patch on the wooden base and also a door lock striker plate which did not show any signs of fire damage. The unusual burn pattern damage to the polyurethane foam squab mattress is not consistent with the fire damage to the rest of the mattress.

Cabin bed showing clean/protected bed base with door lock striker plate. 1: Unusual burn pattern on bed base.

Due to the unusual burn patterns to the mattress squab, the irregular shaped pattern on the deck, the bed and bench seat indicators pointing towards the centre of the cabin being the point of fire origin, and the insecure cabin, incendiarism cannot be discounted as a supposed cause.
