Inquiry 13-202: Bulk carrier, *IDAS Bulker*,
pilotage incident Napier, Hawke's Bay, 8 August 2013

Final Report

Marine inquiry 13-202 : Bulk carrier, *IDAS Bulker*, pilotage
incident Napier, Hawke's Bay, 8 August 2013

Approved for publication: April 2014

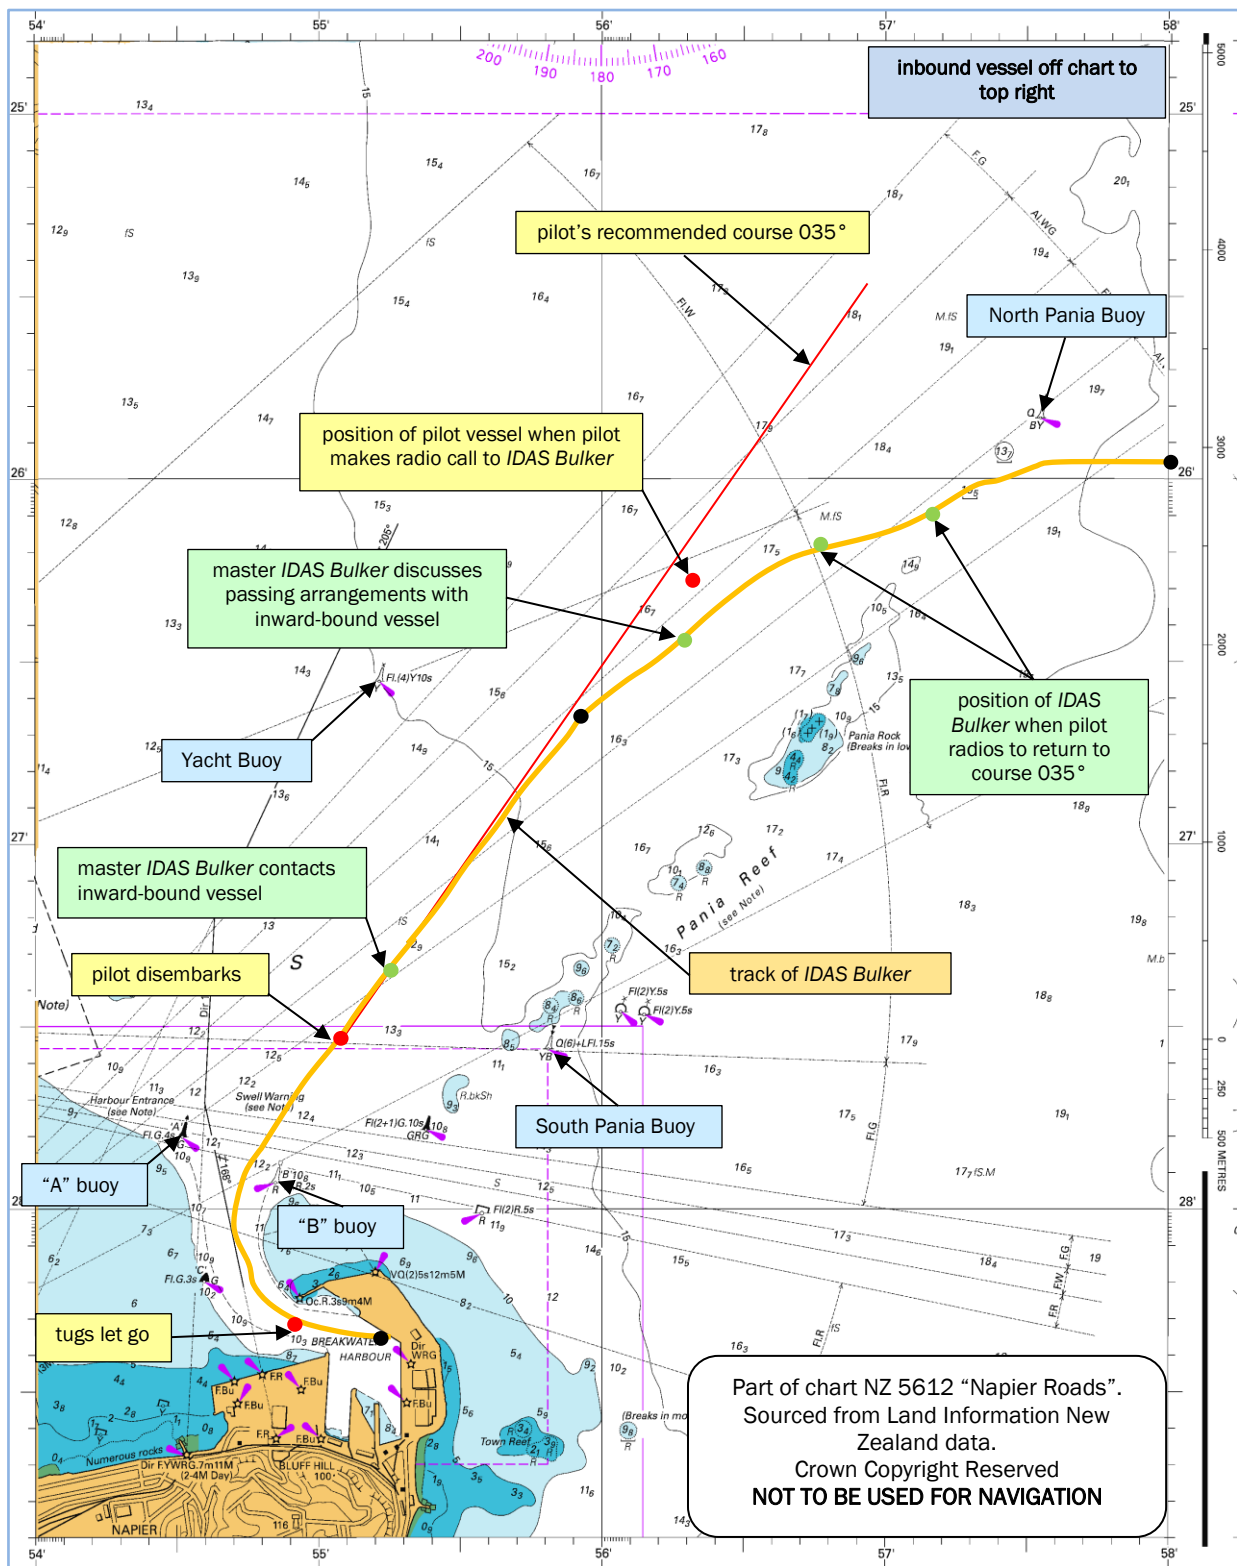
Figure 2
Track of the IDAS Bulker

- 3.1.4. By about 21:18 the *IDAS Bulker* had 2 tugs fast and was then let go from the wharf. The pilot manoeuvred the vessel off the wharf using the tugs and main engine. He ordered the 2 tugs let go as the vessel passed the entrance to the port (see Figure 2).

- 3.1.5. As the vessel passed between “A” and “B” buoys (see Figure 2) at the entrance to the dredged channel, the pilot manoeuvred the vessel to a course of 035 degrees (°). He briefed the master to remain on a course of 035° and leave North Pania Buoy to starboard. He then pointed out visually, on the radar and on the passage plan chart, the position of North Pania Buoy, South Pania Buoy and Yacht Buoy and the position of Pania Reef (see Figure 2).

- 3.1.6. As the *IDAS Bulker* was passing abeam of South Pania Buoy the pilot left the vessel (see Figure 2) and boarded the *Pania*, the pilot vessel. The master then took control of the navigation of the *IDAS Bulker* on the 035° course. The master summoned the navigator (second officer) to the navigating bridge to check the pilot’s designated route as it was not the route that the navigator and master had planned earlier.

- 3.1.9. At this time the *Pania* was astern of and on the port side of the *IDAS Bulker*. The pilot on board the *Pania* noticed both visually and on his multifunction navigation screen that the *IDAS Bulker* was turning to starboard. The pilot then called the *IDAS Bulker* on very-high-frequency radio channel 12 and advised him to alter course hard to port and come back to a heading of 035° (see Figure 2).

- 3.1.10. The master replied to the pilot and immediately instigated a hard-to-port manoeuvre as he believed he was heading into danger. After initiating the manoeuvre the master and second officer studied the chart and decided that the vessel was in safe water and that his intended course was still acceptable. The master then ordered 20 degrees starboard helm to bring the vessel back on a track to pass south of North Pania Buoy (see Figure 2). The pilot called the *IDAS Bulker* again to advise the master to turn back to port; the master replied that he was too close to North Pania Buoy to comply and continued through the clear water to the south of the buoy.

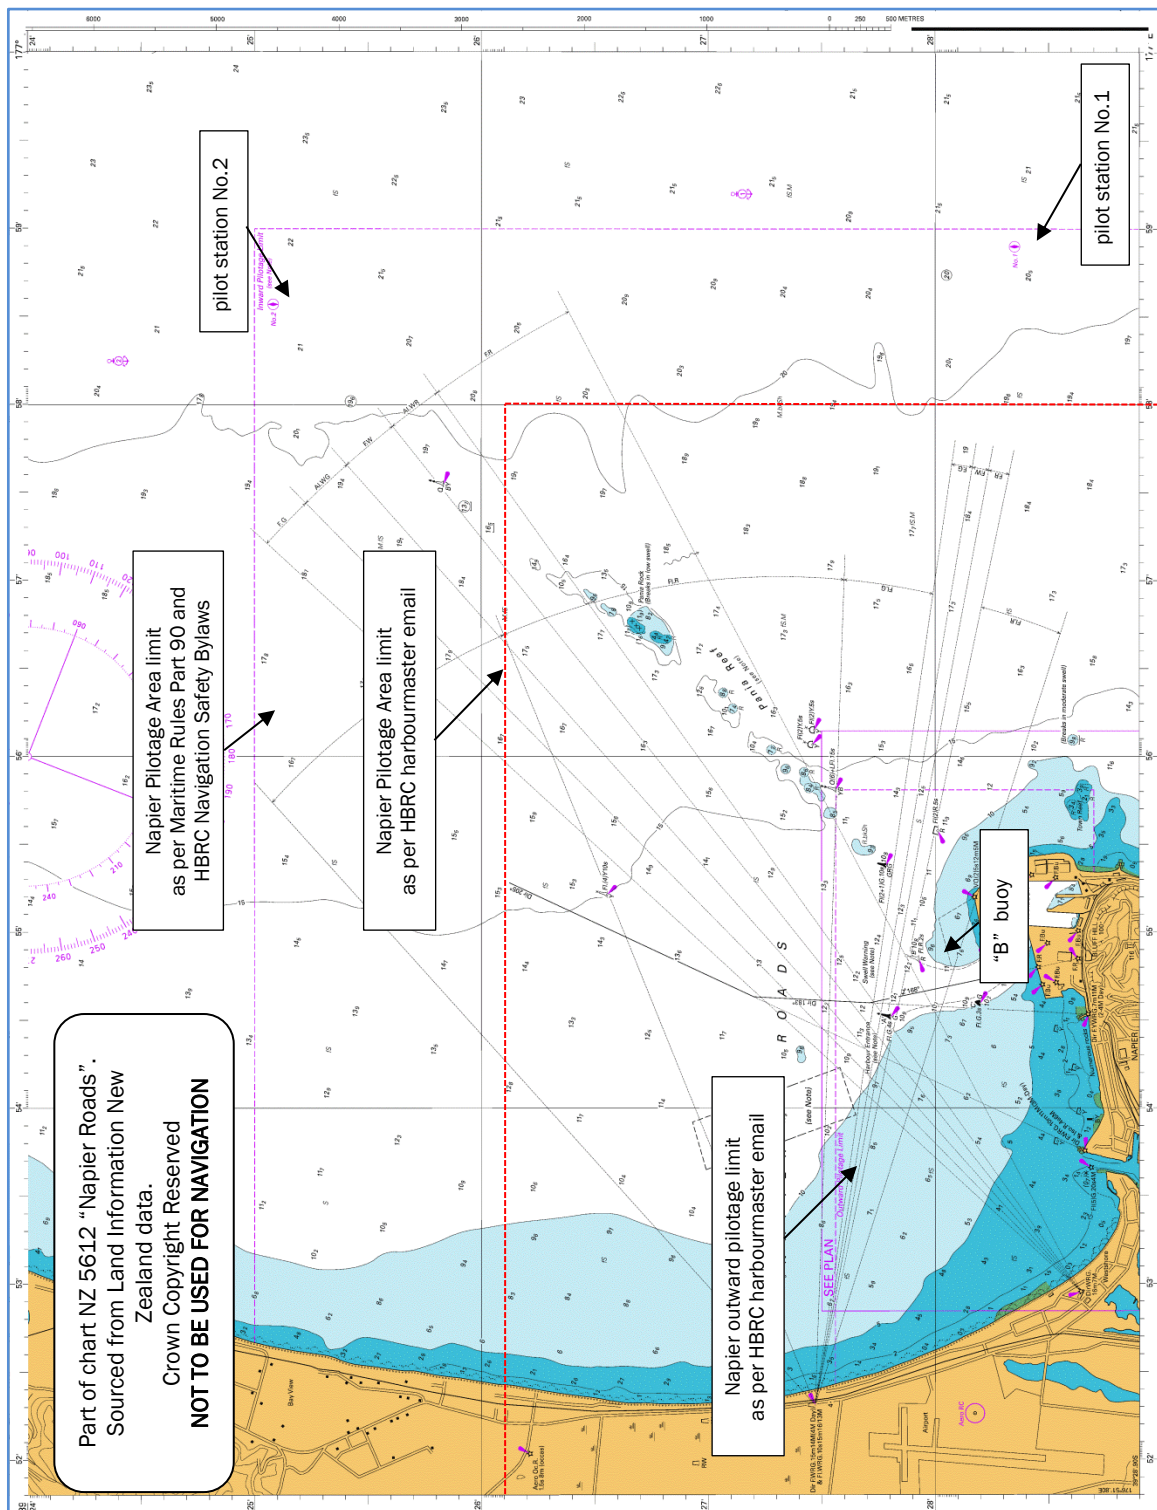
Figure 3
Extent of pilotage areas

The area comprising all port waters between latitudes 39°25'S and 39°29'S, to the west of longitude 176°59'E. (Port limits: the seaward limit of the port is the arc of a circle radius 3 ½ miles centred on East Pier Light (39°28'.7S, 176°53'.7E))

This pilotage area is the same as that shown in the Hawke's Bay Regional Council Navigation Safety Bylaws (see Appendix 4). In the 2010 amendment to Maritime Rules Part 90 the vessel size limits were changed to: "500 gross tonnage or 40 metres length overall".
