Final report AO-2014-005: Eurocopter AS350-B2 (ZK-HYO), collision with terrain during heli-skiing flight, Mount Alta, near Mount Aspiring National Park, 16 August 2014

Aviation inquiry AO-2014-005
Eurocopter AS350-B2 (ZK-HYO)
collision with terrain during heli-skiing flight
Mount Alta, near Mount Aspiring National Park
16 August 2014

Approved for publication: November 2017

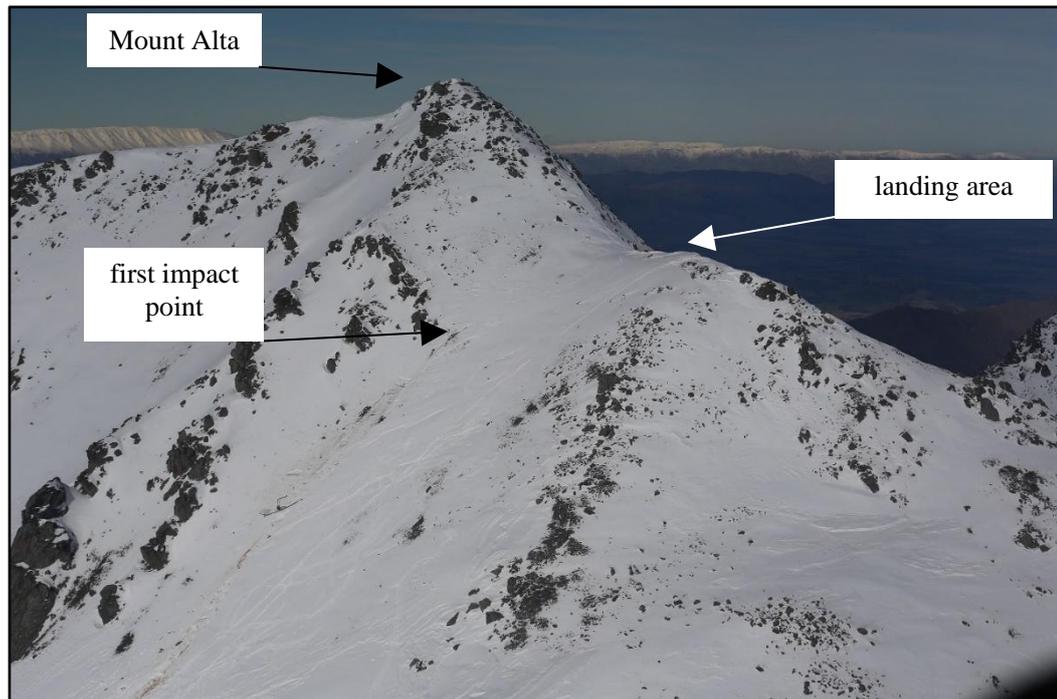
Figure 2
Mount Alta looking southeast in the direction of the landing approach

- 3.1.11. The weather conditions were nearly calm with a very light southerly wind. The pilot elected to approach the landing site from the northwest, into the light southerly wind. A length of orange ribbon on a cane pole had previously been placed close to the landing site to act as a wind marker for pilots. As the helicopter neared the landing site the pilot was unable to see the wind marker, because it was below a small snowbank. He was not sure where the wind was from and considered the possibility that there was a tailwind, so he maintained his airspeed and overflew the ridge.
- 3.1.12. After passing over the ridge, the pilot and guide saw the wind marker below the ridgeline. The wind marker indicated a light southerly breeze, so the pilot overflew the landing site a second time and repositioned the helicopter on the north side of the ridge for an approach (see Figures 2 and 3).

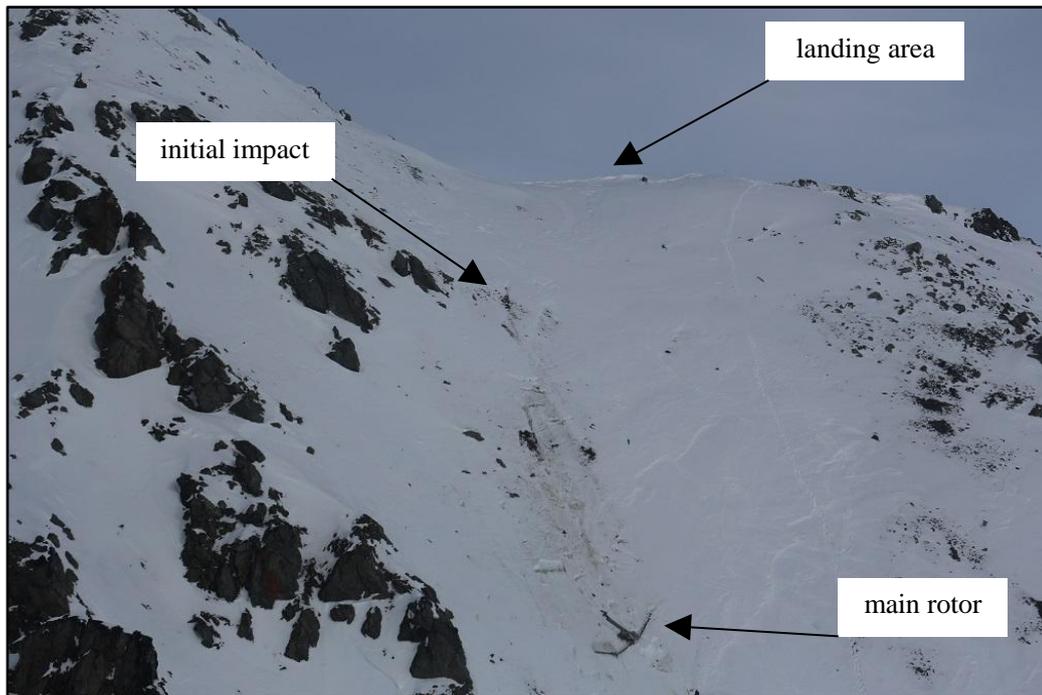
Figure 4
Initial impact site

- 3.2.3. The first impact mark was a cut through the snow about 20 m below and 47 m from the intended landing site. The cut extended for several metres and was adjacent to a flattened or compressed area of snow and rock. Paint transfer was found on some of the exposed rocks in this area. The shape of the cut suggested that one of the helicopter's skids had struck first. The confused nature of the following marks in the snow and the paint transfer marks on the rocks were consistent with the fuselage having started to tumble immediately after the first impact.

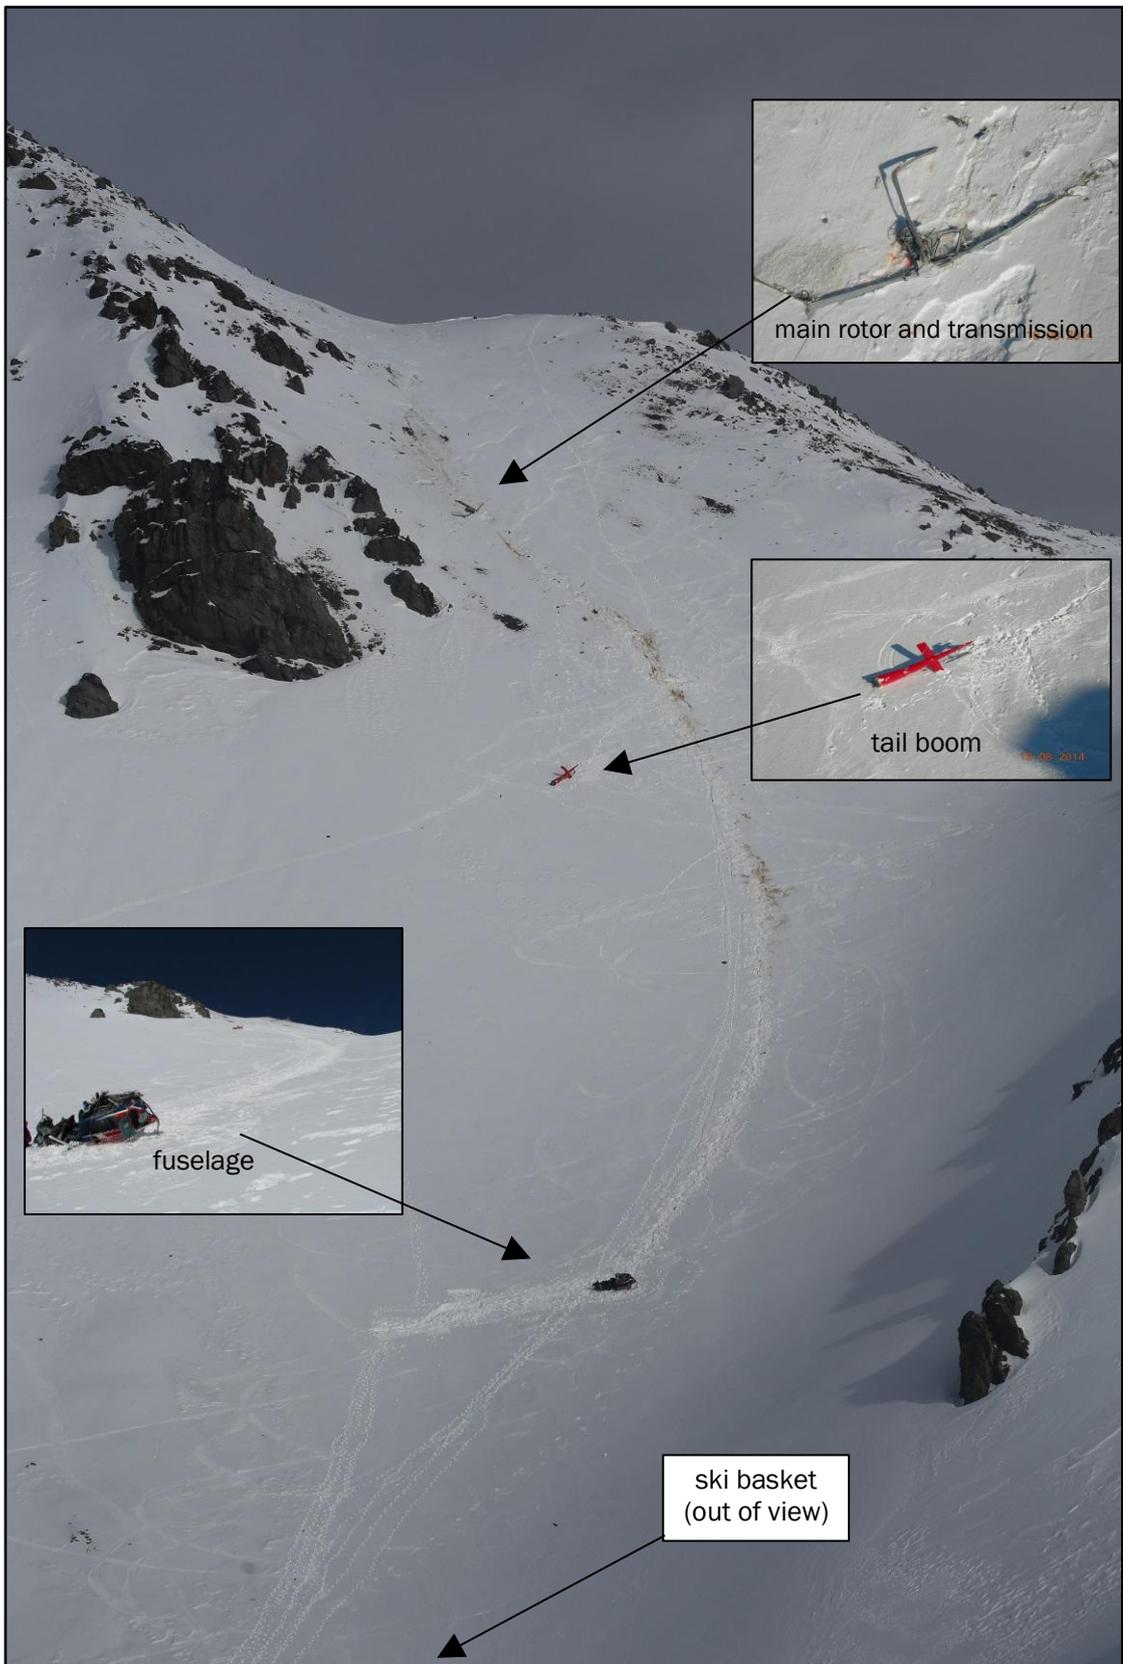
Figure 5
Accident site – general

- 3.2.4. The main rotor assembly, including the transmission and three main rotor blades, was found a further 45 m along the wreckage trail. The number and pattern of rotor blade strikes in the snow and on the exposed rock were consistent with the main rotor blades having been turning at high speed (see Figure 5).

- 3.2.8. The structure around the cabin, including all the doors, roof and nose cowling, had separated, exposing the seats (see Figure 5). The instrument panel had broken from its mounting but remained attached by wiring. Both skids had broken in several locations. The fuel tank was intact but a small amount of fuel was found leaking from the fuel line leading to the engine. The emergency locator transmitter had activated but the cable leading to the aerial had broken as a result of the tail boom separating. The emergency locator transmitter was reported to have been turned off soon after rescue personnel arrived on-site.

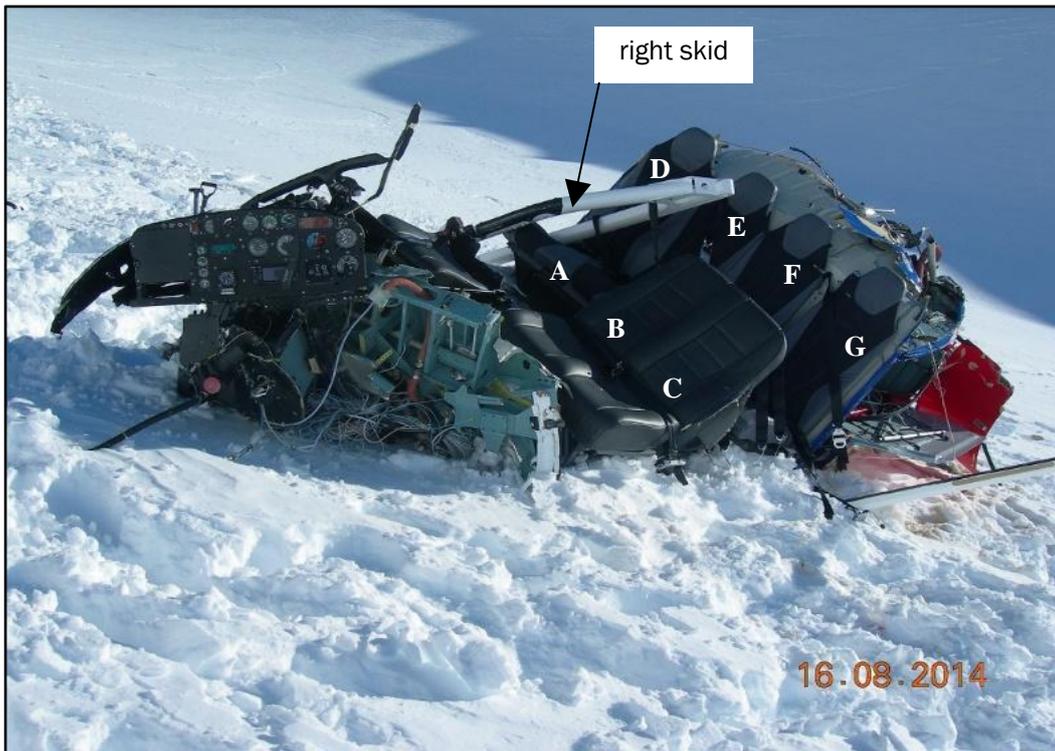
Figure 6
Seating positions

- 4.6.1. The injuries sustained by the deceased passenger were consistent with his having been struck by the broken right skid (see Figure 6), and being ejected from the helicopter and caught between it and the snow-covered slope as the helicopter came to rest. His injuries were unsurvivable. Three of the surviving occupants sustained serious injuries, including fractures, internal injuries and extensive bruising. The remaining three occupants sustained minor to moderate injuries, predominantly extensive bruising and sprains.

Occupant	Injuries	Seatbelt (type, status found, fitting)	Retained/Thrown out
A (pilot)	Moderate	Four-point harness, buckled, pulled tight	Thrown out (probably up and forward)
B	Minor	Four-point harness, buckled, pulled firm	Retained
C (guide)	Serious	Four-point harness, buckled, but broken, pulled firm	Thrown out
D	Fatal	Lap-diagonal, lap unbuckled, loose	Thrown out
E	Serious	Lap-diagonal, buckled, loose	Thrown out
F	Moderate	Lap-diagonal, buckled, firm	Retained
G	Serious	Lap-diagonal, lap unbuckled, loose	Thrown out

- 4.6.6. The three front seats (positions A, B and C) were all equipped with four-point harnesses – a lap belt and two shoulder straps. The outboard lap belt attachment fitting for seat C broke. Despite the seatbelt remaining buckled, the broken attachment effectively released the seatbelt and allowed the guide to be thrown out.
