Final report RO-2014-104: Express freight train striking hi-rail excavator
within a protected work area, Raurimu Spiral, North Island Main Trunk line, 17 June 2014

Rail inquiry R0-2014-104
Express freight train striking hi-rail excavator
within a protected work area, Raurimu Spiral,
North Island Main Trunk line,
17 June 2014

Transport Accident Investigation Commission

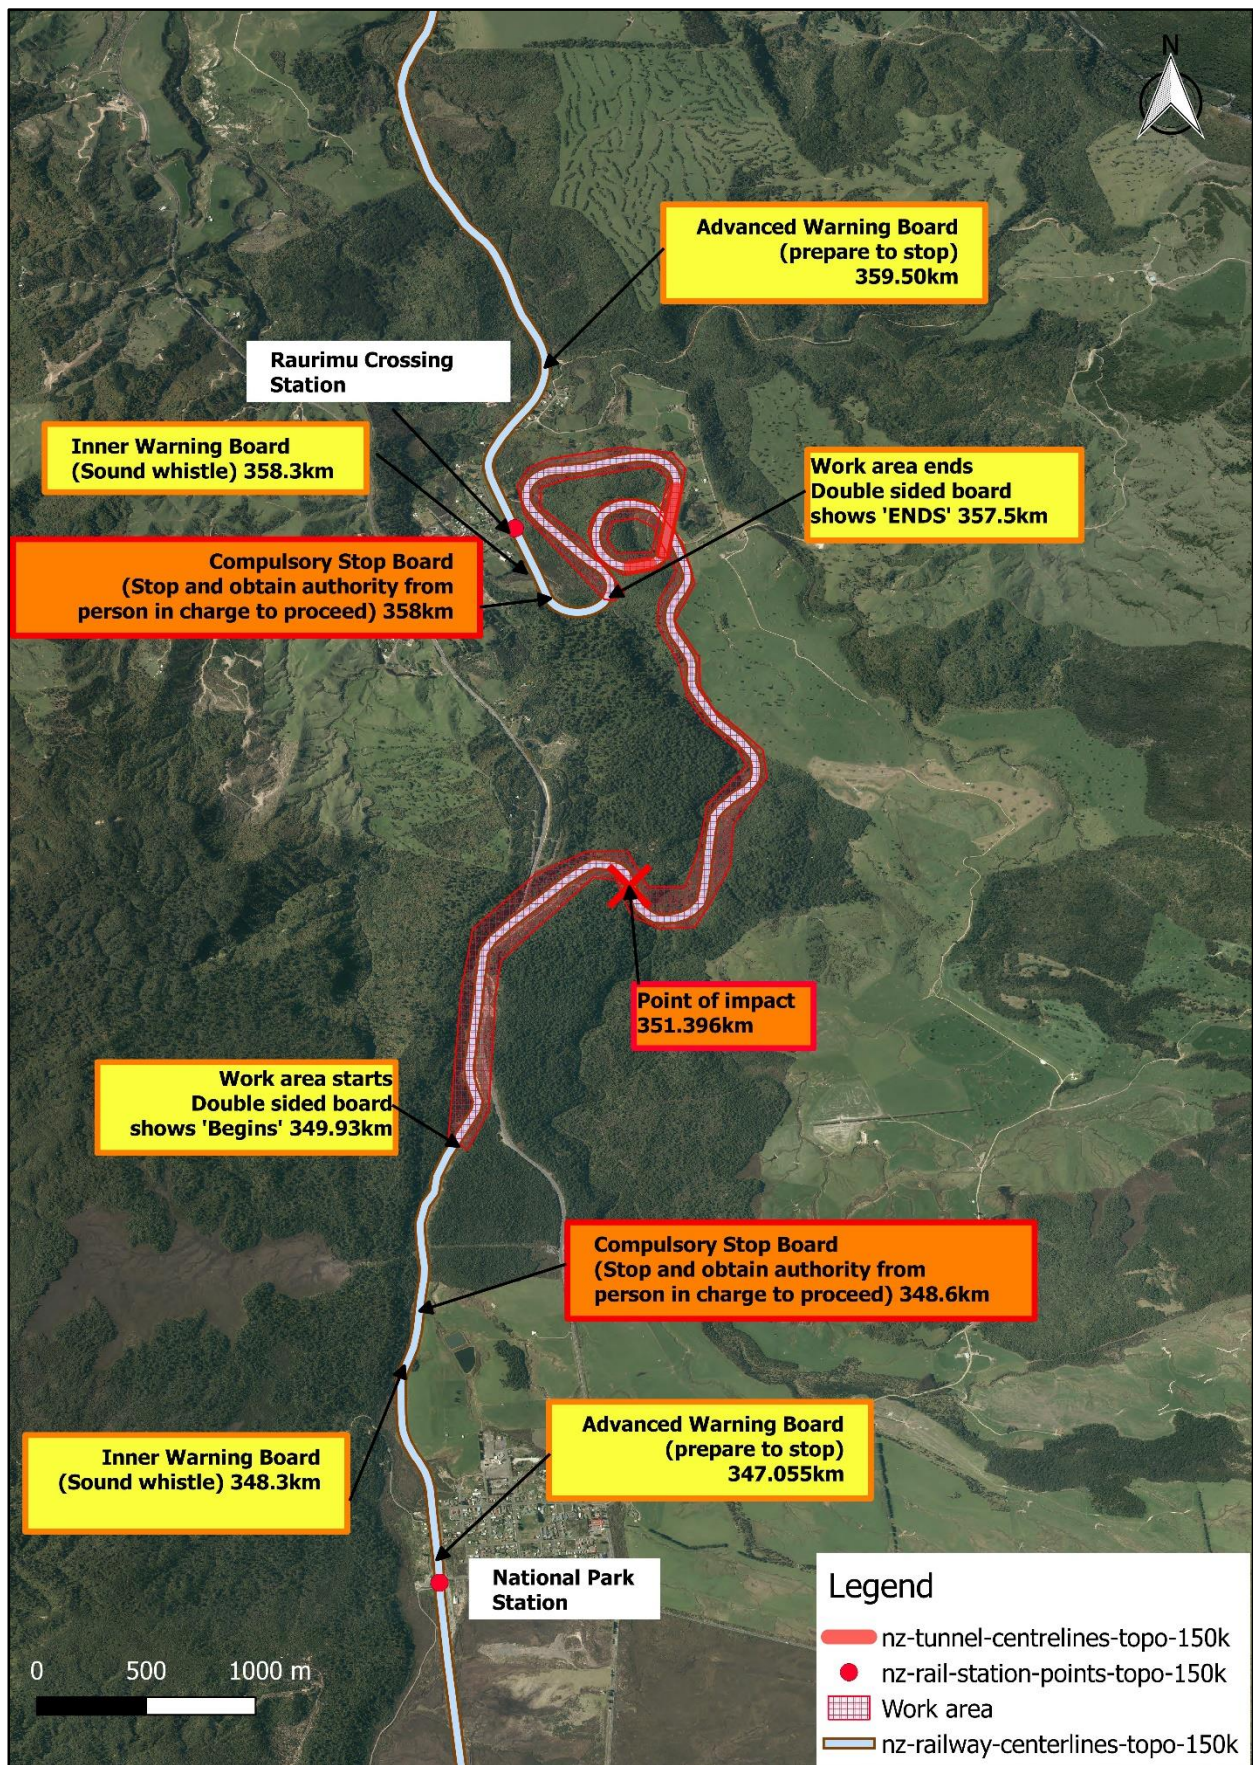
Figure 1
The protected work area

- 3.2.12. The rail protection officer erected the warning boards at the south (National Park) end of the protected work area then drove along the track north towards Raurimu. He stopped where the excavator had been parked overnight and gave the excavator driver verbal permission to on-track his excavator and follow him to the worksite. The electrical observer drove along the KiwiRail access road to the worksite.

- 3.2.13. At 0753 the rail protection officer radioed train control and arranged a five-minute extension to his track occupation. He stopped briefly at the worksite and told one of the work group to *"Stay off the track as I may not get all the boards up in time and there are two trains coming"*. The rail protection officer then continued towards Raurimu.

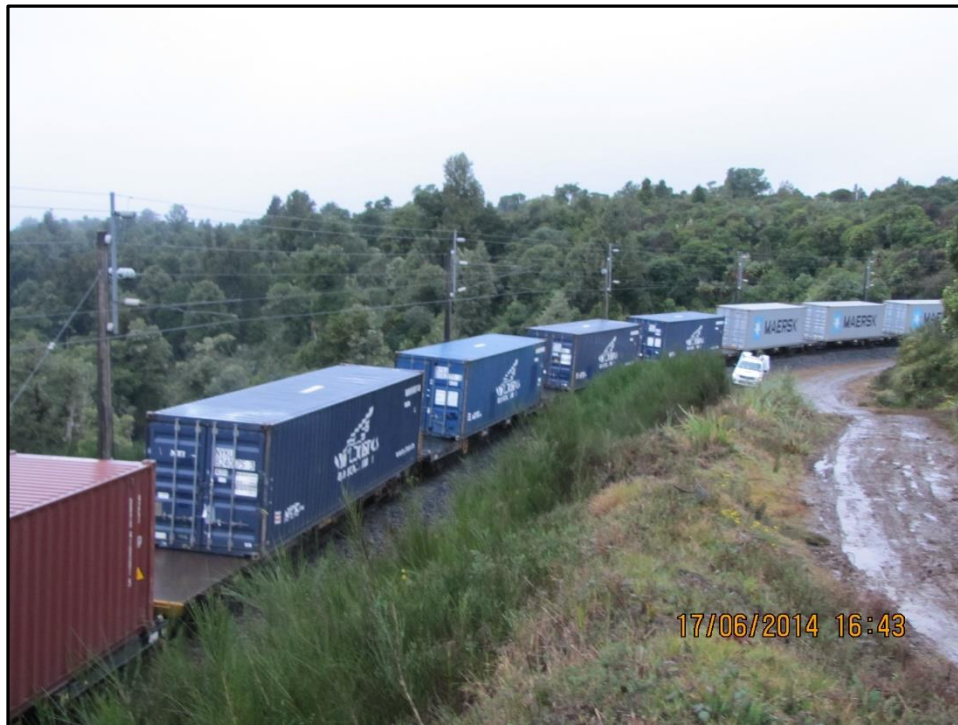
Figure 2
Access road along which the work group vehicles were parked

- 3.2.14. Meanwhile the excavator driver had on-tracked his excavator and driven along the track, arriving at the worksite about five minutes after the rail protection officer had passed through. He then off-tracked his excavator about 40 metres around a curve and out of sight of where the work group had parked their vehicles beside the track (see Figure 2).
- 3.2.15. The excavator driver then radioed the rail protection officer and told him that he was “off and clear of the track”. The excavator driver sat in the cab for about 10 minutes before he walked back and joined other members of the work group who had congregated near their parked vehicles.

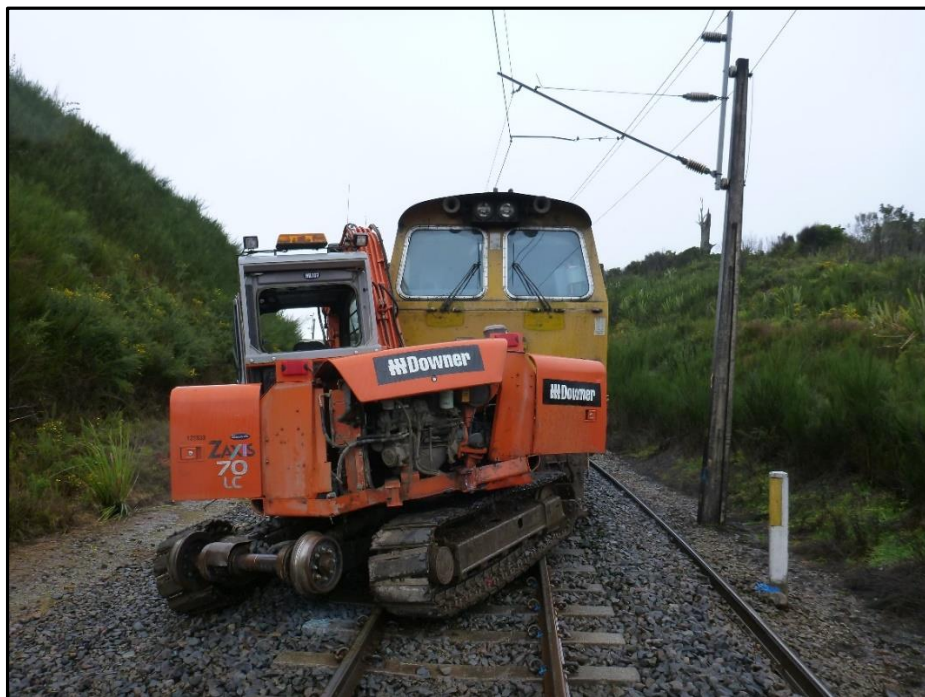
Figure 3
The collision

- 3.2.25. The train driver saw the excavator driver look over his shoulder at the train and begin to rotate the bucket in the direction of the locomotive.

- 3.2.26. The train was travelling at 42 kilometres per hour when it struck the excavator, but it took a further 103 metres to come to a stop (see Figure 3). The excavator was extensively damaged in the collision. The train driver informed the train controller, who alerted the emergency services. KiwiRail staff on site tried to keep the excavator driver alert until emergency services personnel arrived.
