Inquiry MO-2014-201: *Dream Weaver*, flooding due to structural failure of the hull,
Hauraki Gulf, 23 February 2014

Final Report

Marine inquiry MO-2014-201
Dream Weaver
flooding due to structural failure of the hull, Hauraki Gulf
23 February 2014

Approved for publication: October 2015

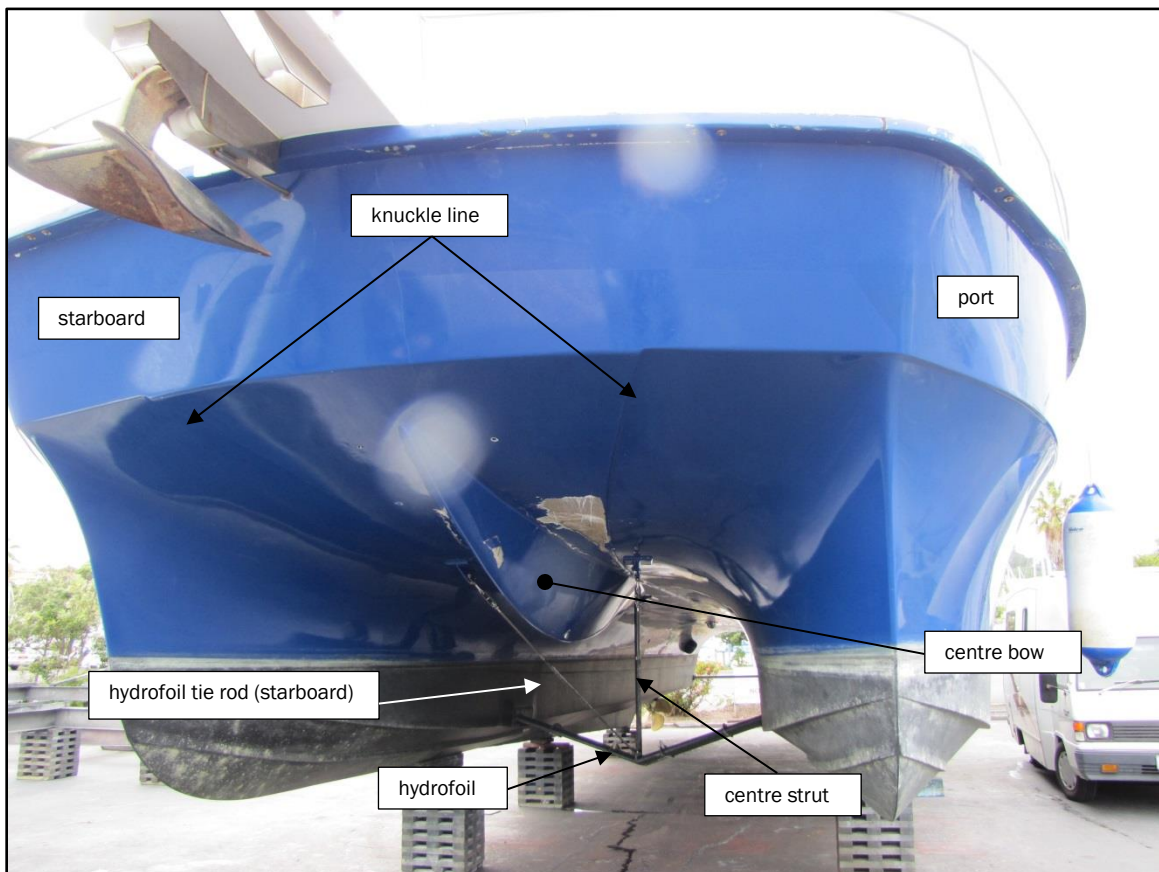
Figure 2
View looking at bows of Dream Weaver

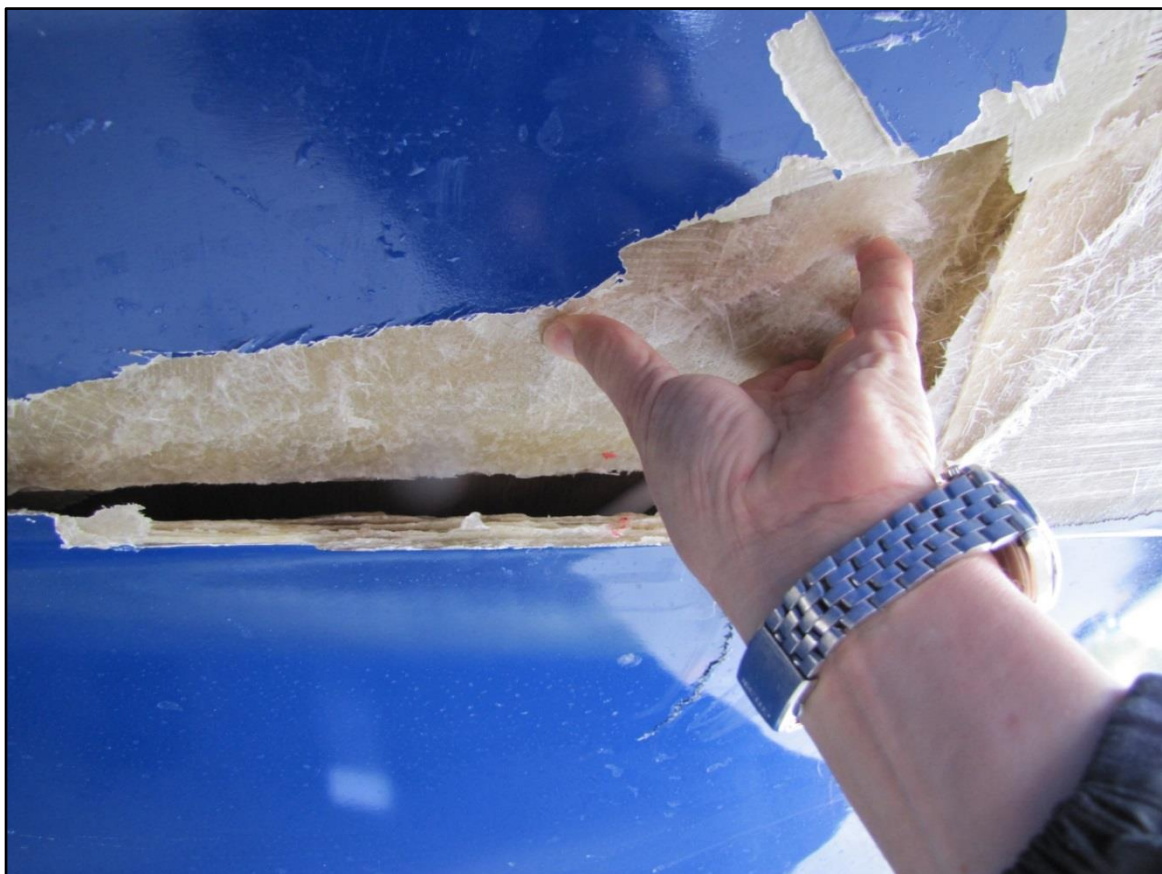
- the underside of the bridgedeck had damage to the fibre-reinforced plastic (FRP) laminate on both sides of the centre bow, including a rupture of the hull skin that had allowed water to enter the port hull (see Figure 3)

Figure 3
Damage sustained to port underside of bridgedeck

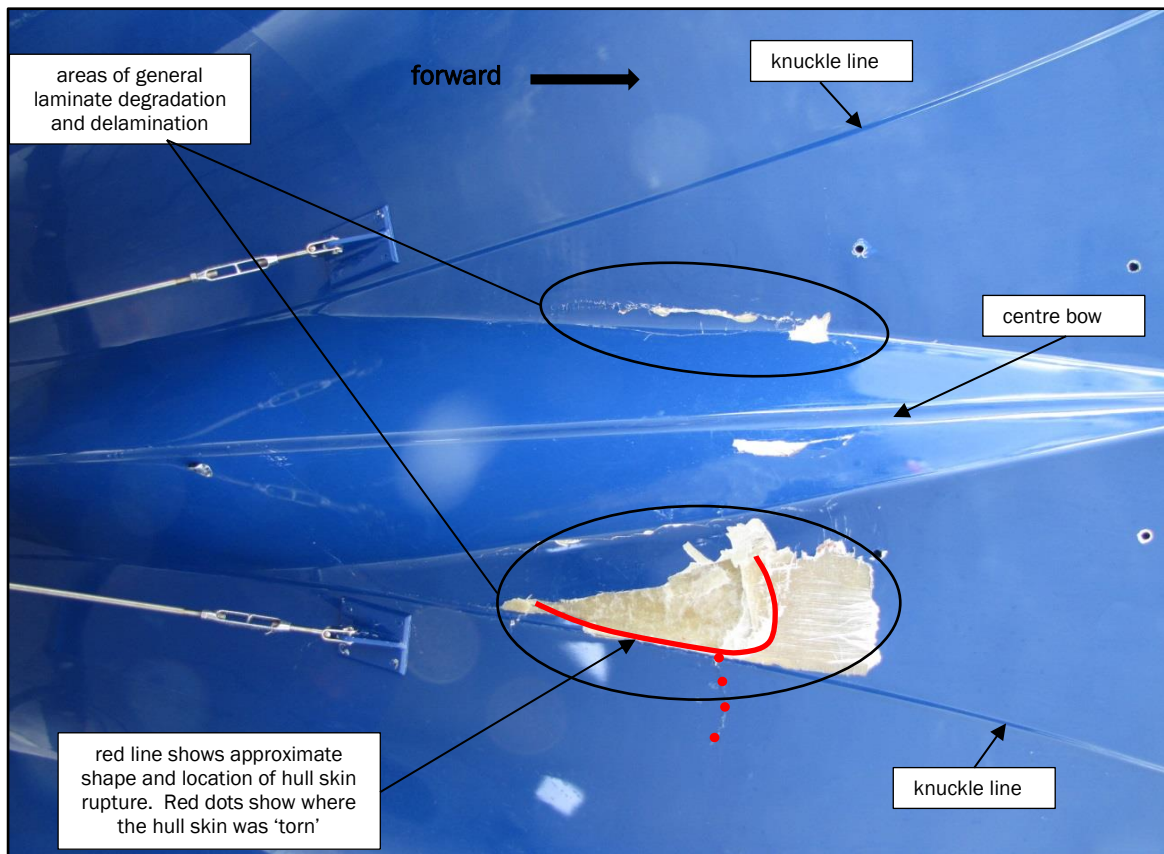
- on the centre bow the FRP of the hull skin had delaminated and ruptured
- on the hydrofoil the starboard side of the lifting foil⁷ was dented and the hydrofoil port tie rod was bent. This was later established to be pre-existing damage

Figure 4
View looking up at centre bow of *Dream Weaver*

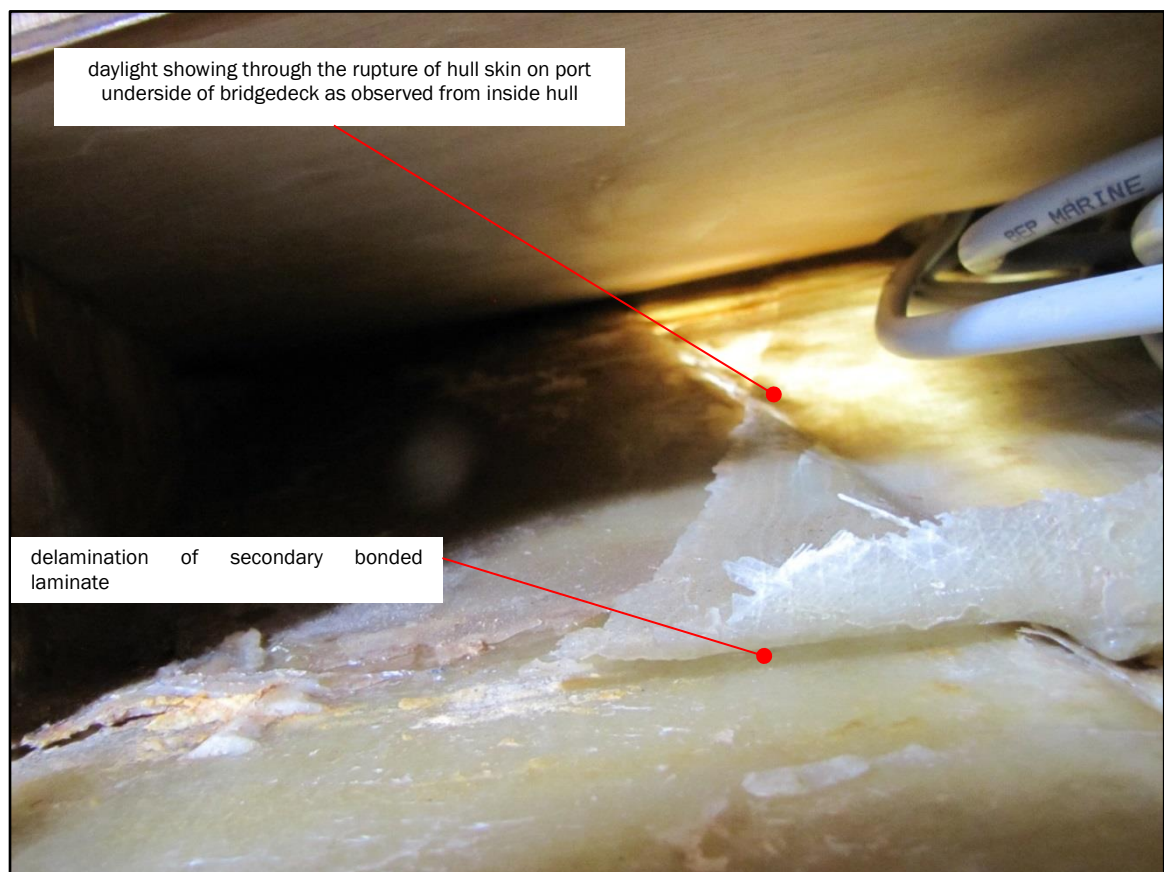
- on the foredeck the port shoulder gunwale⁸ was cracked and deformed
- in the chain locker⁹ the FRP laminates that had been secondary bonded to the hull had delaminated

Figure 5
Secondary bonding delamination on inside of hull skin

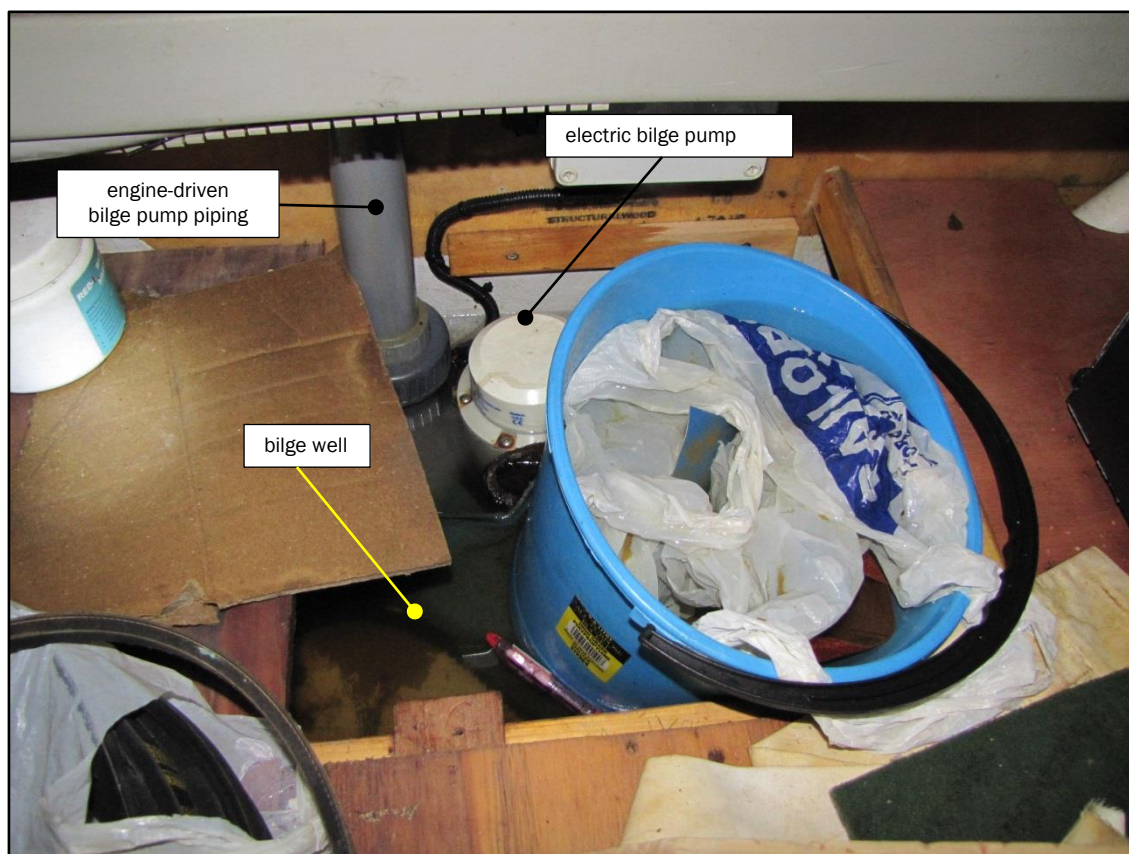
- the port forward bilge well was partially filled with a bucket, cardboard and other small, loose items. Some of this matter was blocking the bilge pump strainer (see Figures 6 and 7)
- on the foredeck washboards¹⁴ were a new addition to the vessel; they had been fitted on both the port and starboard sides to prevent any water shipped onto the bow from flowing back onto the aft passenger decks. On each side this left only one small scupper¹⁵ through which water could drain back overboard
- on the foredeck the LPG gas canister was too big to stow away correctly in its locker (see Figure 8).

Figure 6
Port forward bilge and suction, showing bucket and other detritus in bilge well after plywood bilge well cover had been removed

- 4.3.5. The bilge suctions for both the primary and secondary bilge systems were housed in the same bilge compartment. Figures 6 and 7 show small items of equipment and refuse found in the bilge well during the post-accident inspection. These items were blocking the bilge suctions and were highly likely the reason for the primary pump being unable to keep up with the ingress of water through the ruptured hull. This also meant that even if someone had succeeded in getting the secondary bilge system operating, it too would have failed due to the blocked bilge suction.

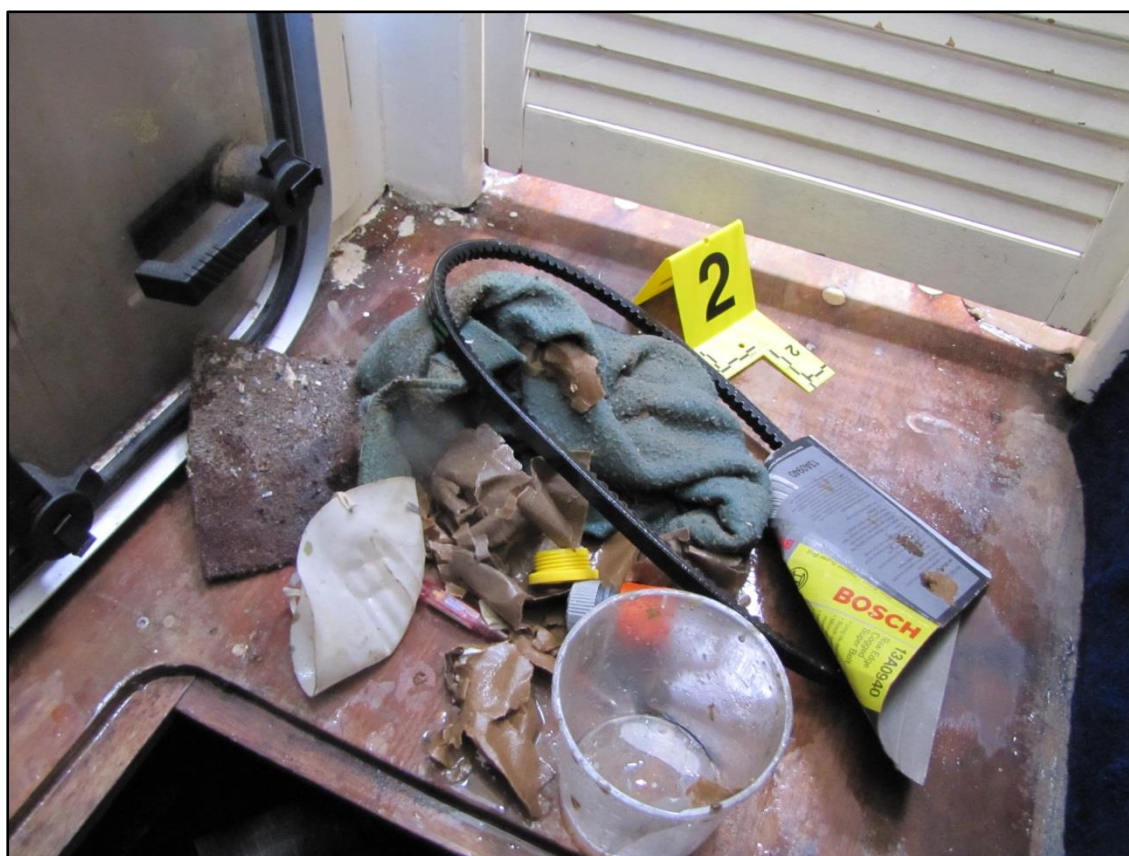
Figure 7
Items recovered from port forward bilge well that were obstructing the bilge suction strainer

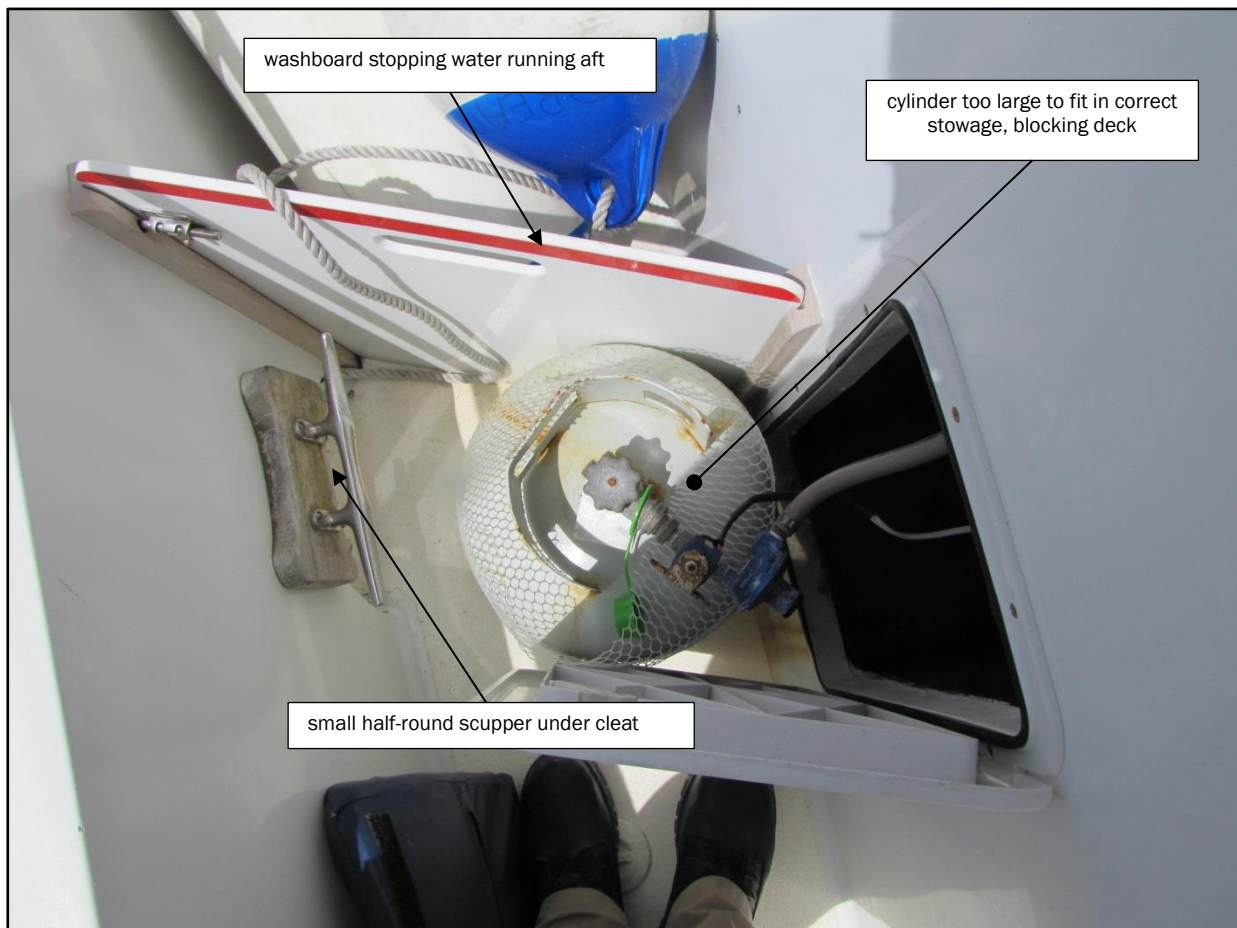
Figure 8
Starboard scupper, washboard and gas cylinder stowage

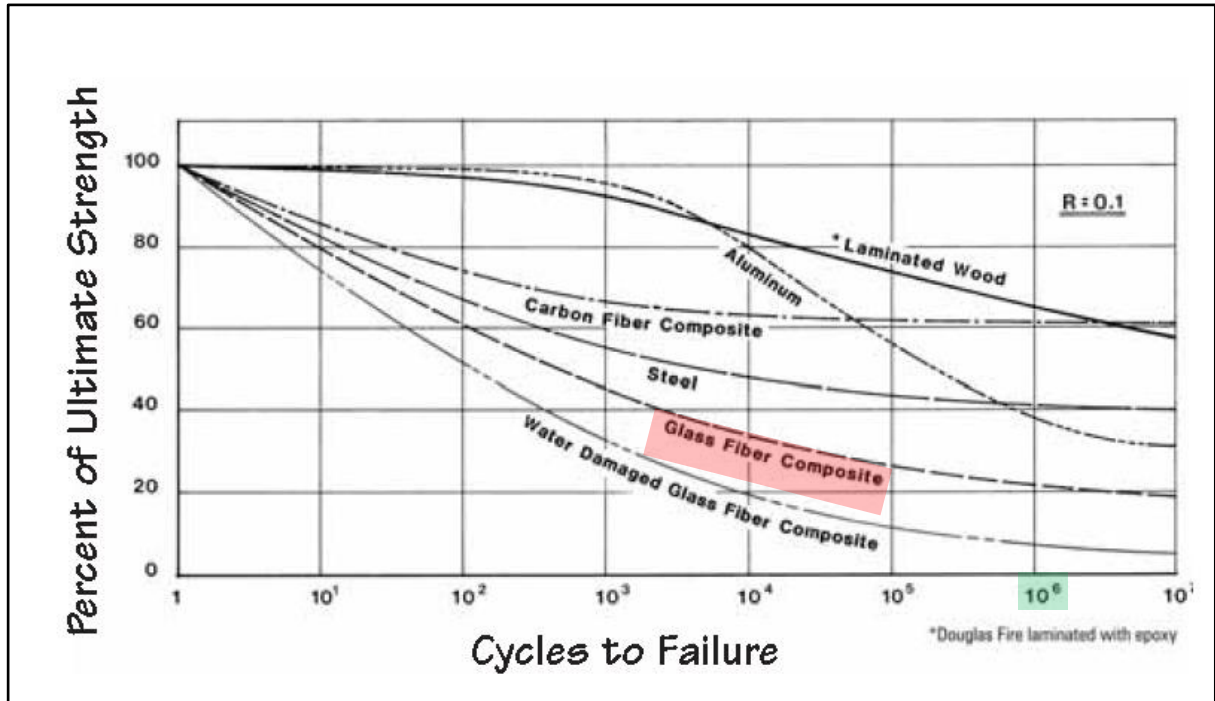
- 4.2.4. Figure 9 shows a graph that Gougeon Brothers produced comparing the tensile fatigue of materials typically used in boat construction (Gougeon Brothers Incorporated, 2005). Under fatigue testing the strength of glass fibre materials was found to reduce to 20% of the original strength. Gougeon Brothers estimated that it would take between about 30 hours (for a high-speed power craft) and 830 hours (for a sail yacht) of continuous operation to accumulate one million (10^6) load cycles. The wide variation in time is due to the unknown operational profile of the vessel, be it a sailing yacht or a high-speed power craft.

Figure 9
Tensile fatigue comparison of materials (Gougeon Brothers)

- 4.2.5. A glass laminate being only 20% of its original strength does not, however, mean that it will fail. Vessels are generally designed with sufficient scantlings¹⁶ to absorb normal operating forces as their strength deteriorates with age and use.
