Inquiry MO-2014-202: lifting sling failure on freefall lifeboat,  
general cargo ship *Da Dan Xia*, Wellington, 14 April 2014

Marine inquiry MO-2014-202  
lifting sling failure on freefall lifeboat,  
general cargo ship *Da Dan Xia*, Wellington  
14 April 2014

Approved for publication: February 2015

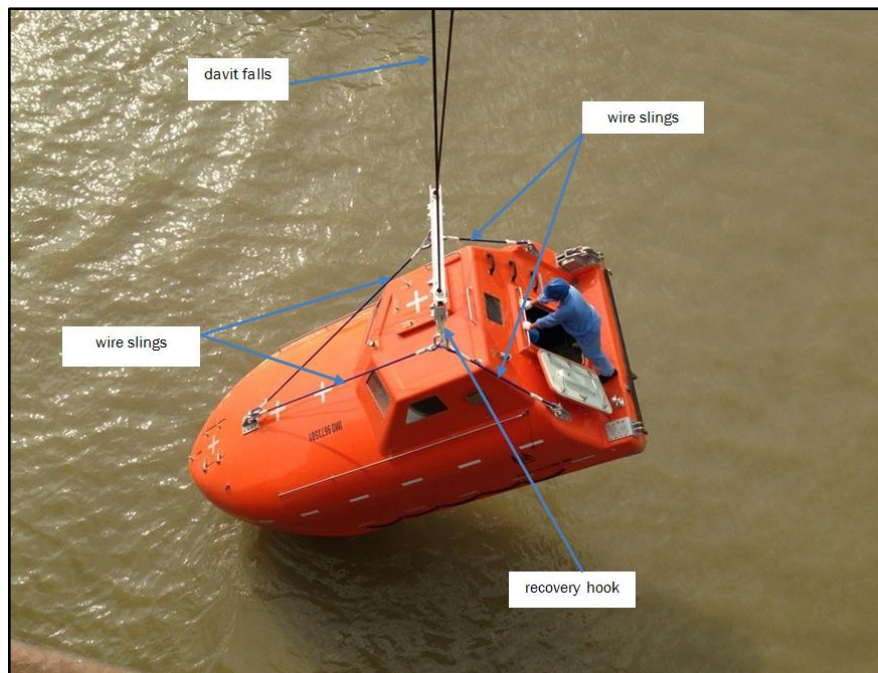
Figure 1  
Location of wire slings on a similar lifeboat  
(photo courtesy of Jiangyinshi Beihai LSA Co., Limited, China)

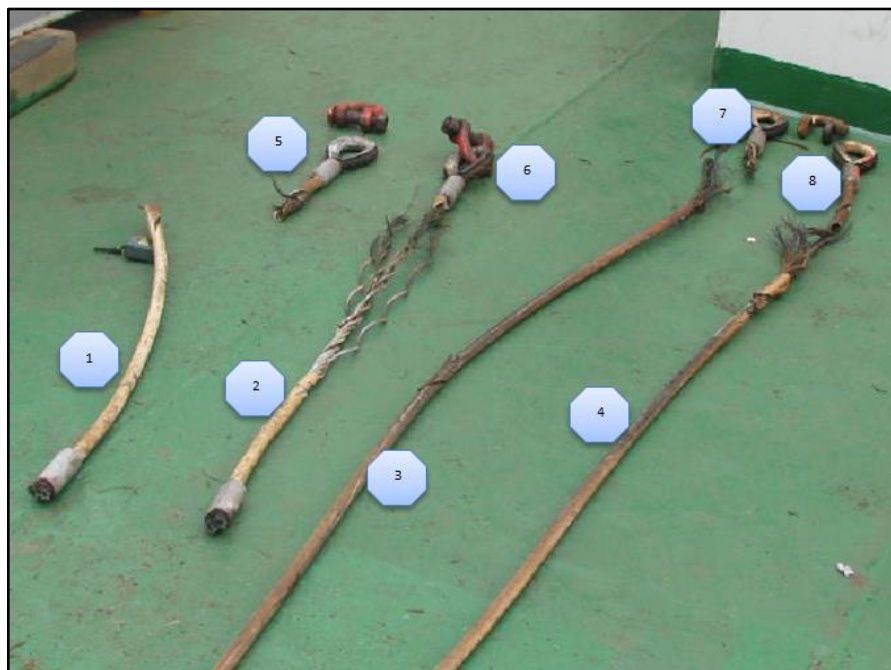
Figure 5  
Eight failed parts of the four wire slings  
(photo courtesy of Maritime New Zealand)

- 4.2.2. The full report on the failure by the Defence Technology Agency can be seen in Appendix 1. The report concluded that all four wire components of the lifting sling had been significantly weakened by severe corrosion. Salt water had penetrated the plastic sheath that encased the wire rope and wasted the galvanising on the steel wire, which then allowed corrosion of the steel wire itself. The

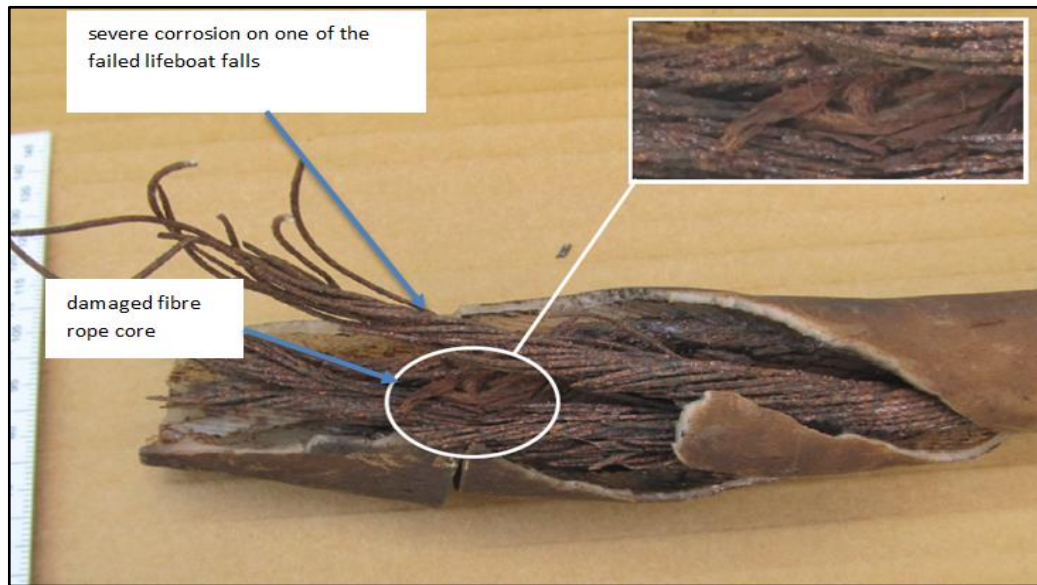
weakened wire ropes then failed by tensile overload during the lifeboat-recovery operation (see Figure 6).

Figure 6  
Severe corrosion on a failed wire sling  
(photo courtesy of Defence Technology Agency)

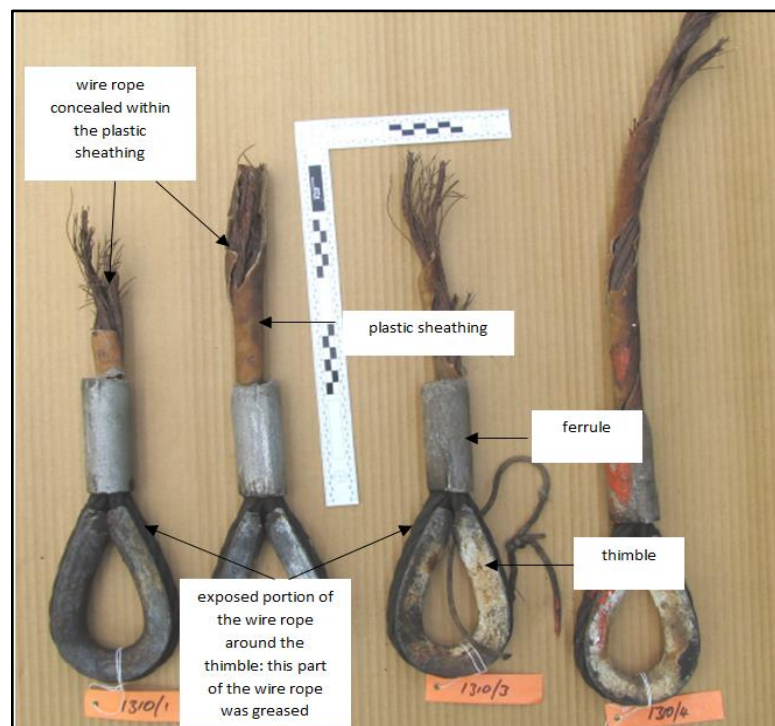
- 4.2.3. The wire rope, where it had been encased in the polymeric sheathing, was totally devoid of any lubrication or other corrosion-inhibiting substances. Grease had been applied to the eyes of the wire rope where it was not encased in the polymeric sheathing (see Figure 7).

Figure 7  
Parts of the wire slings  
(photo courtesy of the Defence Technology Agency)

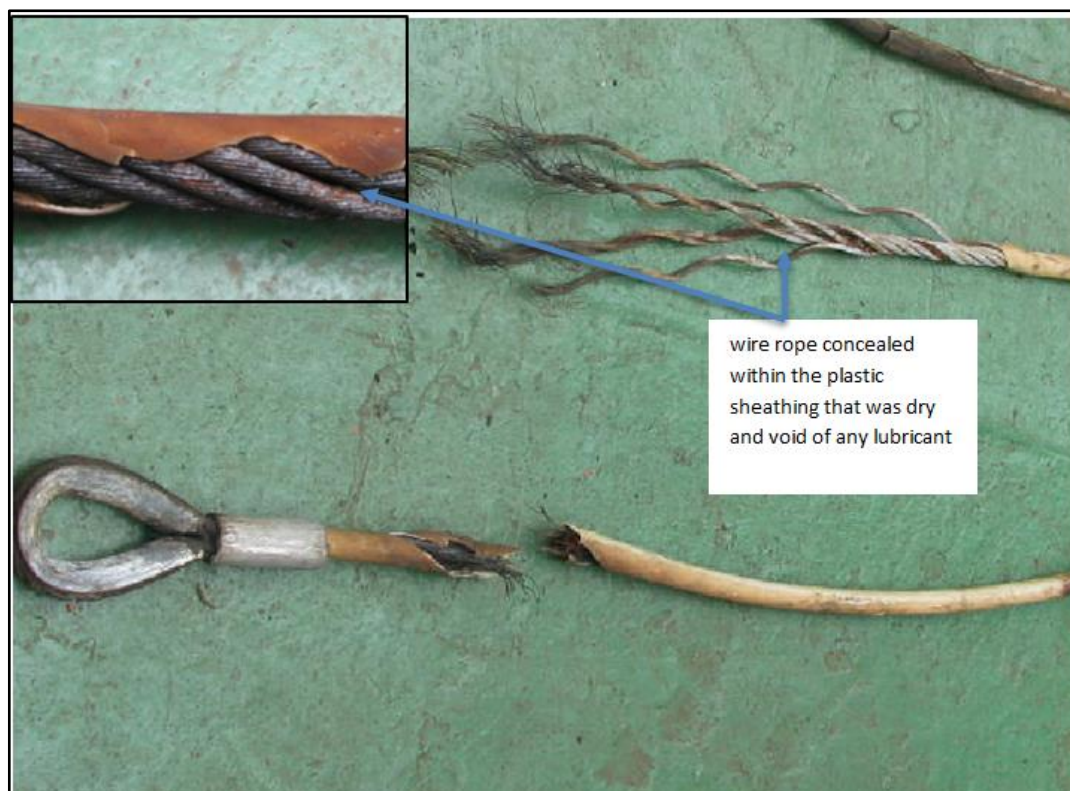
- 4.3.2. The wire slings were secured on the exterior of the lifeboat canopy and were exposed to the elements. Seawater ingress would have taken place over time through the ends of the plastic sheathing, and through any cracks or gaps that developed in the plastic sheathing as it aged and wore. Once salt water penetrated the wire through the plastic sheathing, the sheathing would aid the corrosion process by retaining the salt water around the wire (see Figure 8).

- 4.3.3. The plastic sheathing may also have aided in entrapping the seawater and accelerating corrosion, ultimately resulting in the weakening and failure of the slings.

**Figure 8**  
**Wire rope concealed within the plastic sheathing**

- 4.3.7. The Commission has recommended that the Director of Maritime New Zealand make a submission to the IMO for the relevant subcommittee to start the process of preventing the use of plastic sheathing on steel wire that is likely to be exposed to the weather or is likely to require ongoing inspection and maintenance.

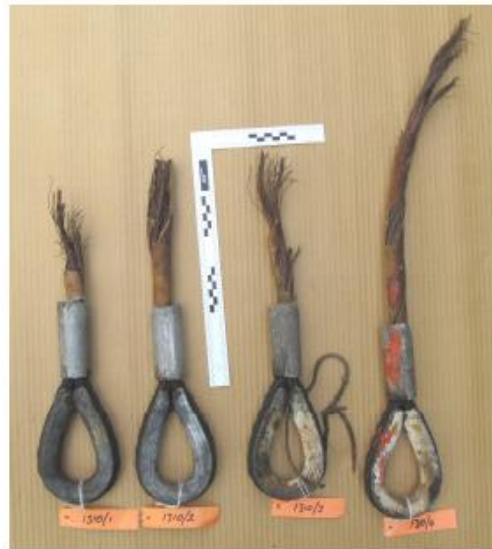
Figure 1. Four portions of the failed wire ropes as received.

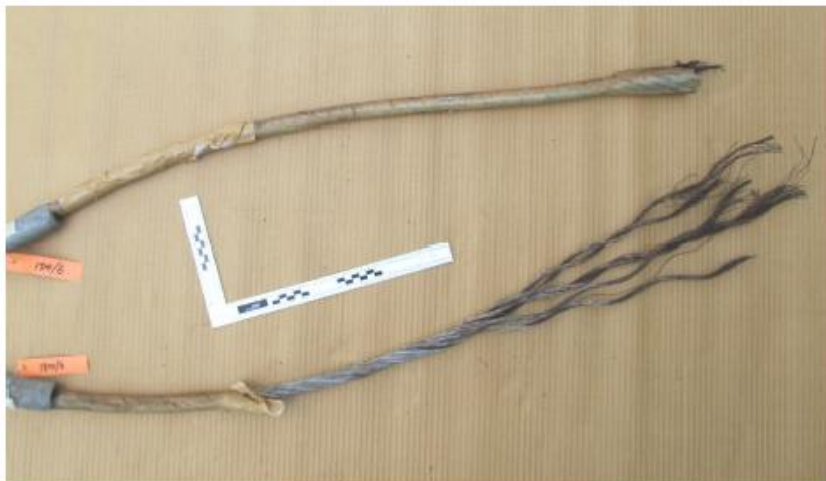
4. Corrosion in each portion was immediately evident extending a minimum of 200mm from the failure locations. Wires had been galvanised, as evidenced by the lower rope in figure 2. However, there was none remaining on any rope in the immediate vicinity of the failures. Each rope was sheathed with a polymeric material which was discoloured, cracked and brittle. Grease was evident around each thimble eye but none was evident beneath the sheathing.

Figure 2. Failed ropes as received.

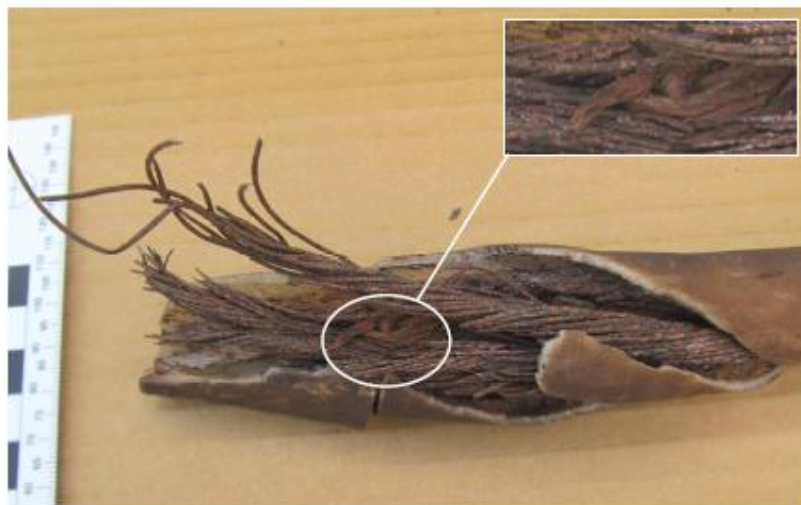
5. Construction of each rope was 6x37 with fibre rope core, right hand regular lay. Rope diameter was found to generally be 18-18.5 mm. The fibre rope core was observed to be darkened and discoloured (rust coloured). Figure 4 shows an example of the rope with the core exposed.

Figure 4. General view of one of the failures. Note the overall corrosion, the fibre rope core (circled and inset) and brittle fracture of the sheath.

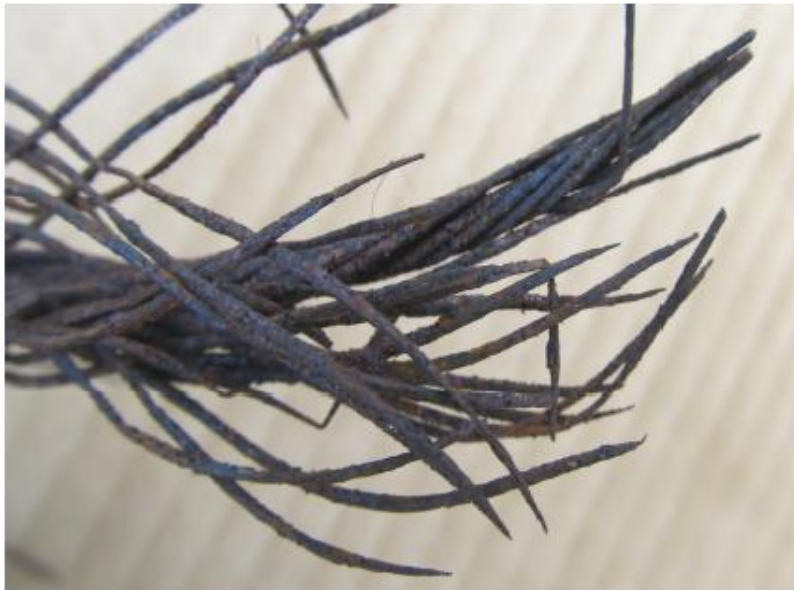
6. One hundred percent of the wires (in the vicinity of the failures) were affected by corrosion to some degree, ranging from light to extreme. Figure 5 shows an example where some wires have been corroded in the extreme, as evidenced by the needle-like points. Evidence of tensile failures of wires was also observed in each rope. These exhibited the waisting and 'cup & cone' features characteristic of tensile overload.

**Figure 5.** Failure (typical) close up showing severe corrosion of the wires (needle-like points).

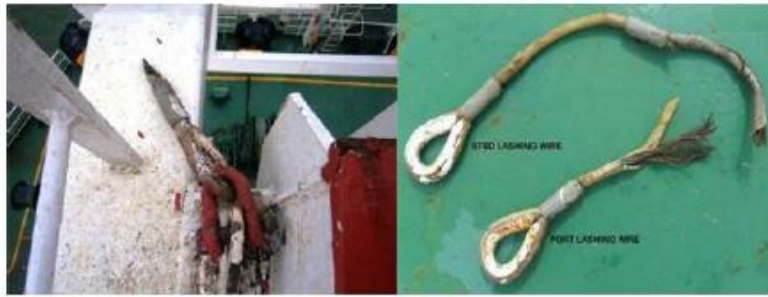
- prior to entering the FFLB an SMS-required tool box meeting and task risk assessment were not performed;
- although part of the FFLB's maintenance checklist, the corrosion on the aft lashing cables, which were covered with plastic sheathing that was cracked and deteriorated due to weather exposure, was not previously detected; and,
- the FFLB was not connected to the davit launching/retrieval cable as per the manufacturer's procedures.

Broken lashing cables, i.e., maintenance wires
