Final report AO-2015-001: Pacific Aerospace Limited 750XL, ZK-SDT,  
Engine failure, Lake Taupō, 7 January 2015

Aviation inquiry A0-2015-001  
Pacific Aerospace Limited 750XL, ZK-SDT  
Engine failure

Lake Taupō  
7 January 2015

Approved for publication: June 2017

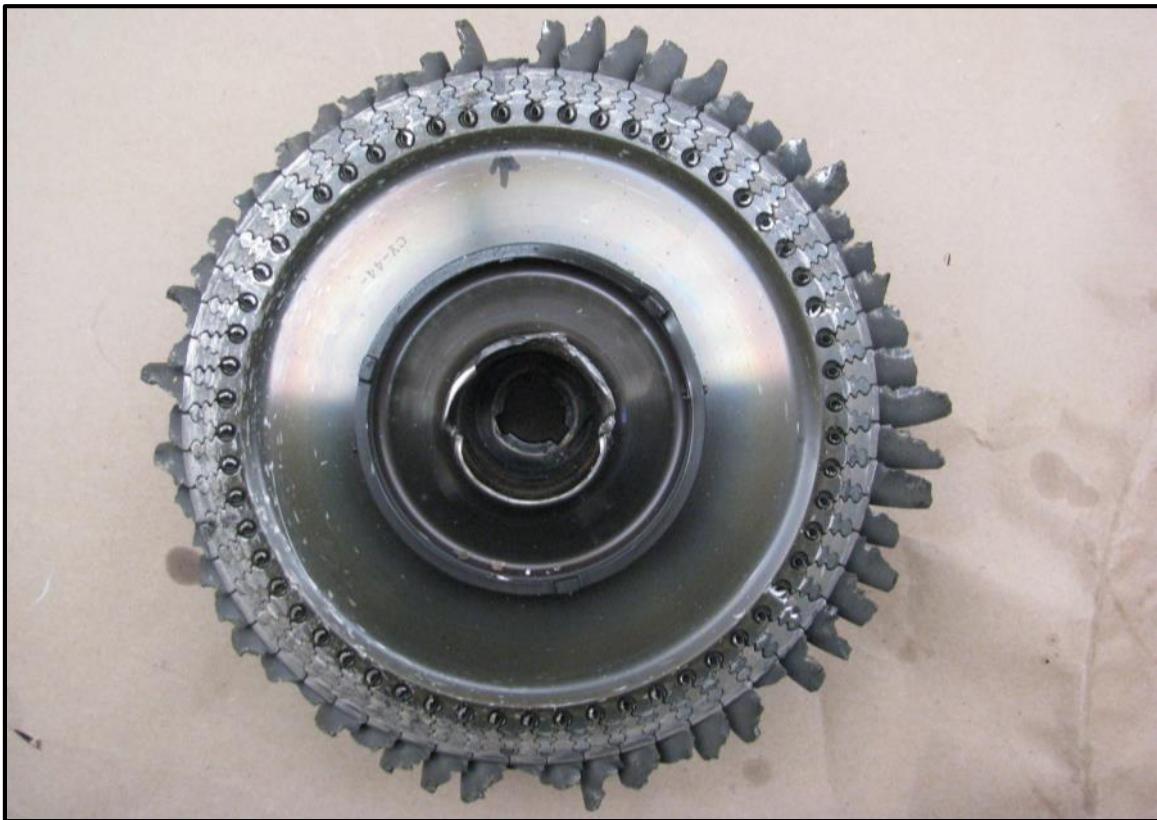
**Figure 2**  
**The failed compressor turbine assembly**

- 3.5.2. All of the blades of both turbines were fractured. A visual examination identified one compressor turbine blade that was suspect (the arrowed blade in Figure 2), because it had a relatively flat fracture surface. The mark 'R1' (reworked once) on the platform of the blade showed that it had been stripped and recoated previously (see Figure 3). Therefore it was very likely that the blade (and the others in the replacement set) had been in service for at least 6,100 hours.<sup>23</sup> Turbine blades are not identified individually and can be re-used as long as they meet the inspection/repair acceptance criteria. The total time in service for the blades was not determined.

(Suspect blade arrowed. Source: P&WC Service Investigation Report)

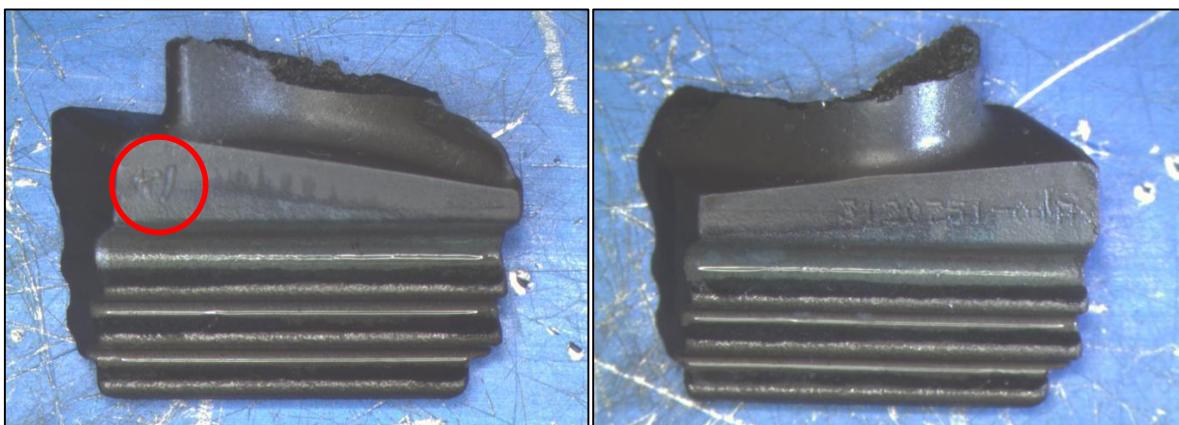
**Figure 3**  
**The compressor blade suspected to have failed first**  
(‘R1’ rework mark circled)

(Source: P&WC Service Investigation Report)

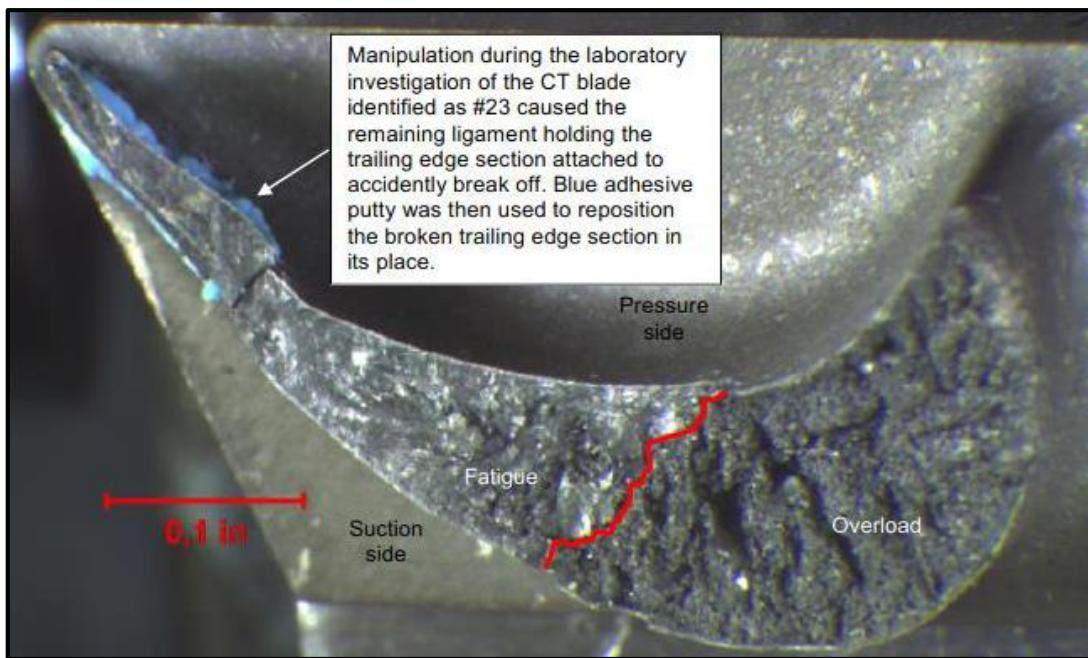
**Figure 4**  
**The fracture surface of the suspect compressor turbine blade**

- 3.5.3. A microscopic examination found that the fracture surfaces of all of the compressor turbine blades, except the suspect blade, were characteristic of overload. The fracture surface of the suspect blade had two distinct zones: one characteristic of fatigue towards the trailing edge; and one characteristic of overload (see Figure 4). There was no metallurgical anomaly in the trailing edge zone that could have initiated the fracture.

- One compressor turbine blade fractured by fatigue initiating at the trailing edge tip of the [blade], propagating towards the leading edge until final fracture by tensile overload.

- The under minimum trailing edge radius may have contributed to the fatigue crack initiation.
- 3.5.6. The compressor turbine blades were overhauled at an approved United States facility that was an associated company of P&WC. The strip and recoat process used by the supplier was approved by P&WC and complied with its aftermarket specification.

(Showing distinct fatigue and overload fractures. Source: P&WC Service Investigation Report)

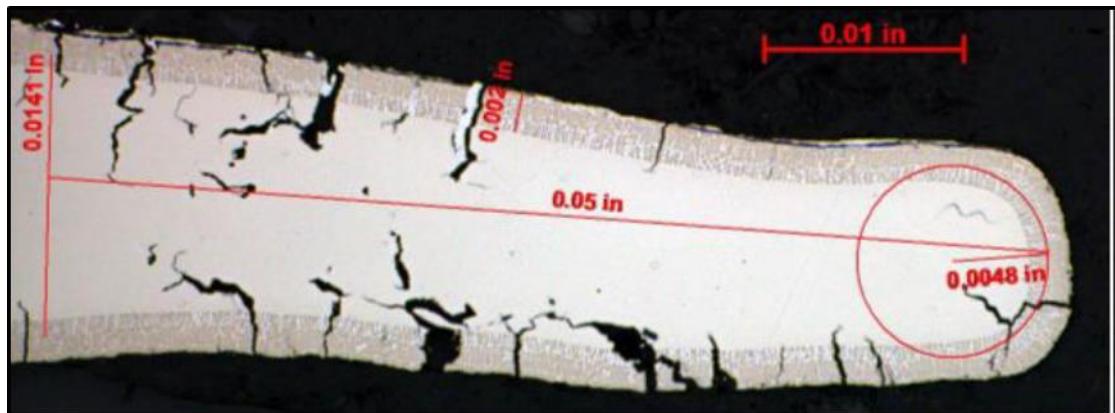
**Figure 5**  
**Microscopic image of the trailing edge cross-section of another sampled blade**

- 4.2.1. The examination of the engine by P&WC identified the compressor turbine blade that had fractured first and caused the engine failure. The blade fracture surface had distinct fatigue and overload zones. Due to the damage, only approximate measurements of the blade dimensions in the fatigue zone could be performed. These showed that the radius of the trailing edge, after allowing for the thermal coating applied to blades, was less than that specified for a new blade.
- 4.2.2. Measurements were also taken of the remnants of six other overhauled blades and one of the two blades that had been new when installed in May 2013. One of the overhauled blades was under-size in trailing edge thickness and radius (see Figure 5), and two more

were at the minimum limit for one or other dimension. The dimensions of the blade that was new when installed in May 2013 met the required specifications.

(With measurements of trailing edge thickness and radius. Source: P&WC Service Investigation Report)

- 4.2.3. During the overhaul, the blade had required repair in accordance with the P&WC-approved supplier process MPP1, based on document 725009-SRR-001. This document did not require the measurement of repaired blades in all of the dimensions specified by P&WC for the acceptance of new blades, although there had always been a verification of the minimum trailing edge thickness for blades that had been through a strip and recoat process.

- 4.2.7. P&WC subsequently revised Repair Requirement Document 725009-SRR-001, for all of its PT6 engines, so that the trailing edge thickness measurement requirements matched those for new compressor turbine blades.
