Final Report AO-2015-002: Mast bump and in-flight break-up,
Robinson R44, ZK-IPY, Lochy River, near Queenstown, 19 February 2015

Aviation inquiry AO-2015-002
Mast bump and in-flight break-up,
Robinson R44, ZK-IPY
Lochy River, near Queenstown,
19 February 2015

Approved for publication: July 2016

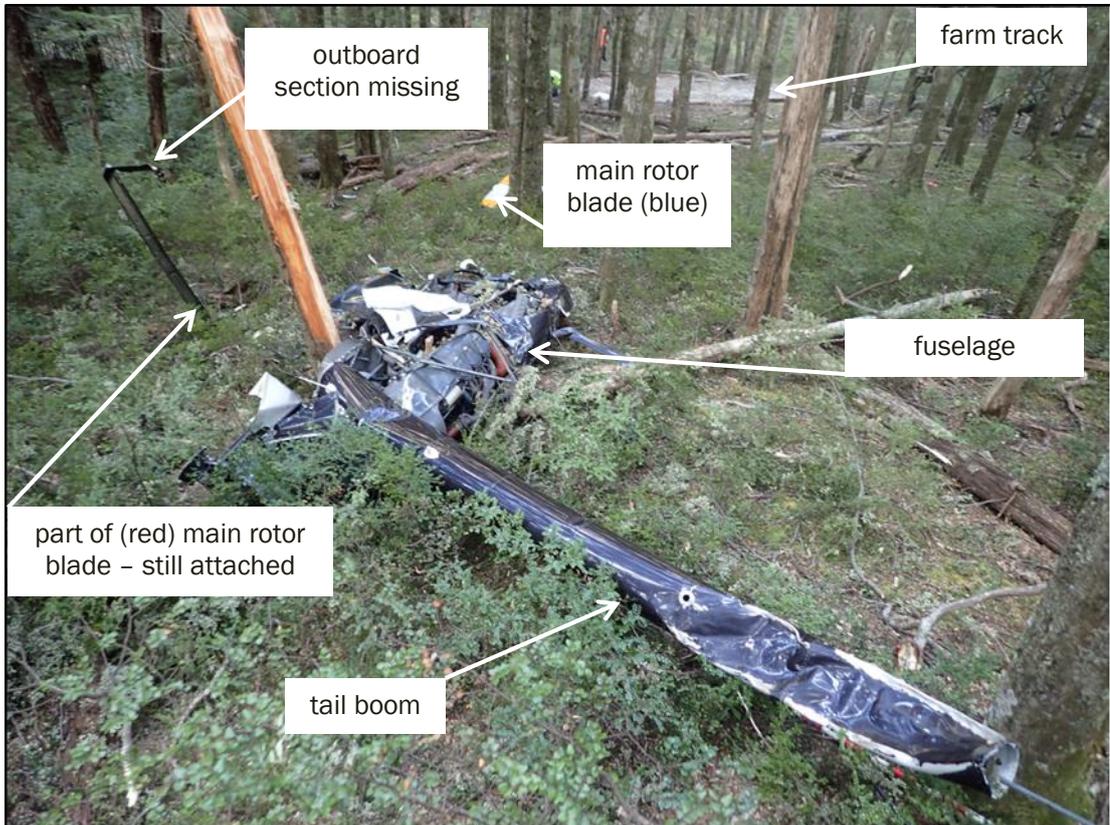
Figure 2
Accident site

2.3 m of the red main rotor blade.⁹ Pieces of Perspex and cabin structure were found throughout the accident site.

3.2.4. Several items were seen suspended in the tree canopy. The largest was a section of fuselage panel from above the engine and behind the main rotor mast.¹⁰ This was recovered by using the rotor downwash from a helicopter to blow the panel free.

3.2.5. The main fuselage was resting nearly upright on the forest floor. It lay against a tree that had significant gouging down one side, consistent with the fuselage having slid down the side of the tree. The tail boom remained partially attached but bent at nearly 90° to the fuselage. The tail rotor assembly and empennage from just forward of the tail rotor gear box had separated and lay 2-3 m from the end of the boom.

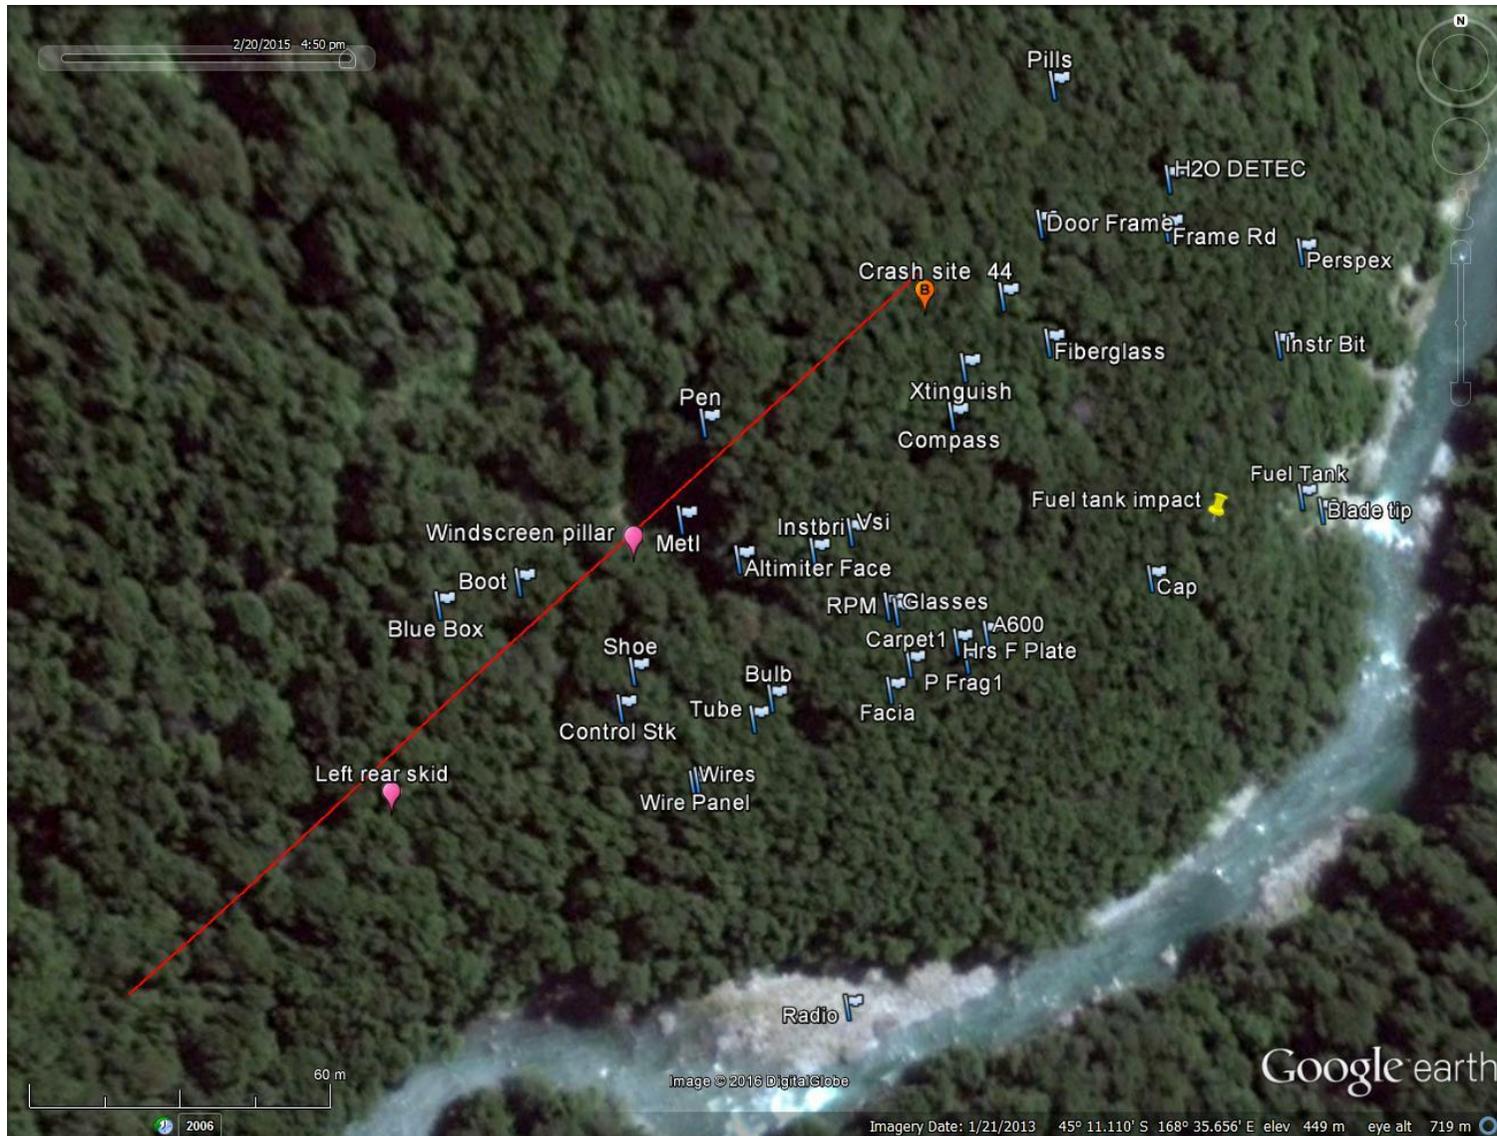
Figure 4
Main items of wreckage

- 3.2.6. The engine, transmission, mast and main rotor hub assembly were still connected but had twisted to the left. The blue main rotor blade had broken off 1.4 m out from the hub. The outboard section, approximately 3.5 m long, lay about 5 m from the fuselage. The red main rotor blade had two 90° downward bends at 0.6 m and 2.5 m from the hub. The blade had separated 0.4 m outboard of the second bend. The separated tip end was found near the river.

- 3.2.8. The damage to the trees, the ground markings and the wreckage damage and its spread were consistent with the wreckage having fallen nearly vertically through the forest canopy in a near level or flat attitude.

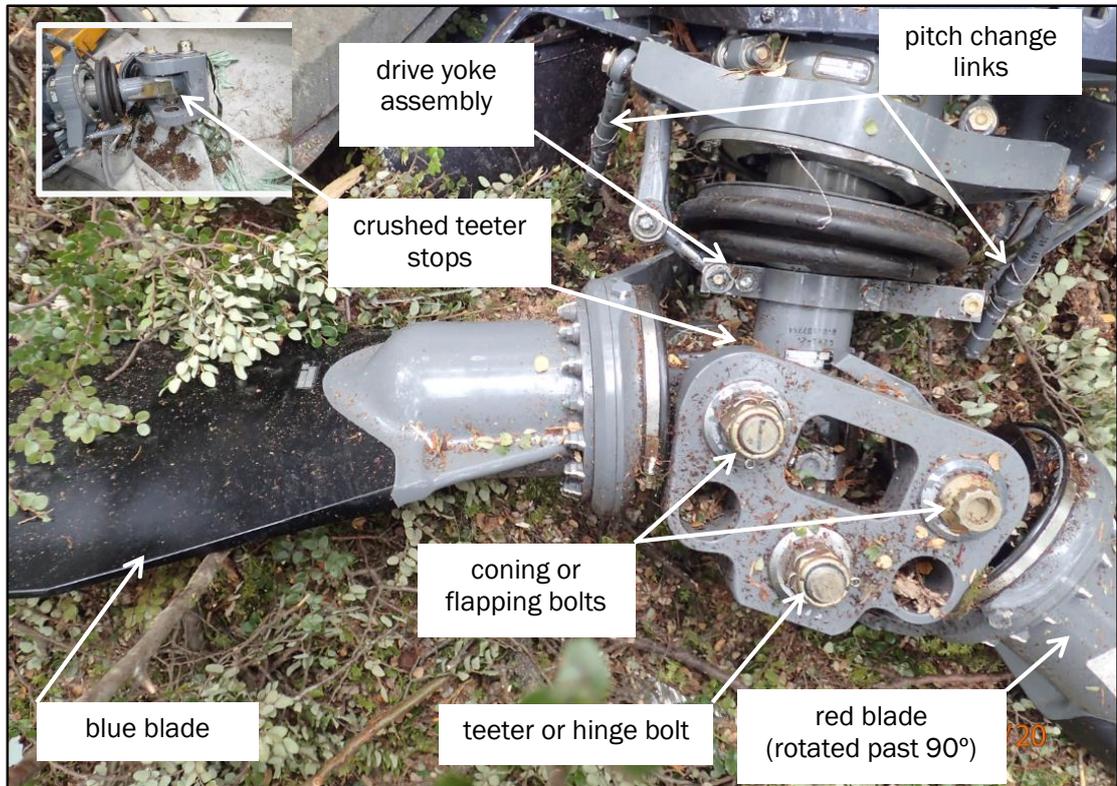
Figure 5
Main rotor head showing broken components and extreme flapping of blades

- 3.3.15. Both of the pitch change links, which connect the swashplate to the main rotor blades and control the pitch angle of the blades, had failed in overload¹⁴, likely after a reverse bending motion (see Figure 5). Both teeter stops were split horizontally through the middle, and their retention brackets were bent.
- 3.3.16. Both main rotor blades had fractured (see Figure 6). Because the fracture of the red blade was near the point where another R44 blade had failed, which the CAA suspected had been due to fatigue, the Commission had this blade examined by a metallurgist at the earliest opportunity. The metallurgist’s initial assessment was that the blade had failed in overload. Subsequent detailed examination by the same laboratory and a further examination by an

ATSB metallurgist confirmed this. The ATSB also determined that the failure of the blue blade was the result of overload and not fatigue, with the blue blade exhibiting “significant plastic deformation in the region of the fracture surface consistent with an overstress failure”. Both blades were examined for signs of any pre-existing delamination or dis-bonding, and none was found.¹⁵

4.2.1. The crushing of the teeter stops found on the rotor head was a clear indication of a mast bump. Other rotor head damage found included broken pitch change links, a bent rotor shaft and scoring on the inside of the hub from excessive movement of the spindle tusks. This damage was a typical signature of a significant mast bump.

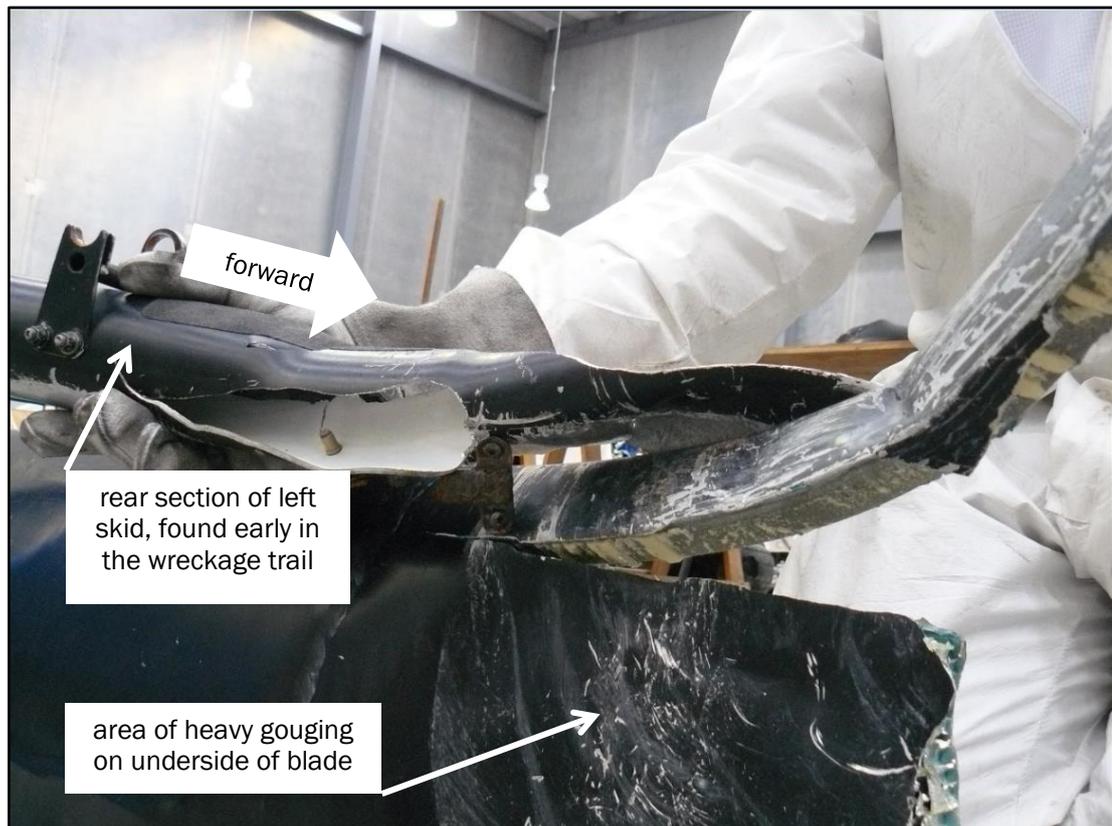
Figure 8
Main rotor blade strike on rear of left skid

4.2.2. A significant mast bump event often results in the main rotor blades striking the fuselage. In this case one of the main rotor blades (the red blade) struck the cabin area of the fuselage twice. The first strike was through the top left side of the cabin. The second strike, as little as 0.15 seconds after the first⁴², hit the upper instrument console and left handle of the cyclic control stick. The blade then swung under the fuselage to strike the rear of the left skid. The tip bent around the skid and separated to the right of the flight path (see Figure 8). The main fuel tank located on the left side was dislodged early in the sequence and also ejected out to the right of the flight path.

4.2.3. The spread of the wreckage on the ground was typical of an in-flight break-up initiated by a mast bump and the main rotor blades striking the fuselage.

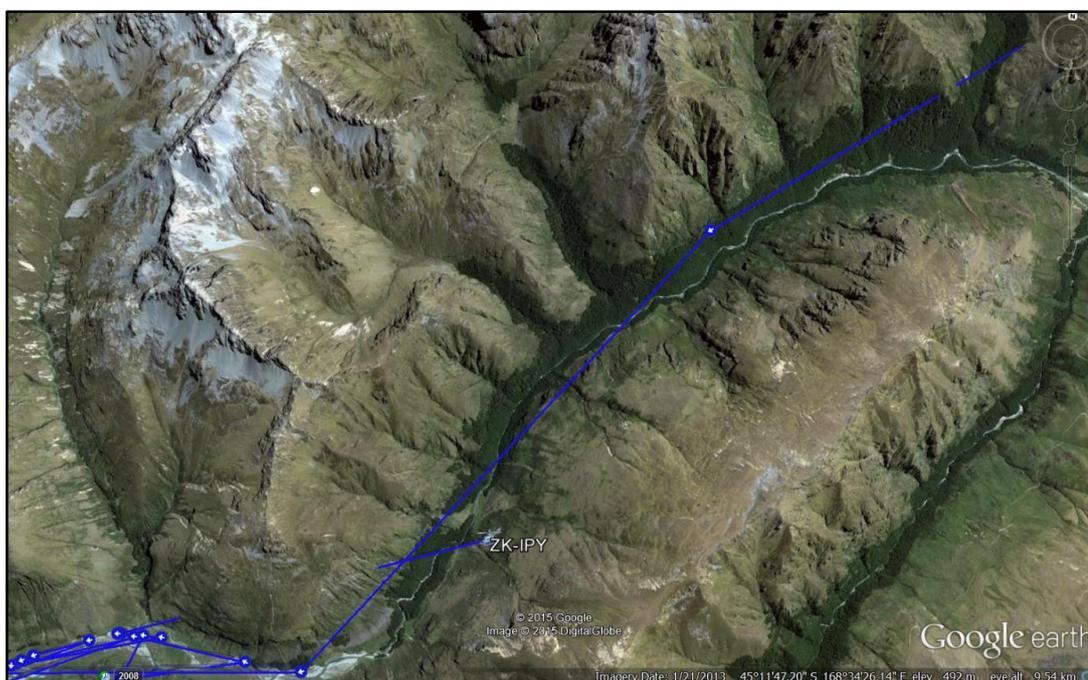
Figure 9
Track presentation and accident location⁴⁴

- 4.3.23. Before starting to leave the valley the helicopter likely flew a left orbit, followed by a nearly 180° turn before heading down the valley (see Figure 9). The straight-line distance from the last data report made at 1340:30 to the start of the wreckage field was two nautical miles (3.73 km).
