Final report AO-2015-005: Unplanned interruption to
national air traffic control services, 23 June 2015

Aviation inquiry AO-2015-005
Unplanned interruption to
national air traffic control services,
23 June 2015

Transport Accident Investigation Commission

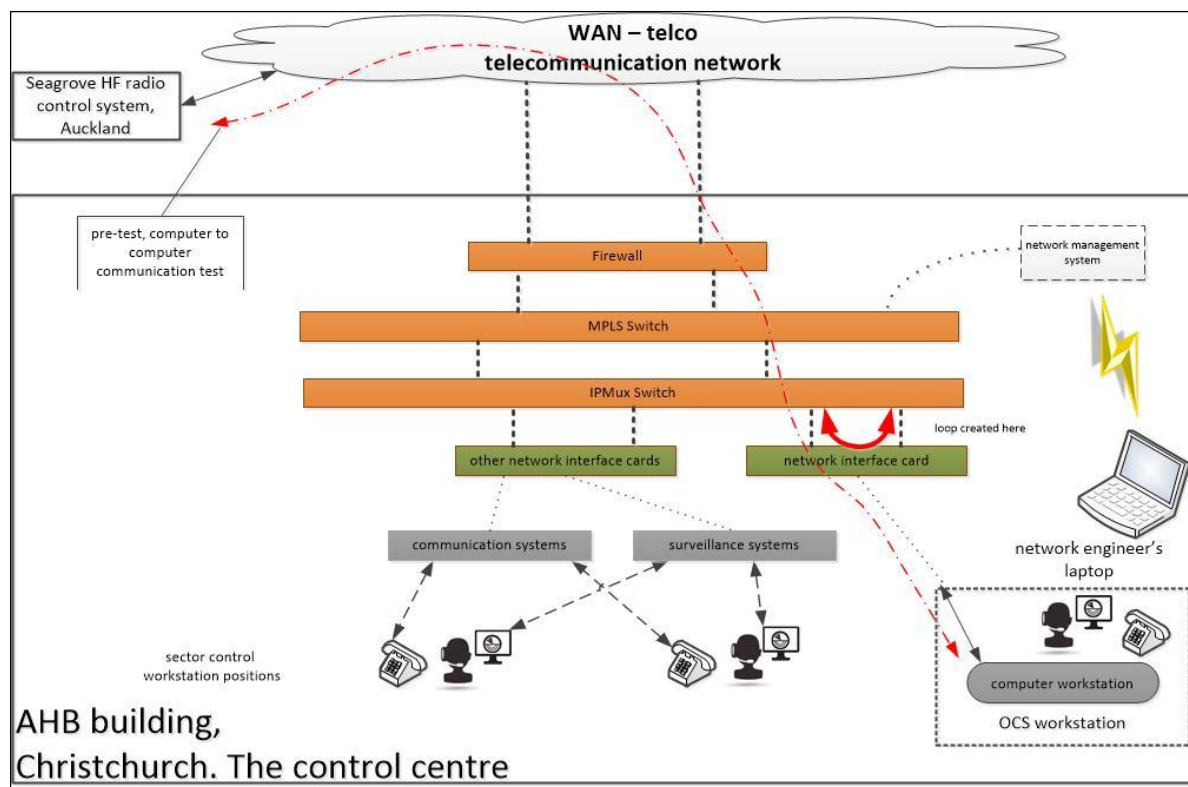
Figure 2
Where the broadcast storm started⁹

- 4.2.4. The network test traffic between the two computers would be transported on the same virtual local area network (VLAN)¹⁰ that carried all services that were essential for the operation of the control centre, but this commonality was not considered at the time to be a risk for the pre-test.
- 4.2.5. The pre-test was conducted on 16 June 2015, with a radio engineer operating the Christchurch OCS contingency workstation adjacent to the control centre. The radio engineer was unable to get the two computer devices to communicate, so another pre-test was scheduled for 23 June 2015 with a network engineer present to assist.

- 4.2.15. The firmware in the network interface card had a dormant code error that had escaped the manufacturer's quality assurance tests. It was found later to have an effect only when the firmware was upgraded from the factory default version to the version current at the time of the pre-test. Airways' engineers were not aware that the code error existed either, because they had not made this particular firmware version upgrade. The network interface card was connected to the switch by two separate ports to provide redundancy if one path failed. When the engineer rebooted the network interface card to install the upgraded firmware, the code error took effect. It unintentionally bridged the two ports on the network interface card, which formed a loop in the switch and thereby created the conditions for a broadcast storm.

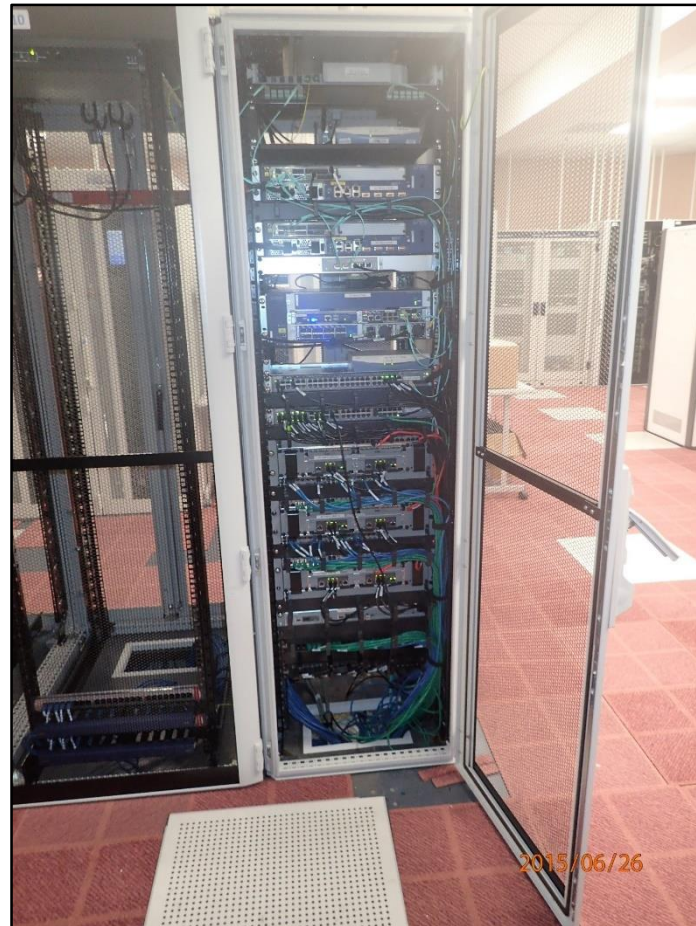
Figure 3
Digital data network cabinet

- 4.2.8. The network engineer proceeded with the firmware upgrade without hesitation. He remotely downloaded the new firmware to the network interface card, then rebooted it to commence the installation process. After a delay that he considered was too long, the network interface card had not come back online, so he went to the equipment room to remove the card from the mounting rack (see Figure 3).

- 4.2.9. In doing so he walked through the ATC room and past the technical co-ordinators to the equipment room. He partially extracted the network interface card to disconnect it from the power supply, then left it in the mounting rack while he went to get an antistatic bag to take the card back to the workshop. He was diverted from that task to assist with a major problem that had developed in the control centre. This was the outage.
