Final report RO-2015-101: Pedestrian fatality, Morningside Drive pedestrian level crossing,  
West Auckland, 29 January 2015

Rail inquiry RO-2015-101  
Pedestrian fatality,  
Morningside Drive pedestrian level crossing,  
West Auckland  
29 January 2015

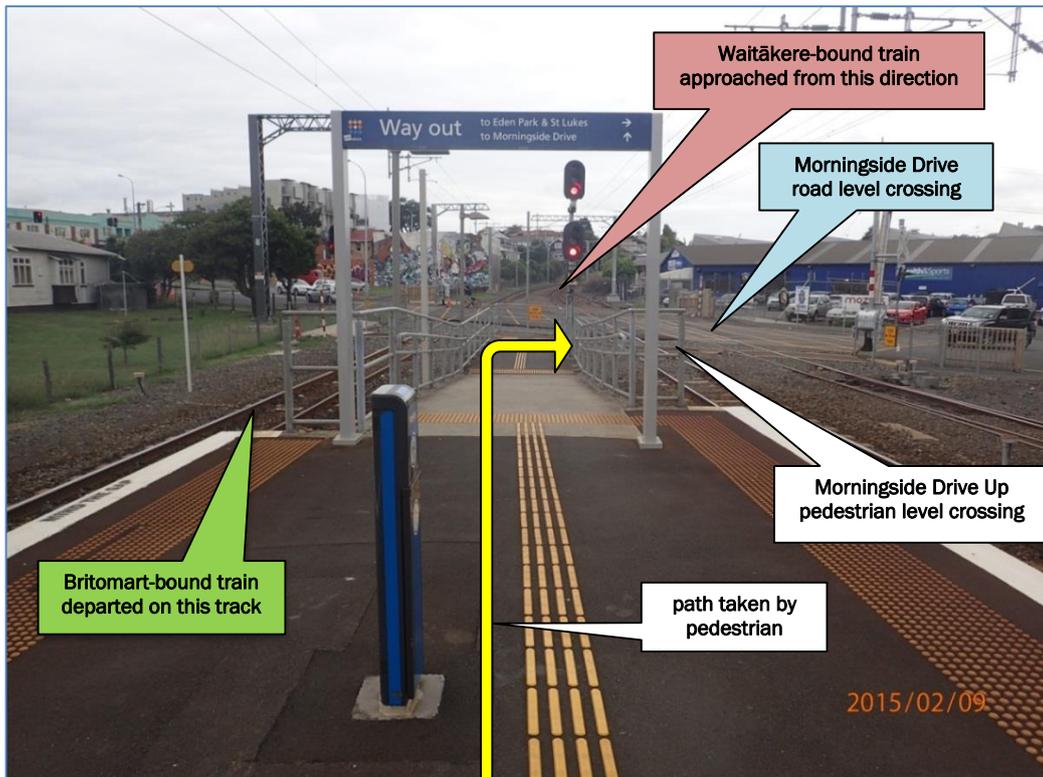
Figure 1  
The fenced platform ramp at the eastern end of Morningside Station

- 3.1.3. The flashing lights and barrier arms, however, are directed at vehicle drivers and pedestrians who are following Morningside Drive. The only visual cue warning pedestrians walking down the platform ramp to 'look for trains' is a yellow sign.

- 3.1.5. The pedestrian walked alone along the platform to the eastern-end electronic ticket register, where he recorded his fare payment at 1841. He then walked down the platform ramp leading to the Morningside Drive pedestrian level crossing (see Figure 1).

- 3.1.7. Meanwhile the pedestrian had walked to the end of the platform ramp, during which time he was facing the direction of the approaching Waitākere-bound train. He turned right through an opening and stepped out in front of the train. The train struck the pedestrian at 1841:24 and he was fatally injured.

- 7.2.3. On 30 July 2015 the Commission **recommended** to the Chief Executive of the NZ Transport Agency that in the interests of passenger and pedestrian safety he liaise with the appropriate authorities to ensure that they address the safety issue whereby some form of active warning device or barrier is installed that will prevent pedestrians inadvertently stepping out in front of trains when entering or exiting the Morningside Station platform. (O10/15)

- the footpaths have been re-aligned from 70 degrees to 85/90 degrees.
- the main road has been made smaller to accommodate the change to the footpath.
- moving of the HAB/FLBs [warning devices], allowing the footprint of the maze foundations to be moved to allow the pedestrian crossings to be moved from a 70-degree angle towards a 90-degree angle, thus allowing the mobility and wheelchair units to cross more safely, i.e. a more direct (perpendicular) route than at an oblique angle, which reduces the risk of the mobility device wheels becoming stuck in the gaps.

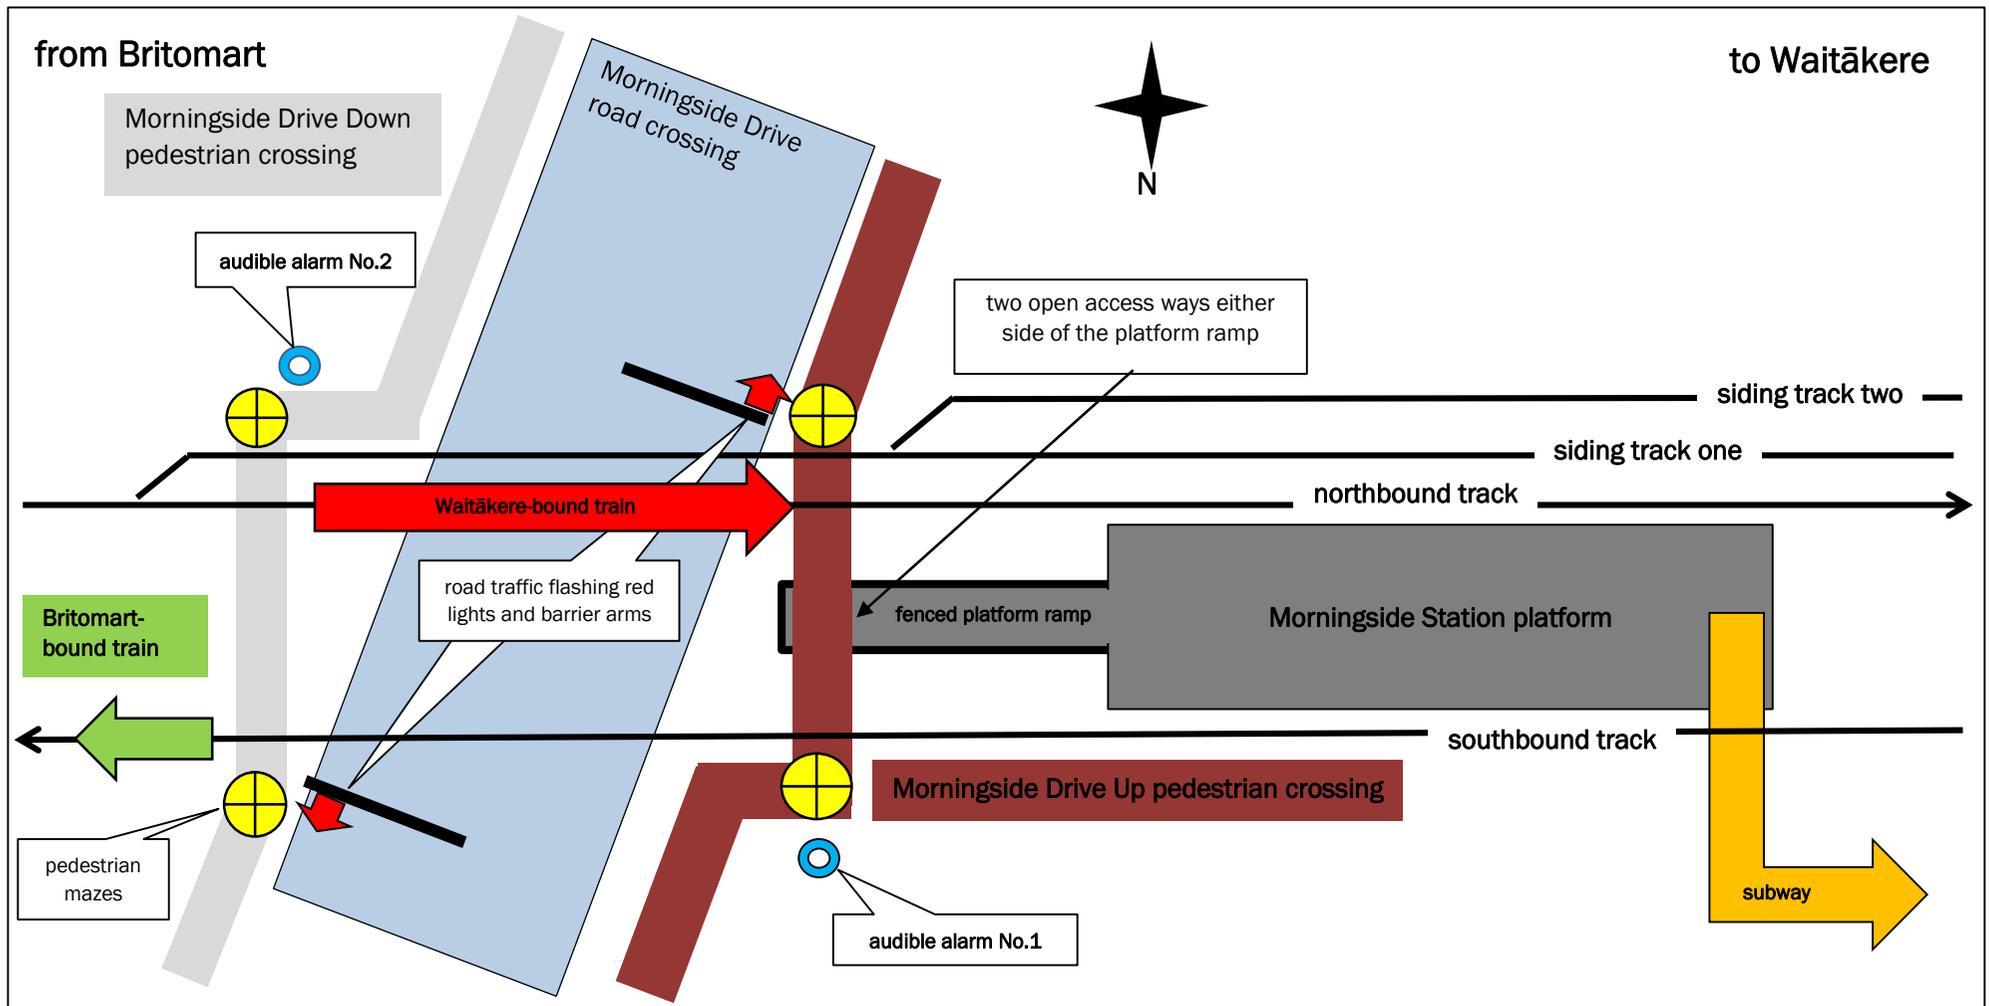
Figure 2  
Plan of Morningside Station and the Morningside Drive level crossings (not to scale)

- 3.2.1. The Morningside Drive level crossing comprised one roadway and two pedestrian footpaths that flanked the roadway (see Figure 2). All three crossed both main line tracks and a siding track close to the eastern end of the station platform.
- 3.2.2. Mazes had been installed at the four entrances to the two pedestrian level crossings during 1986. The mazes had been upgraded in 2011. The mazes were designed to channel pedestrians along a nominal two-metre distance towards the direction that trains would normally approach the level crossing (see Figure 3).
