Final report R0-2015-102: Electric locomotive fire at
Palmerston North Terminal, 24 November 2015

Rail inquiry R0-2015-102

Electric locomotive fire at Palmerston North
Terminal
24 November 2015

Approved for publication: February 2017

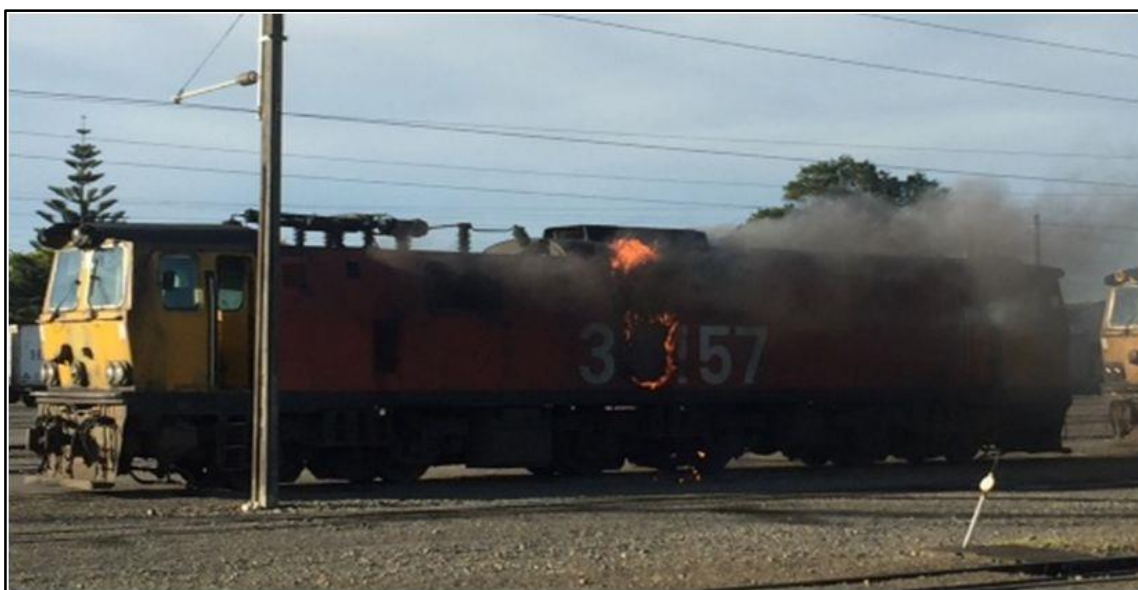
Figure 1
Electric locomotive burning at KiwiRail Palmerston North Terminal
Source: Witness mobile phone video still

- 1.2. The Fire Service attended, but the fire was not extinguished until later that evening at 2023. The locomotive's transformer compartment suffered fire damage. No-one was injured during the incident.

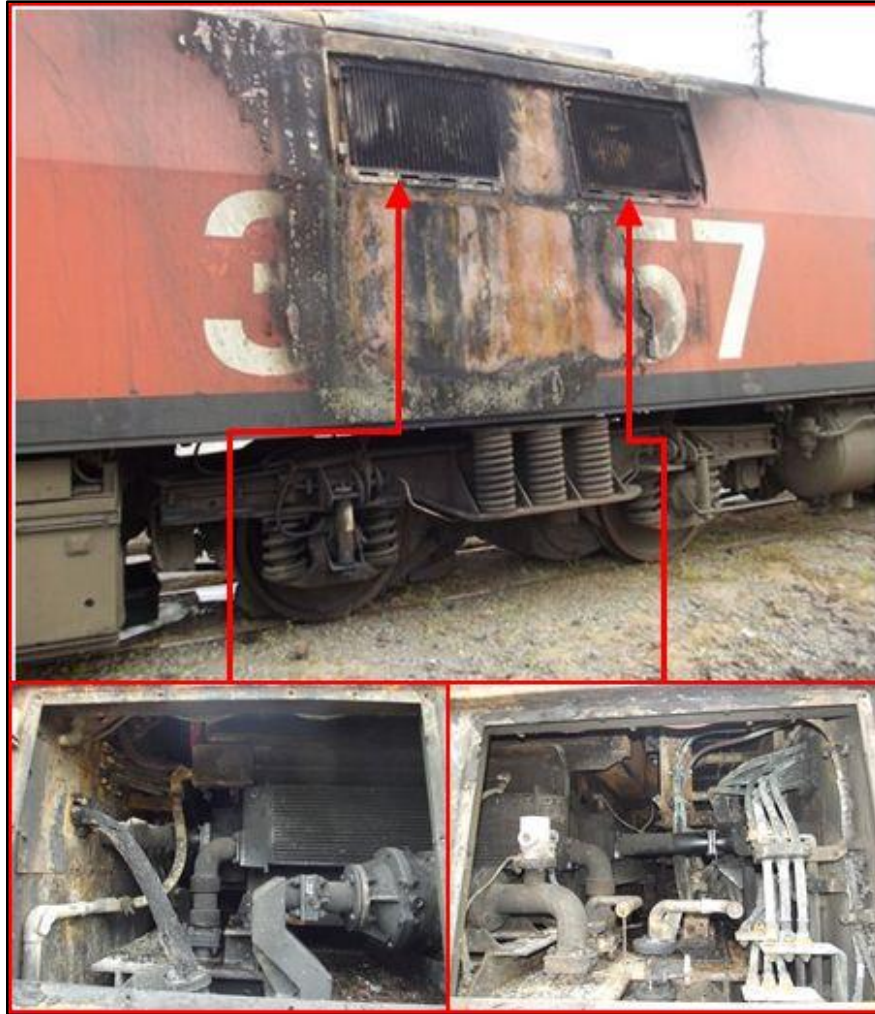
Figure 4
Fire damage to the exterior and interior of the transformer compartment

- 3.1.13. The fire was declared extinguished at 2023.
- 3.1.14. Both the interior and the exterior of the transformer compartment were damaged by the fire (see Figure 4). The fire was contained within the transformer compartment and the locomotive is considered repairable by KiwiRail.

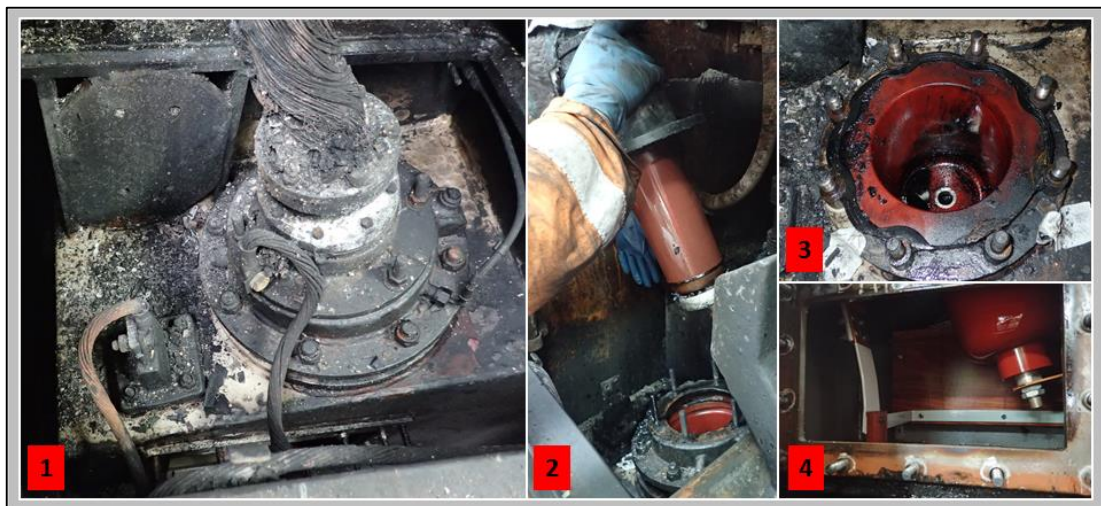
Figure 6
The high-voltage cable assembly – post fire

- Picture 1 – the cable and plug bolted on to the transformer housing
 Picture 2 – the plug being lifted clear of the oil-filled socket in the transformer housing
 Picture 3 – the socket in the transformer housing with the oil drained
 Picture 4 – the socket inside the transformer housing, viewed from the side access hatch

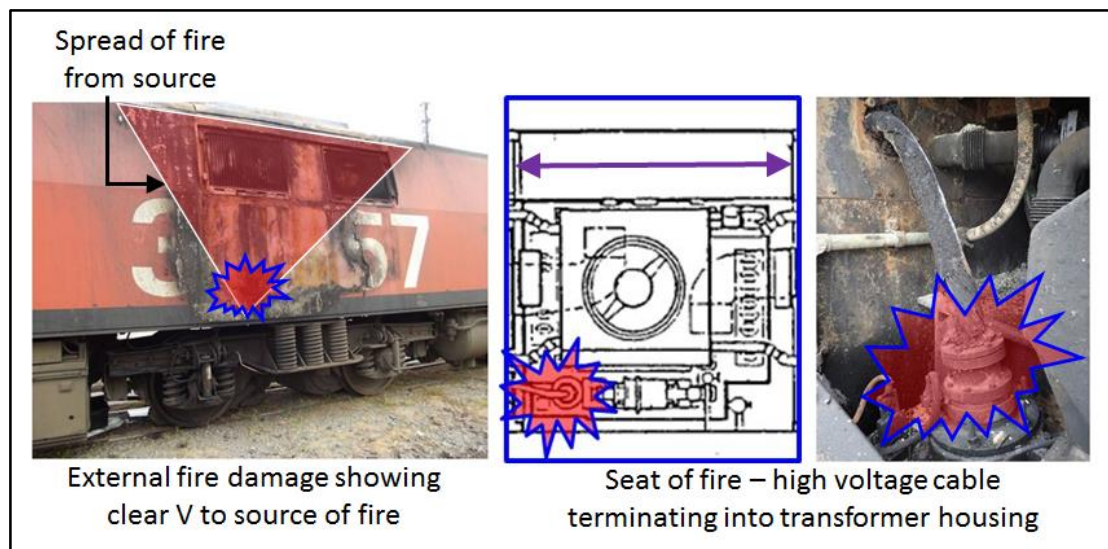
Figure 7
Seat of the fire – high-voltage cable terminating in the transformer housing

- 3.4.1. In conjunction with the Palmerston North Fire Service and KiwiRail's EF class high voltage expert, a visual examination of the scene was carried out to identify the source of the fire. After observing the burn pattern, the spread of the fire and the heat damage to equipment in the transformer compartment, the source of the fire was traced to where the high-voltage cable entered the transformer housing (see Figure 7).

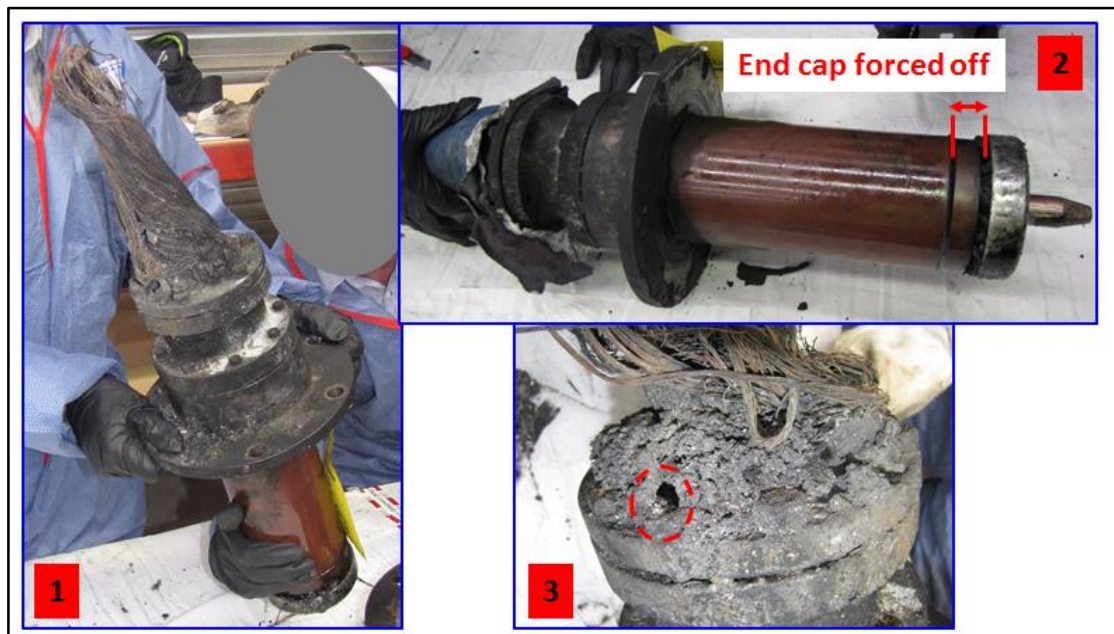
Figure 8
High-voltage cable plug removed from EF30157 transformer housing

4.2.1. The damage caused by the fire was contained within the transformer compartment. Commission investigators, assisted by KiwiRail's high voltage expert, removed and inspected the high-voltage plug that had been identified as the source of the fire (see Figure 8).

Picture 1 – the cable plug assembly from EF30157

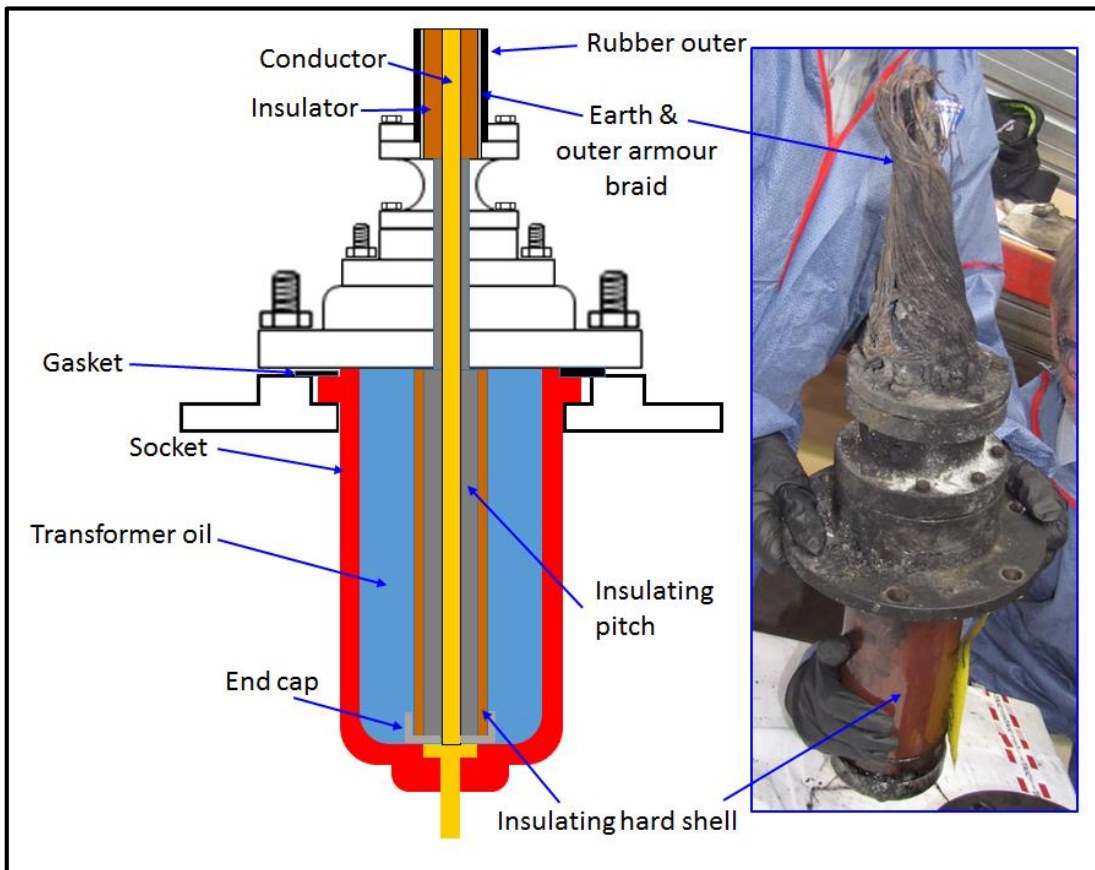
Figure 9
The high-voltage cable socket and plug assembly

4.2.2. An inspection of the high-voltage cable plug showed that the insulation had failed within the plug (see Figure 9 for cross-section detail). The breakdown of the insulation allowed a short to earth, causing an explosion that distorted the cable plug and started the fire. This happened

shortly after the locomotive had been parked on the electric departure road, when it was stationary and under no electrical load.

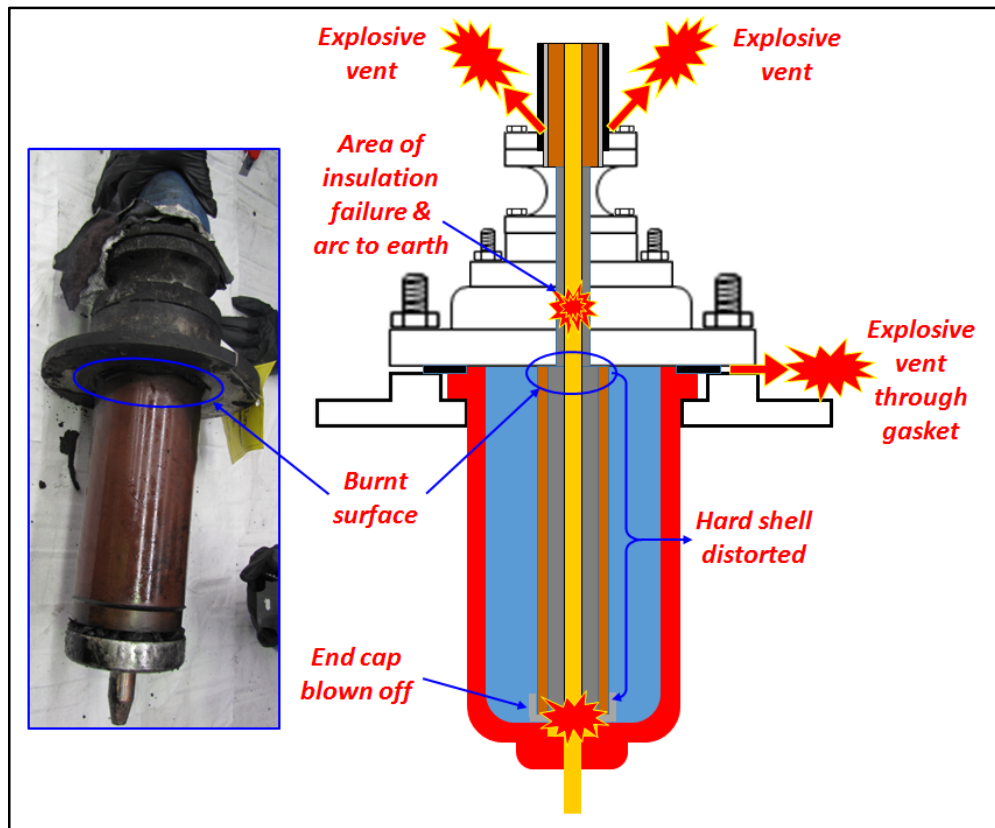
Figure 10
Diagram of cable failure

- 4.2.3. An inspection of the high-voltage cable plug showed evidence of expansion in all directions due to an explosion:
- an explosive gas vent had occurred through the plug's copper earth screen just above the plug assembly. It had melted several strands of the earth and armour braid and exited through the rubber outer sheath (see Figure 10)
 - the plug's insulating hard shell was burnt near the upper flange and the outer surface was distorted. The insulating pitch inside it had expanded and forced the end cap off (see Figure 10)
 - the pressure build-up inside the oil-filled socket had breached the gasket seal between the cable plug flange and the transformer housing through an arc of approximately 60° (see Figure 11). The damaged gasket section allowed transformer oil to be forced out through the broken seal.

- 4.2.4. The explosion caused by the high-voltage cable plug failure simultaneously expanded the high-voltage plug and forced oil out of the socket and ignited it. It also caused the electrical protection breakers on the locomotive to trip.
- 4.2.5. The oil socket was designed so that any leakage of oil was automatically topped up by a gravity feed from a multipurpose 3,000-litre oil reservoir. Once the oil had been ignited the fire received a constant supply of oil that fuelled the fire.
