Final report RO-2015-103: Track occupation irregularity, leading to near collision, Between Manunui and Taumarunui, 15 December 2015

Rail inquiry RO-2015-103

Track occupation irregularity
leading to near collision,
Between Manunui and Taumarunui,
15 December 2015

Approved for publication: August 2017

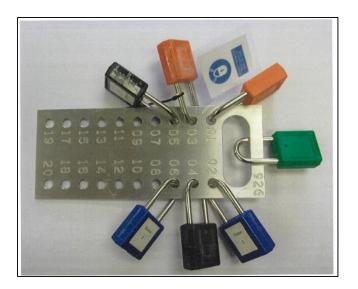
Figure 1
A lock-on frame with padlocks secured

3.2.1. KiwiRail's Track Safety Rule 902 described how maintenance workers and vehicles were to be managed under the direction of a rail protection officer. Each worker was provided with a numbered padlock and a key that were registered against their name on an approved form. When the rail protection officer had confirmed that it was safe for the workers to occupy the track, he attached his own padlock to a lock-on frame. Each worker was then required to lock their padlock to the frame before occupying the track (see Figure 1).

- 3.2.2. The reverse process applied when it became necessary to clear the worksite for a train or on the completion of work for the day. The maintenance workers were required to unlock and remove their padlocks from the lock-on frame after they reached the designated safe place. The process was supervised by the rail protection officer, and when all other padlocks had been removed he then removed his own padlock.

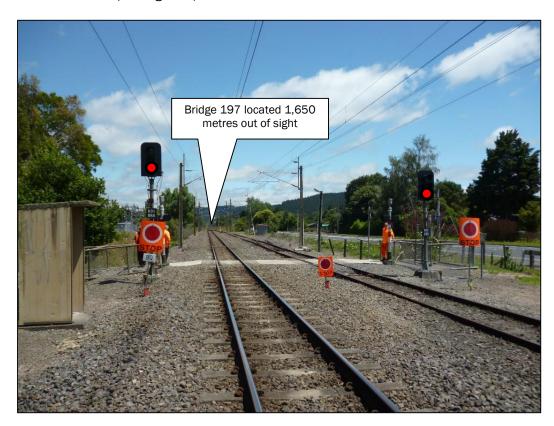
Figure 2
The stop boards and signal at Manunui (looking north)

- 3.2.3. KiwiRail's Track Safety Rule 905 described how maintenance workers were to be protected from passing trains. The trains were required to stop at compulsory stop boards (stop boards). The stop boards were positioned a minimum of 500 metres from both ends of a worksite. For northbound trains a stop board was placed adjacent to a signal, which the train controller held at red until the rail protection officer asked them to change it to green to allow the passage of a train through the worksite.

- 3.3.4. The freight train stopped at the stop boards and requested authority to pass through the worksite. At 1349 the rail protection officer requested the train controller to change the adjacent signal from red to green, then authorised the freight train driver to pass the stop boards at Manunui (see Figure 2).
