Final report MO-2015-201: Passenger ferry *Kea*, collision with Victoria Wharf,
Devonport, 17 February 2015

Marine inquiry MO-2015-201
Passenger ferry *Kea*,
collision with Victoria Wharf, Devonport,
17 February 2015

Approved for publication: August 2017

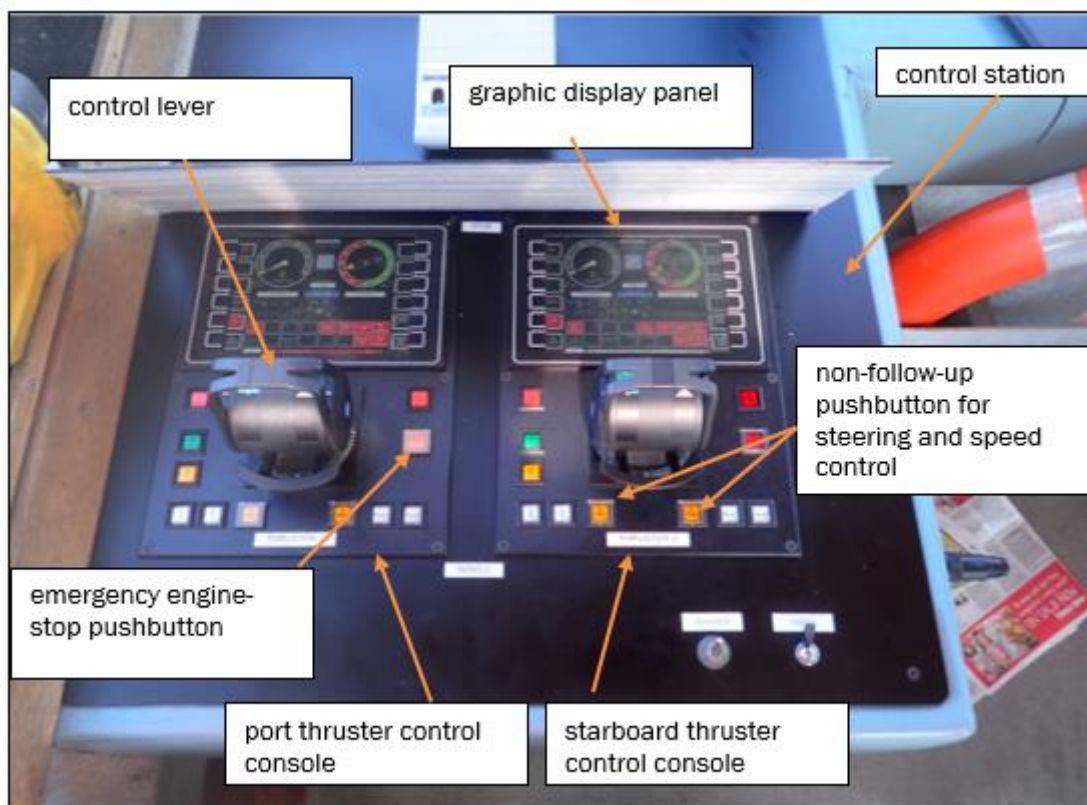
Figure 3
Control station layout

- 4.2.5. It is about as likely as not that the master did not push the give-away button with sufficient force to initiate the transfer. The transfer button was beneath a flexible, plastic, water-resistant shield, which had to be depressed with sufficient force to push/click the underlying button. During subsequent trials it was found possible to not activate the underlying button if the push was not hard enough or off-centre.

- 4.2.6. Each give-away button on each console was equipped with an audible alarm that sounded when the button was pressed to initiate a transfer sequence. Normally, a failure to push a button properly would not activate the transfer alarm. However, it was standard practice to press both give-away buttons simultaneously. If one button was pushed correctly and the other was not, one alarm would sound, but it would not be recognisable that the other did not because the two alarms were indistinguishable from each other.

- 4.2.10. Since the accident, the Kea has been fitted with eight new control levers and incorporated modifications to reduce the risk of a control system failure. The audible alarms have also been modified to sound continuously until control is assumed at the receiving control station.

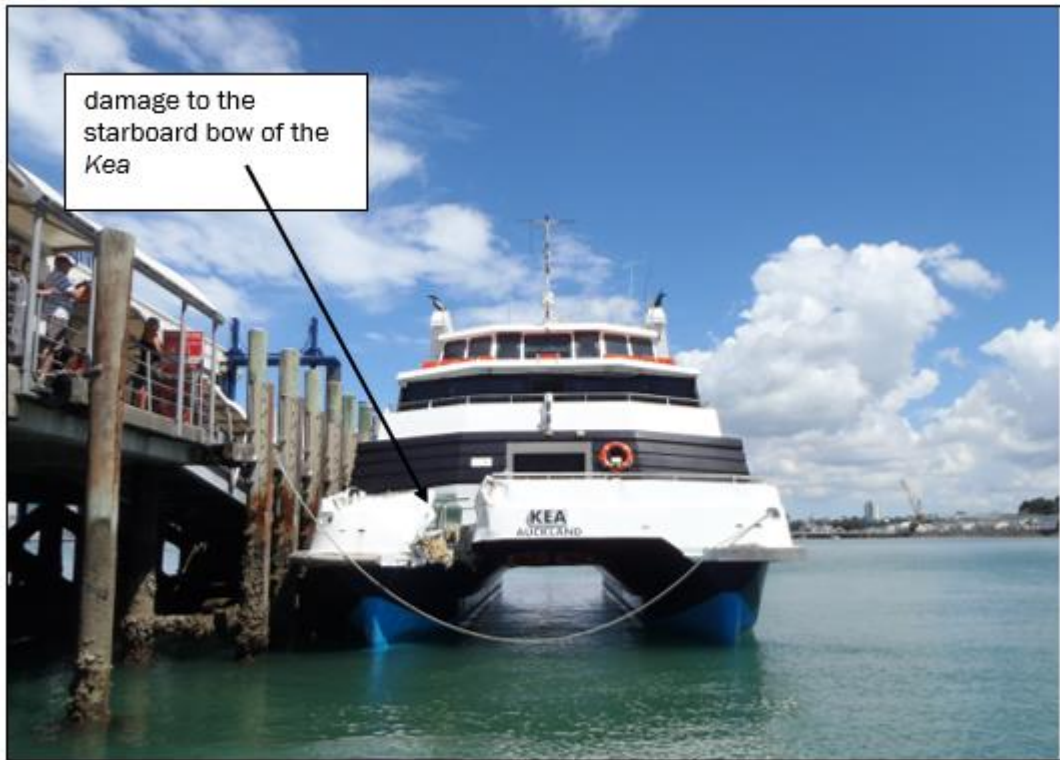
Figure 6
Impact damage to the Kea's starboard bow area

Damage significant impact damage to the Kea’s starboard bow

- 1.6. The *Kea* sustained significant damage to its starboard hull above the waterline and many passengers received minor injuries. Seven passengers were hospitalised with non-life-threatening injuries.

- 3.6.15. Shortly afterwards the vessel's starboard bow collided with a concrete pile on Victoria Wharf.

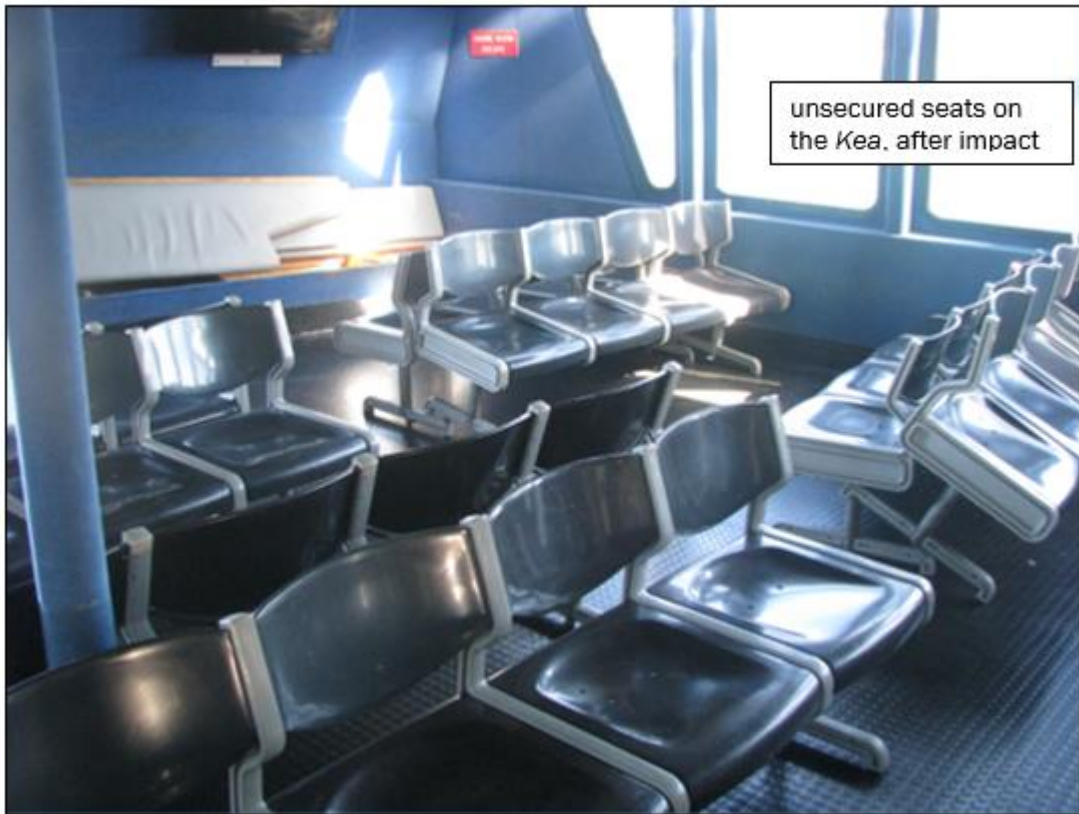
Figure 7
Unsecured seats on the Kea

- the regulatory system did not ensure an appropriate level of surveyor oversight of the project to replace the *Kea*'s propulsion control system
 - Fullers had not assessed the risk of operating ferries with unsecured passenger seating.
