Final report MO-2015-202: Containership *Madinah*, loss of person overboard,
Lyttelton Harbour entrance, 2 July 2015

Marine inquiry MO-2015-202
Containership *Madinah*, loss of person overboard,
Lyttelton Harbour entrance
2 July 2015

Approved for publication: September 2016

Transport Accident Investigation Commission

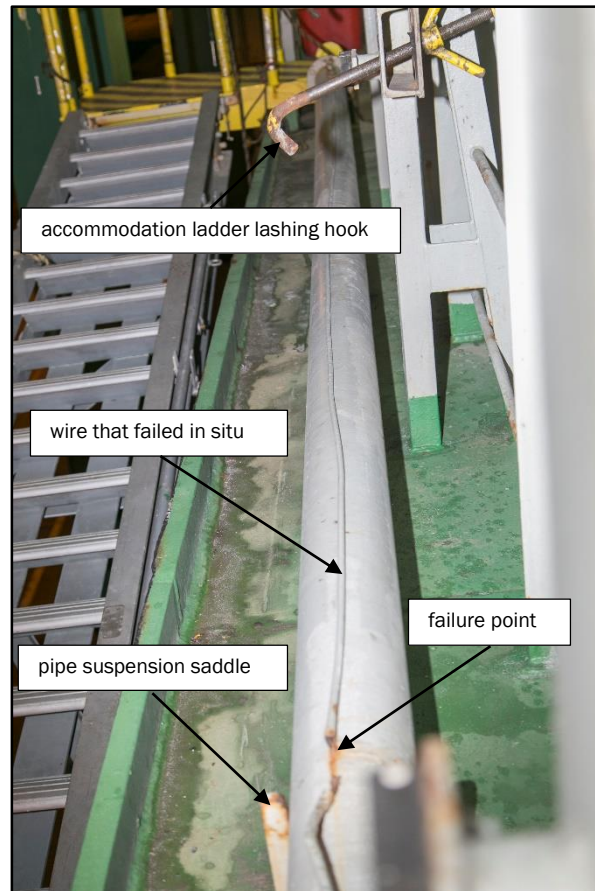
- 4.3.6. The point where the wire failed was severely corroded. There were holes in the plastic sheathing in the area of the failure (see Appendix 1). This had allowed water to penetrate through the sheathing and corrosion to form.

Figure 5
Port accommodation ladder and pipe showing the wire that failed
(a pipe suspension saddle is a support for a pipe)

- 4.3.7. An expert on ropes, chains and fittings¹¹ stated that best practice was not to use plastic-covered wire rope when wire grips were to be used. It further stated that to attain an 80% of rope minimum breaking load for an eight-millimetre-diameter wire rope, a minimum of three wire grips should be used. The method used for forming the eyes at each end of the wire rope did not therefore comply with industry best practice. Even though the eyes were not the part of the wire that failed, this lack of best practice was of concern.

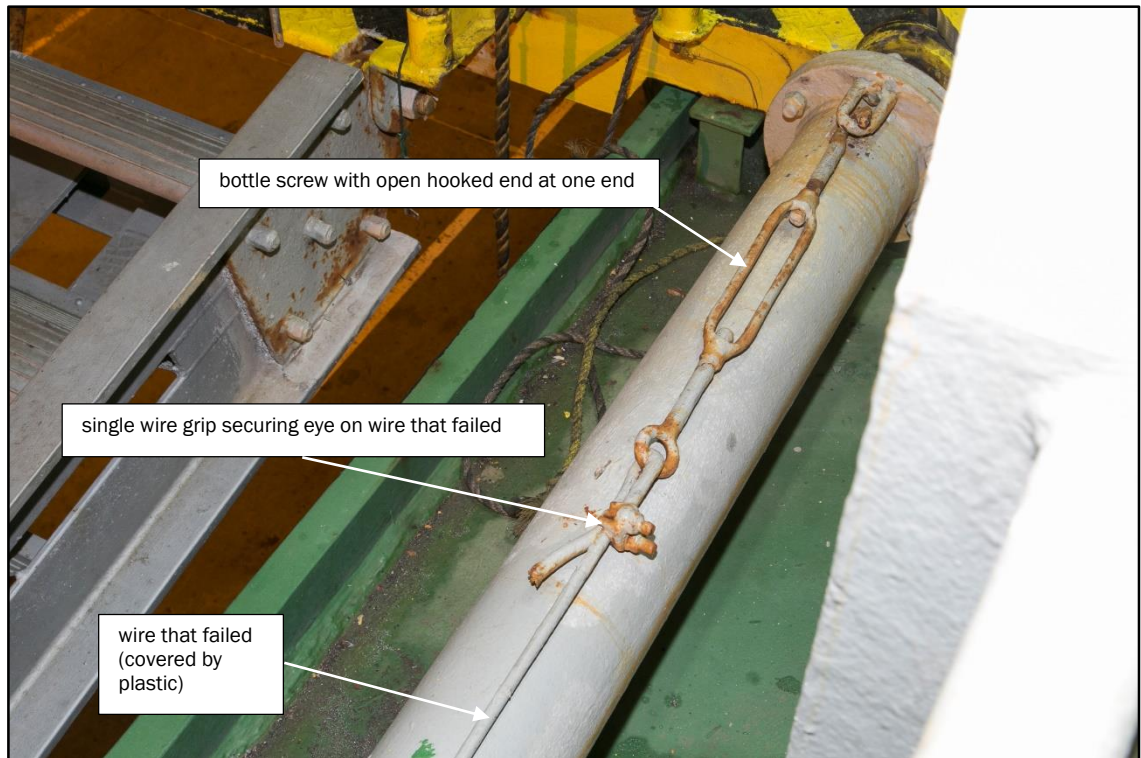
- 4.3.8. It is about as likely as not that the wire rope was originally intended to be used as a safety lifeline. There was no other logical reason for it being fitted. If this was the case a safety lifeline, which is critical equipment, should have been constructed to industry best practice and regularly maintained. The complete assembly, including the attachment points, should have been assessed for adequate strength and made up of permanent components. The use of an open hook on the bottle screw¹² was another potential point of failure.

Figure 6
Port accommodation ladder showing wire formation and hooked bottle screw

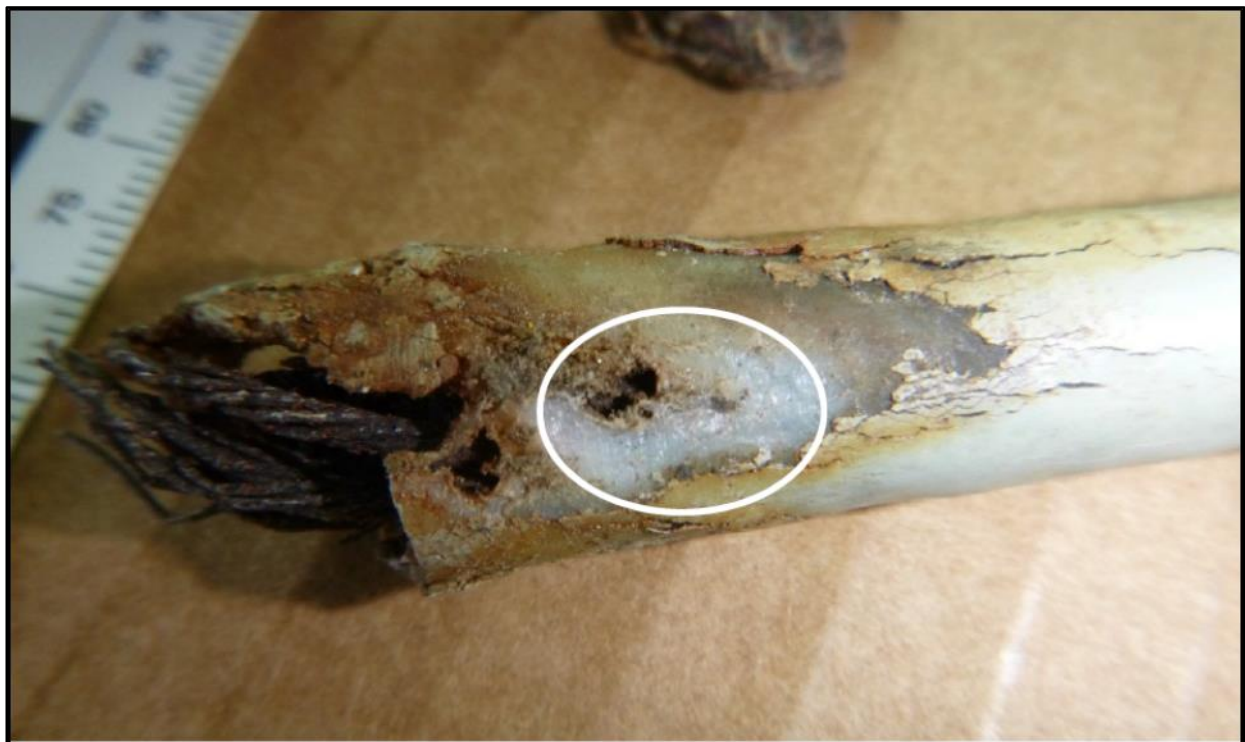
Figure 7
End of failed wire showing corrosion and sheath degradation

- 5.3. The wire rope parted because it was significantly weakened by corrosion. The corrosion had gone undetected because the wire was coated in plastic, a significant safety issue that prevented the wire rope being properly inspected and maintained.

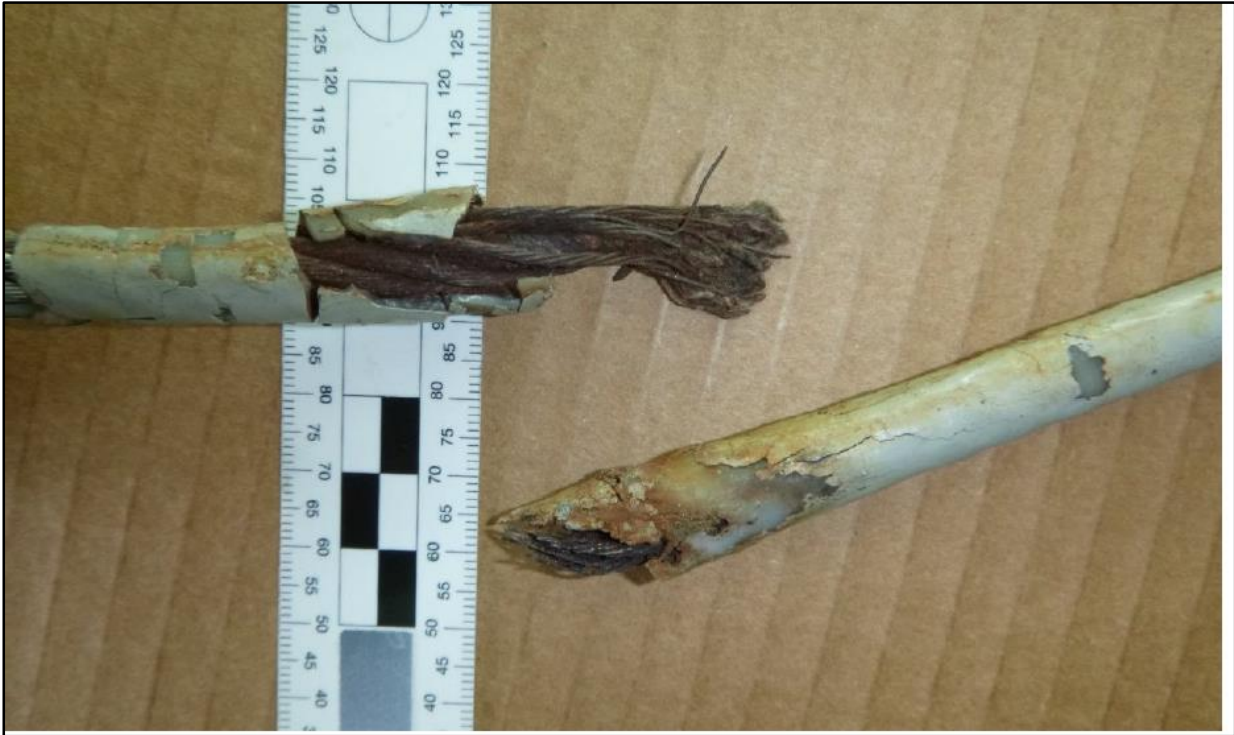
Figure 1. Failed ends of the rope upon receipt

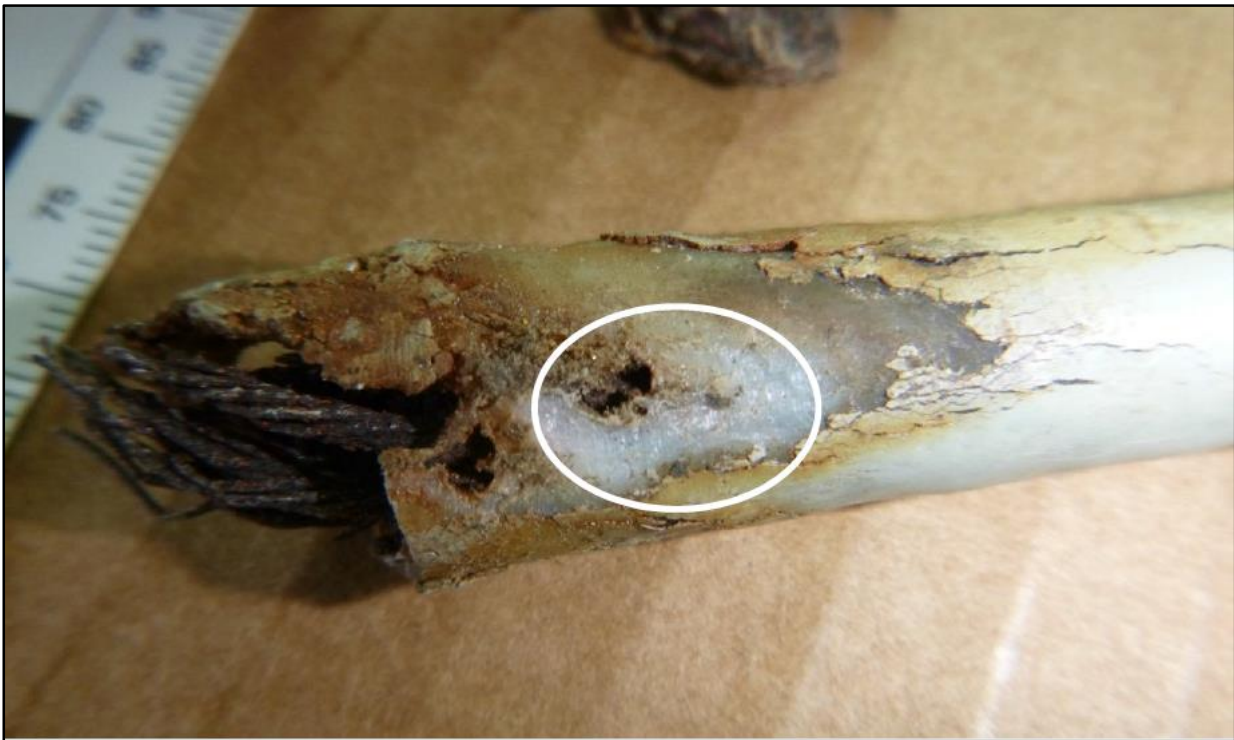
Figure 2. Local degradation of outer sheathing and fresh abrasions (circled).

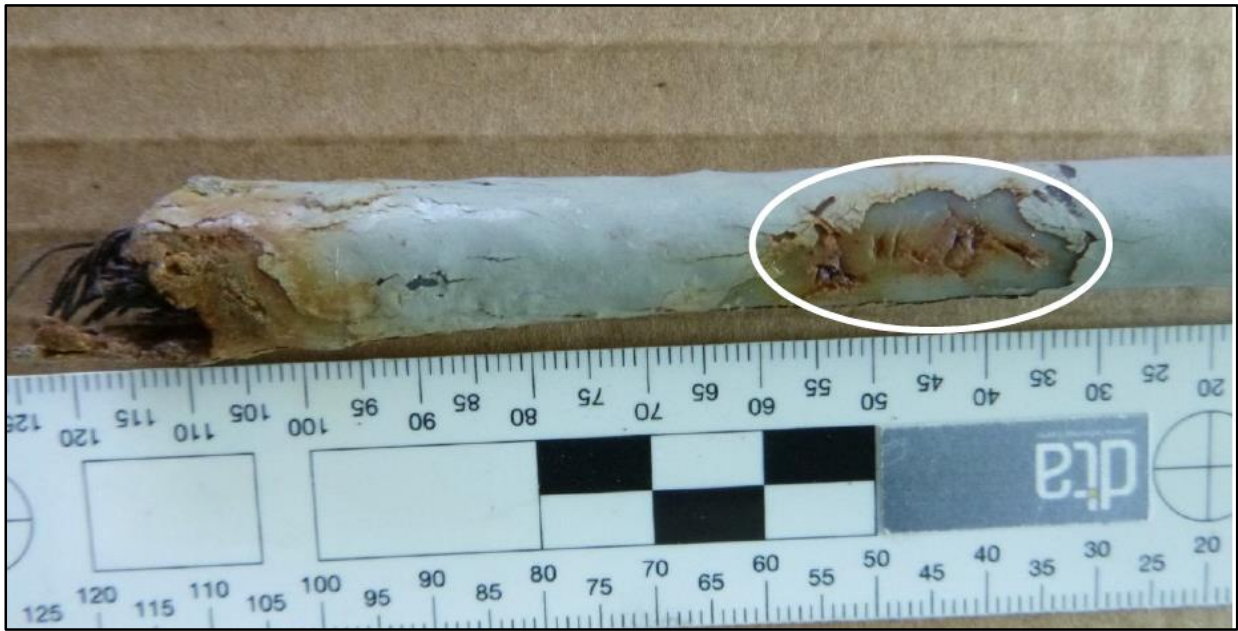
Figure 3. Penetrations of the outer sheathing 60 – 70 mm from failure

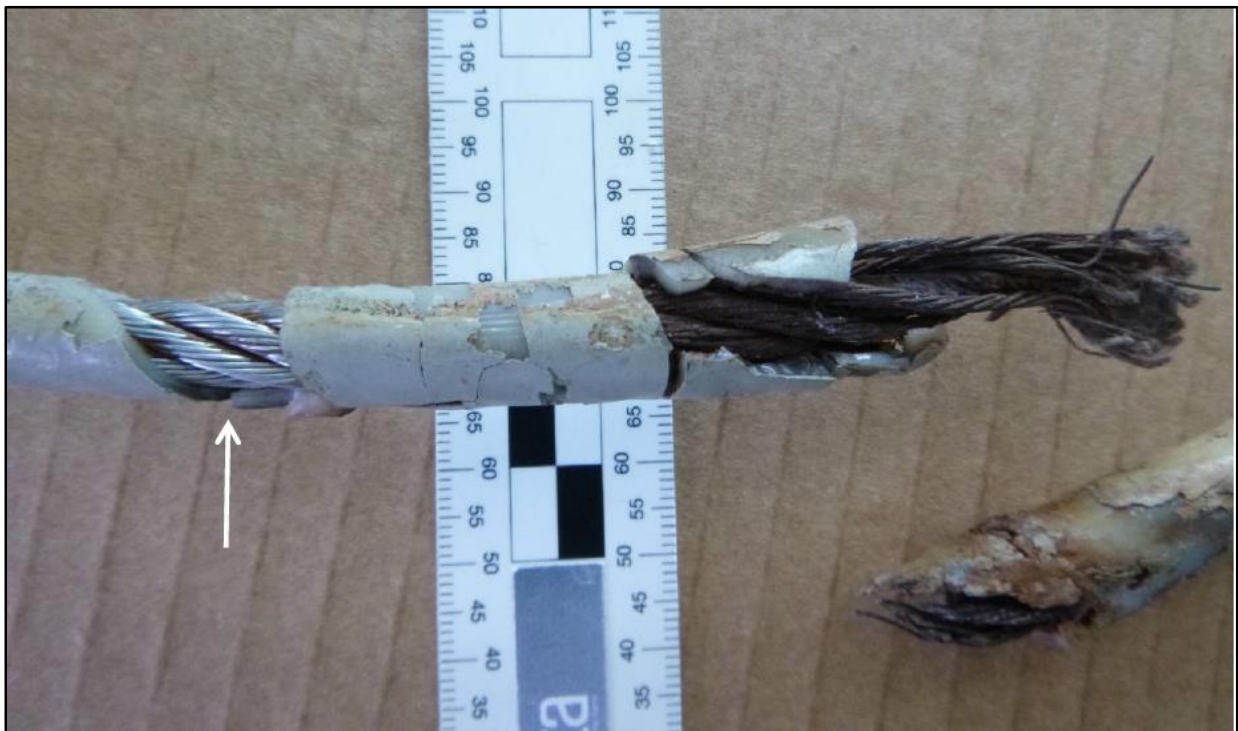
Figure 4. Relatively uncorroded wires present close to the failure (indicated by arrow)

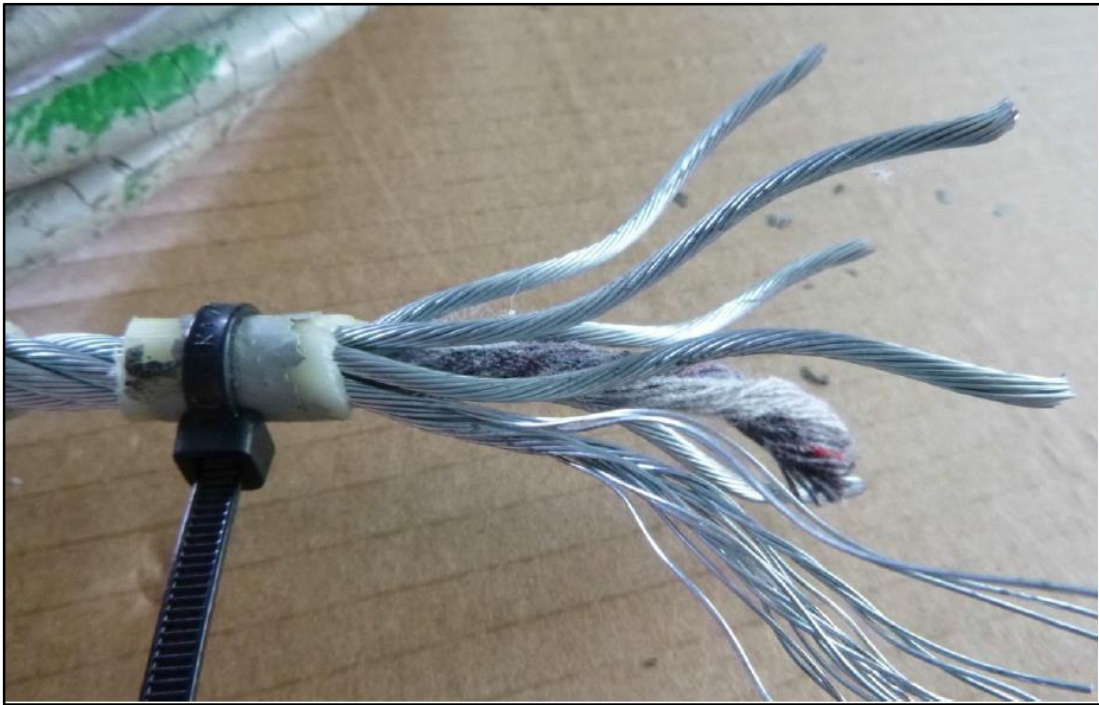
Figure 5. Uncorroded condition approximately 900 mm from the point of failure

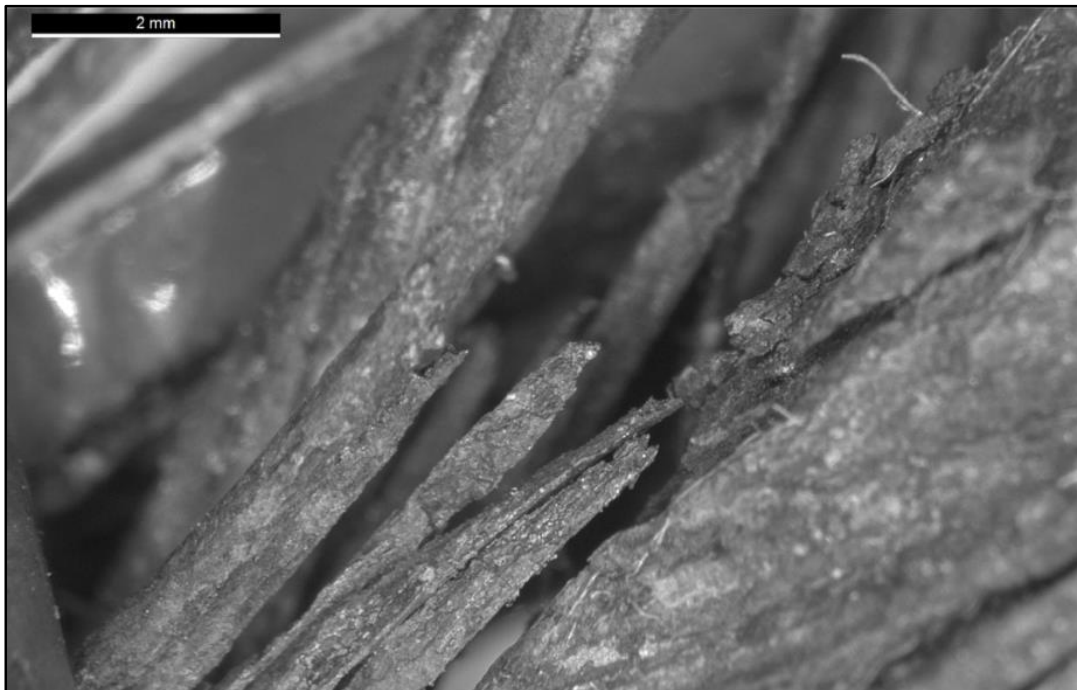
- 7 All of the wires at the point of failure were corroded to the extent that none of the zinc coating remained. A great number of the wires were severely corroded to the point that individual wire strength would have been negligible. This was evidenced by extreme thinning of the wires as shown in figures 6 and 7.

Figure 6. Severely corroded wires at the point of failure

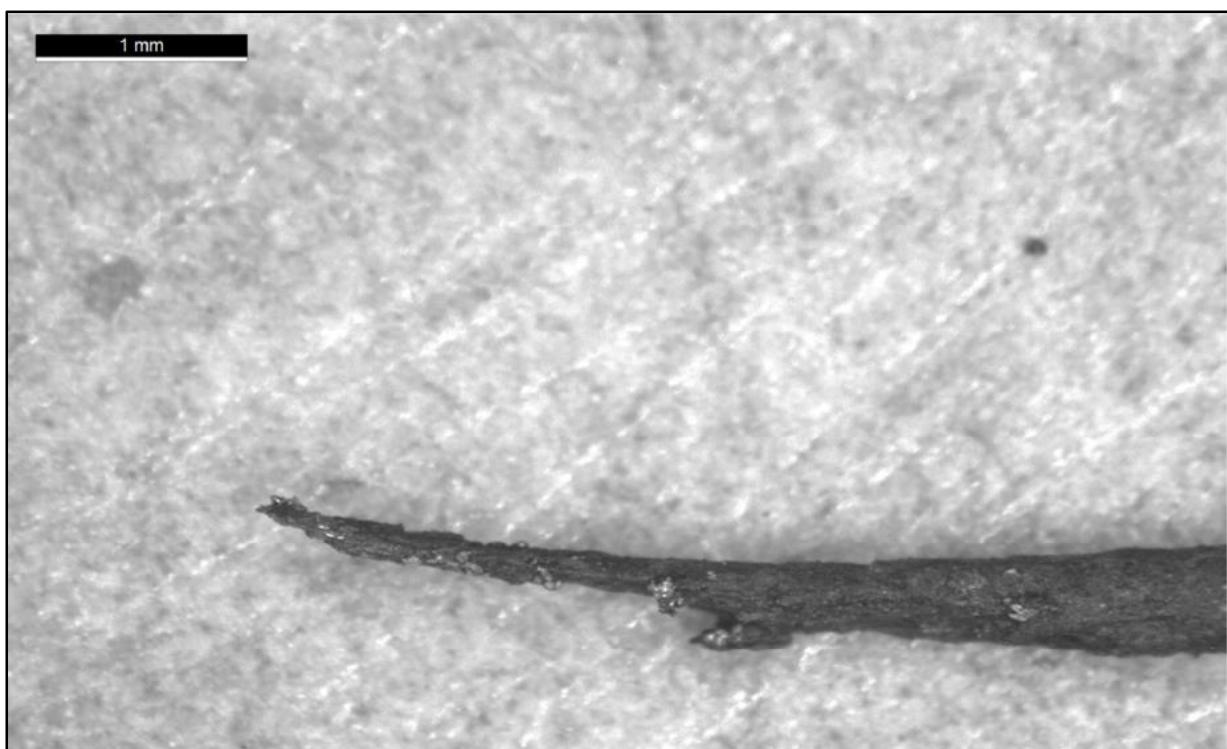
Figure 7. A single severely corroded wire extracted from the failure zone
