Final report MO-2015-203: Loss of the fishing vessel *Jubilee* and all hands,  
12 nautical miles off the Rakaia River mouth, 18 October 2015

Marine inquiry M0-2015-203

Loss of the fishing vessel *Jubilee* and all hands,  
12 nautical miles off the Rakaia River mouth,  
18 October 2015

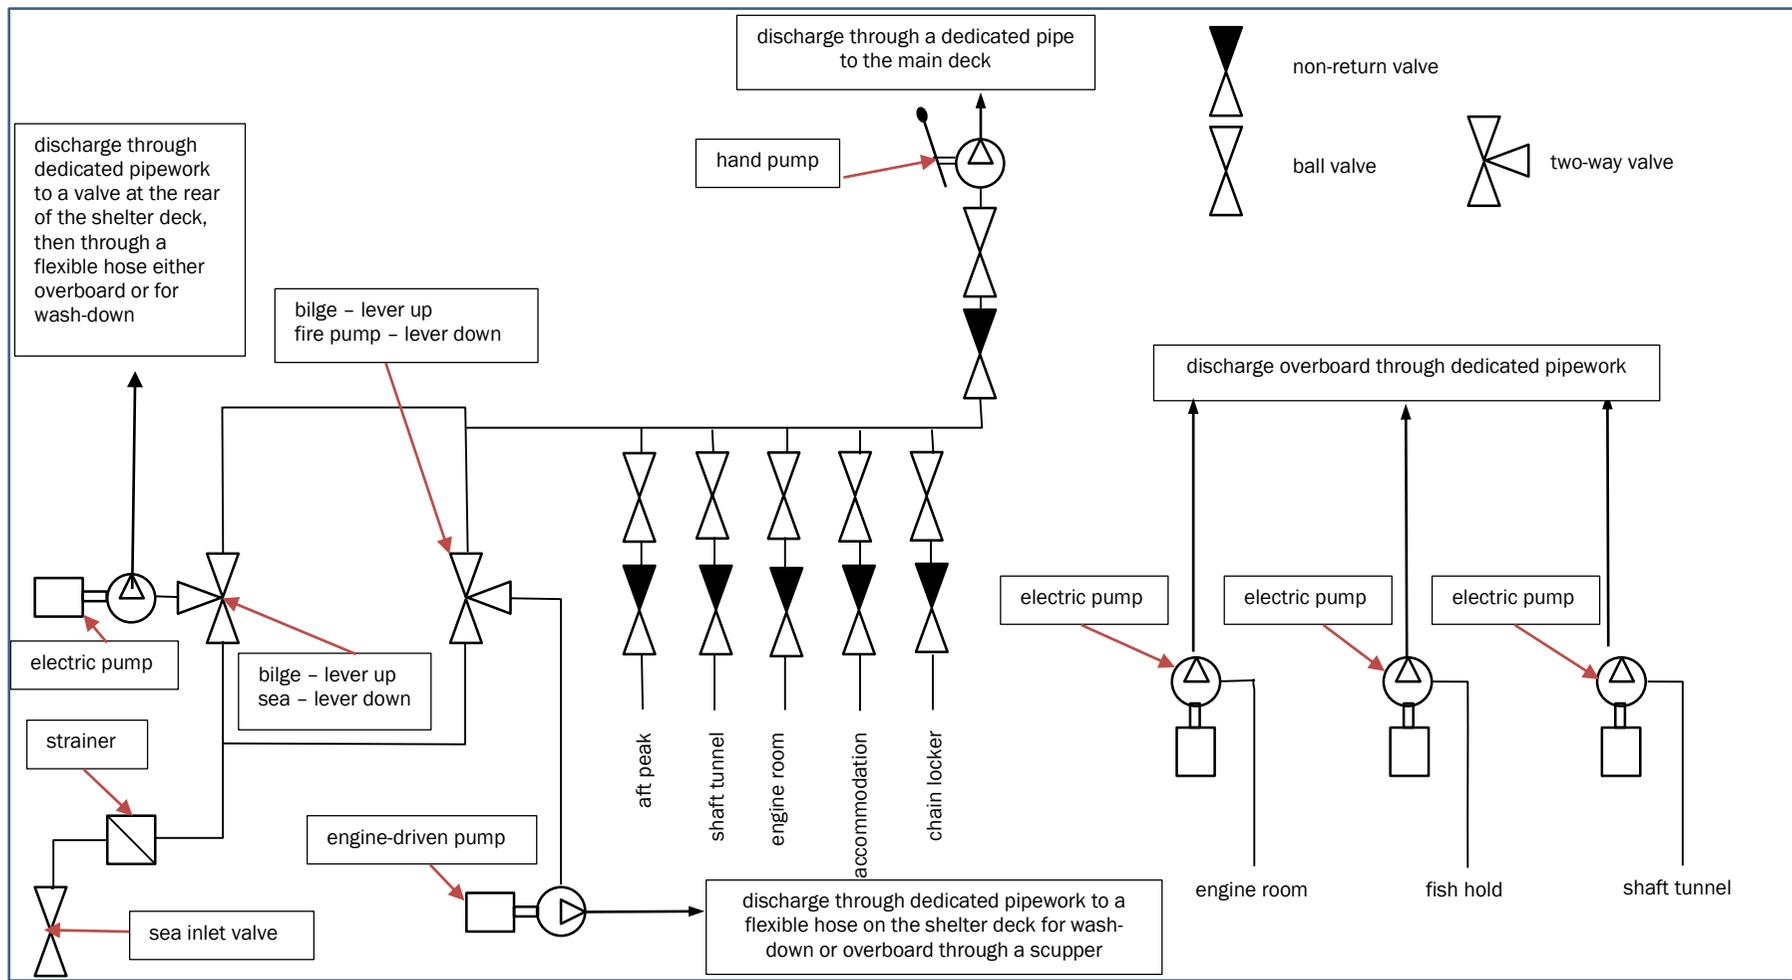
Figure 3  
Diagram of bilge pumping arrangement on the Jubilee

- 4.3.39. The fish hold bilge was not fitted with a bilge alarm and there was no visual alarm at the steering position in the wheelhouse to indicate when the pump was operating. The absence of a visual alarm was a serious safety issue and was contrary to Maritime Rules Part 40(D).28 (6)(d) (see Appendix 3).

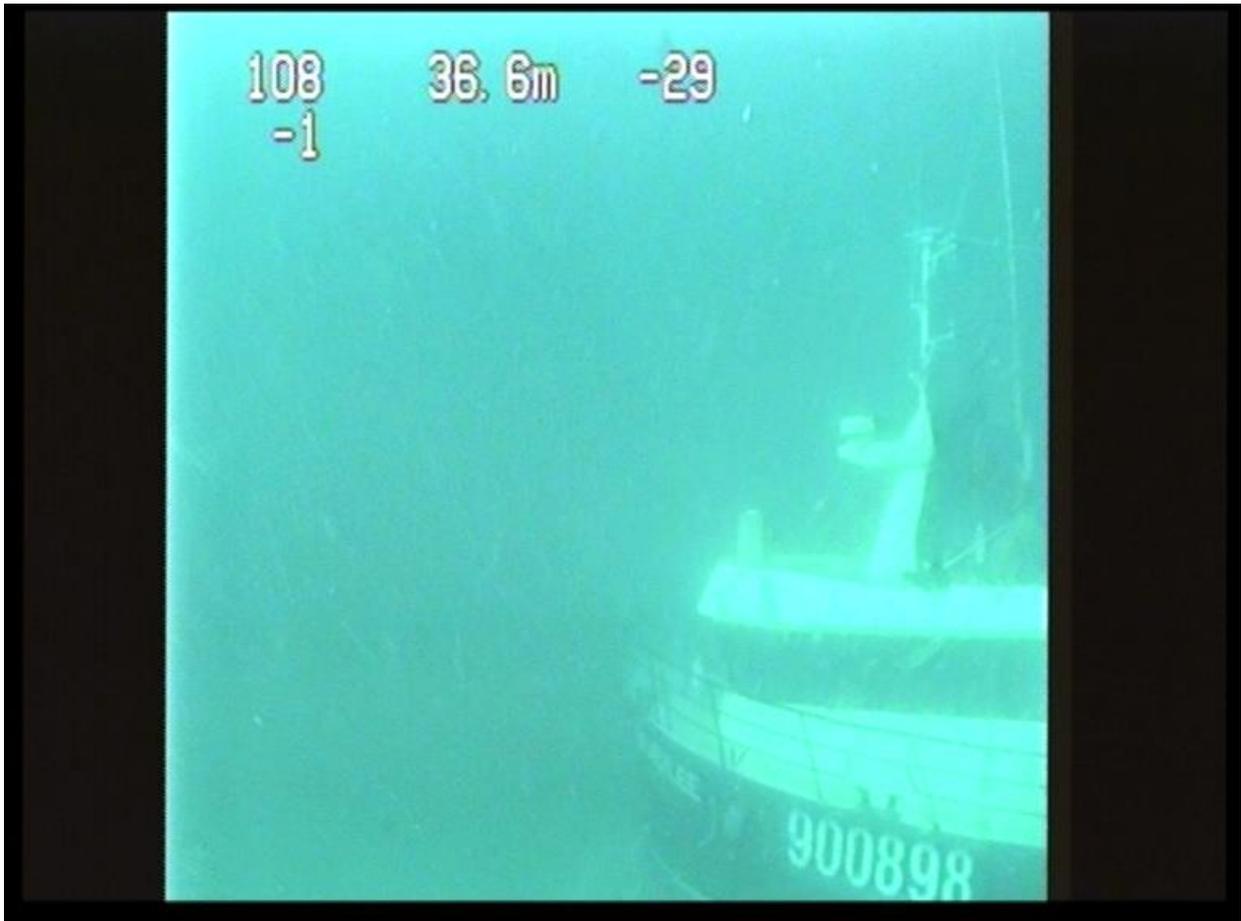
Figure 4  
Video still from the remotely operated vehicle search for the *Jubilee*,  
showing the vessel sitting upright on the seabed

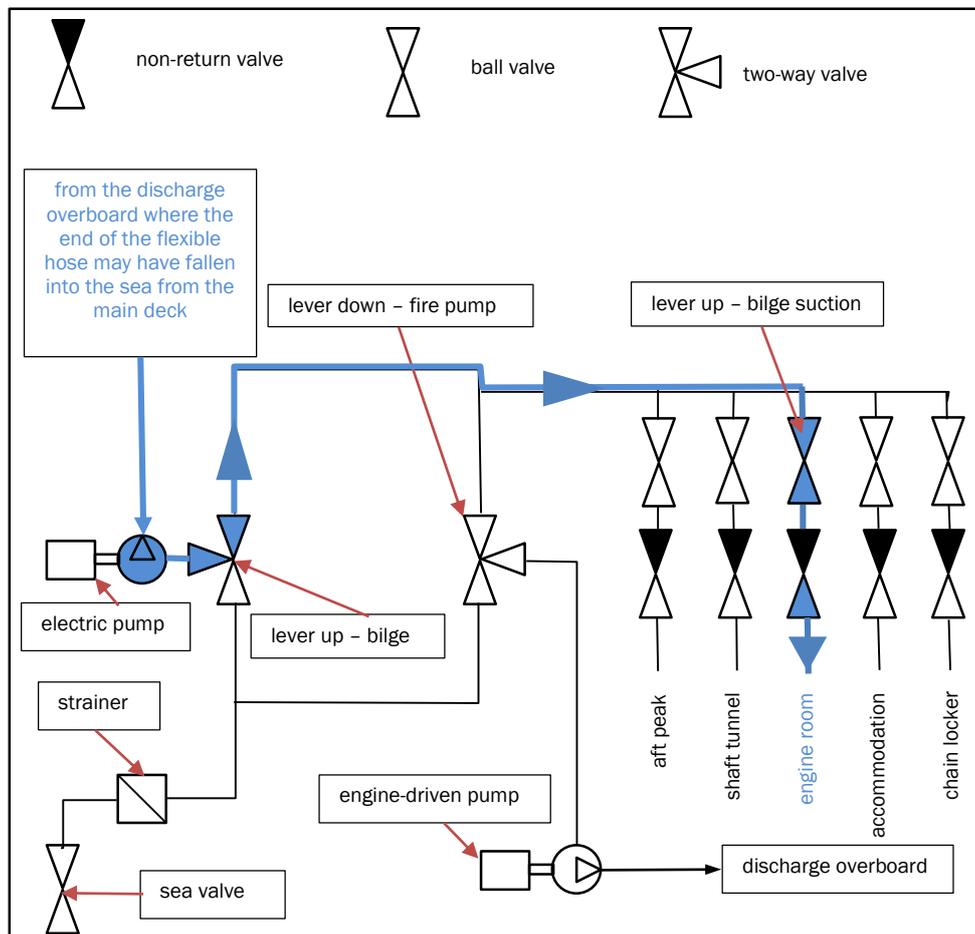
**Figure 5**  
Diagram showing possible track of back flooding into the engine room

4.3.13. However, Figure 5 shows a potential path for water to have back-flooded through the bilge system and entered the engine room via the electric-driven pump.

return valve<sup>15</sup> that was designed to prevent this scenario. The engine room bilge non-return valve was recovered from the vessel. When tested it was found to leak back a small amount under mains water pressure. The amount siphoned back would have been very small due to the constriction of the non-return valve; another non-return valve was located at the end of the bilge suction pipe that would have also stopped or restricted any siphoning. Any water potentially entering the engine room would automatically have been pumped overboard and a bilge alarm sounded in the wheelhouse.

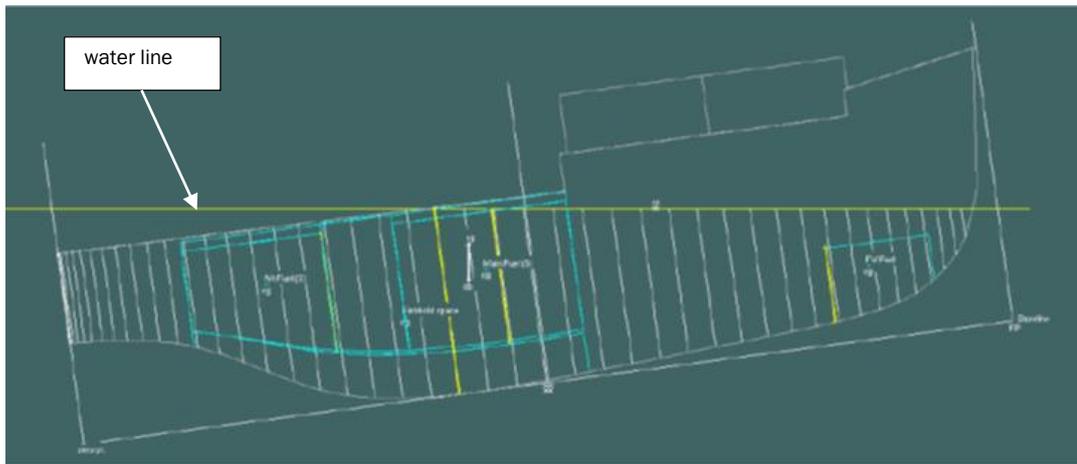
Figure 6  
Fish hold 60% flooded (up to this point stability remains positive but greatly reduced)

- 4.3.24. The calculations carried out by the naval architect showed that the fish hold only needed to be between 60% and 70% full before down-flooding<sup>17</sup> occurred into other compartments. Down-flooding would occur through unsecured openings in the deck or the superstructure and would cause the vessel to sink by the stern.

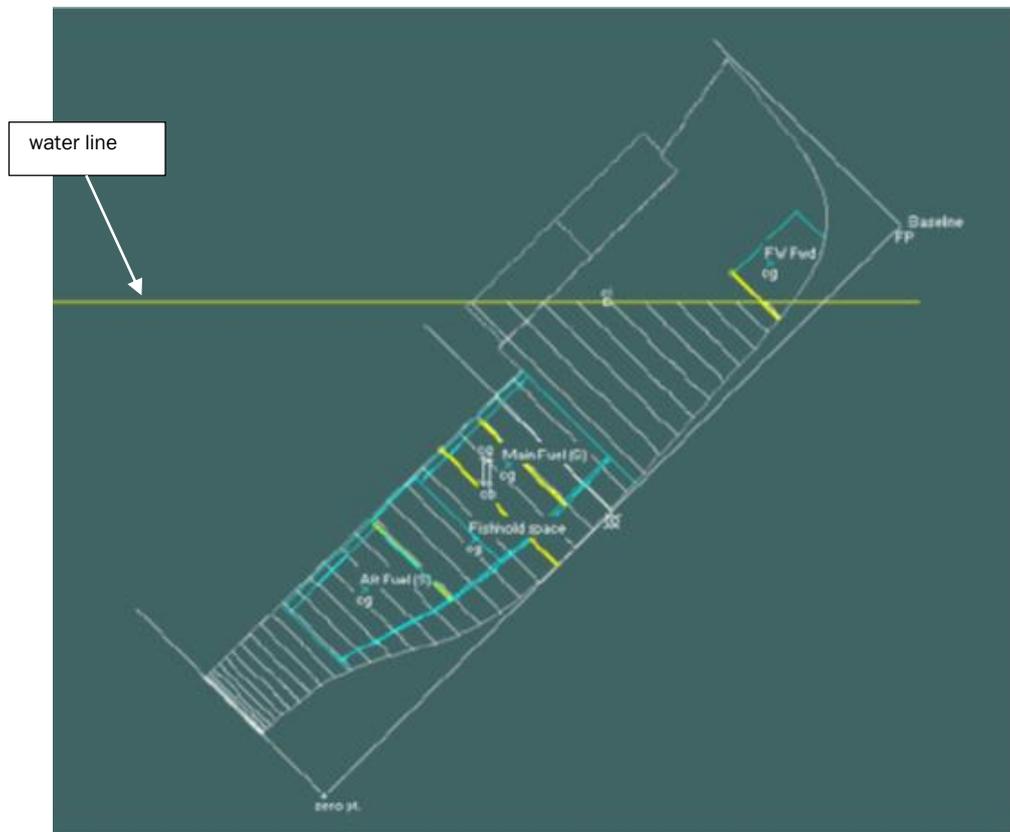
Figure 7  
Fish hold 70% flooded (forward section down-flooding)

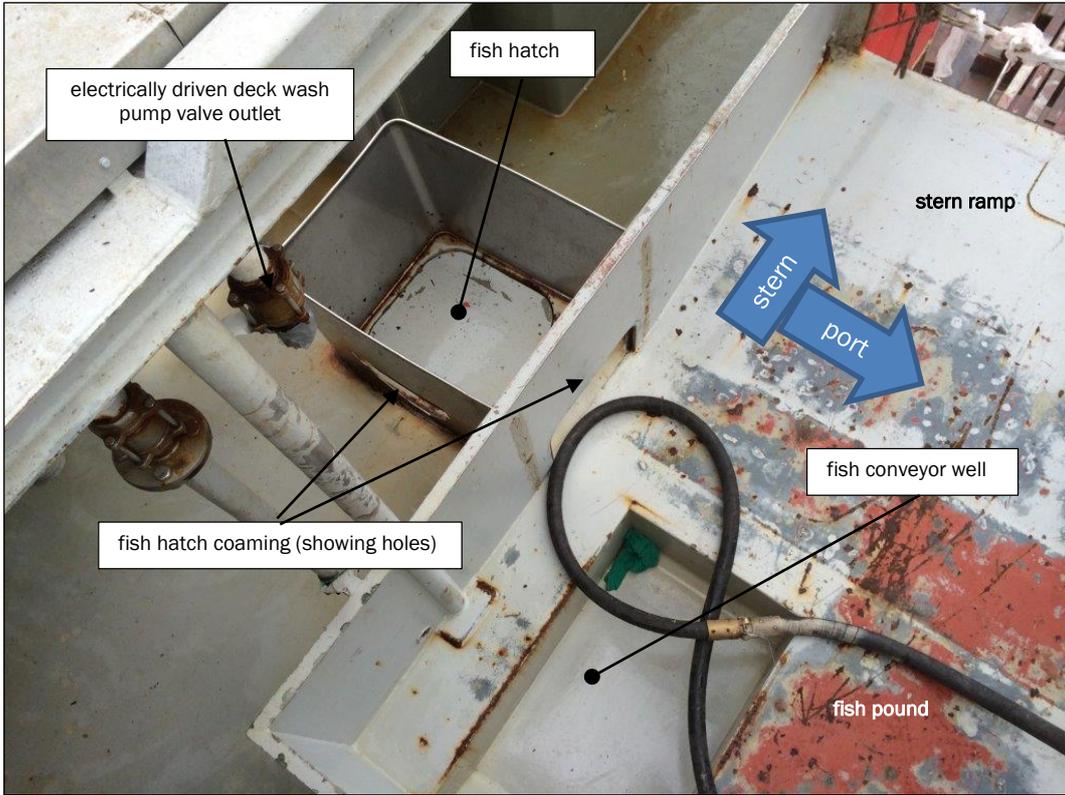
- 4.3.26. There were two hatches leading to the fish hold. The main and larger of the two hatches opened upwards from a raised coaming<sup>19</sup> that extended 300 millimetres (mm) above deck level. It was positioned further forward under the weatherproof cover. The RNZN dive team found that the main hatch (see Figure 2) was closed but not secured. As it could not be established what actions the crew took after discovering their plight, it is not possible to say whether this hatch was open during the night. Nevertheless, given its position and the height of the coaming it would have been unlikely to flood in anything but exceptional seas.

**Figure 9**  
 Fish pound and fish hatch on the *Jubilee* (photograph taken in dry-dock, from above)

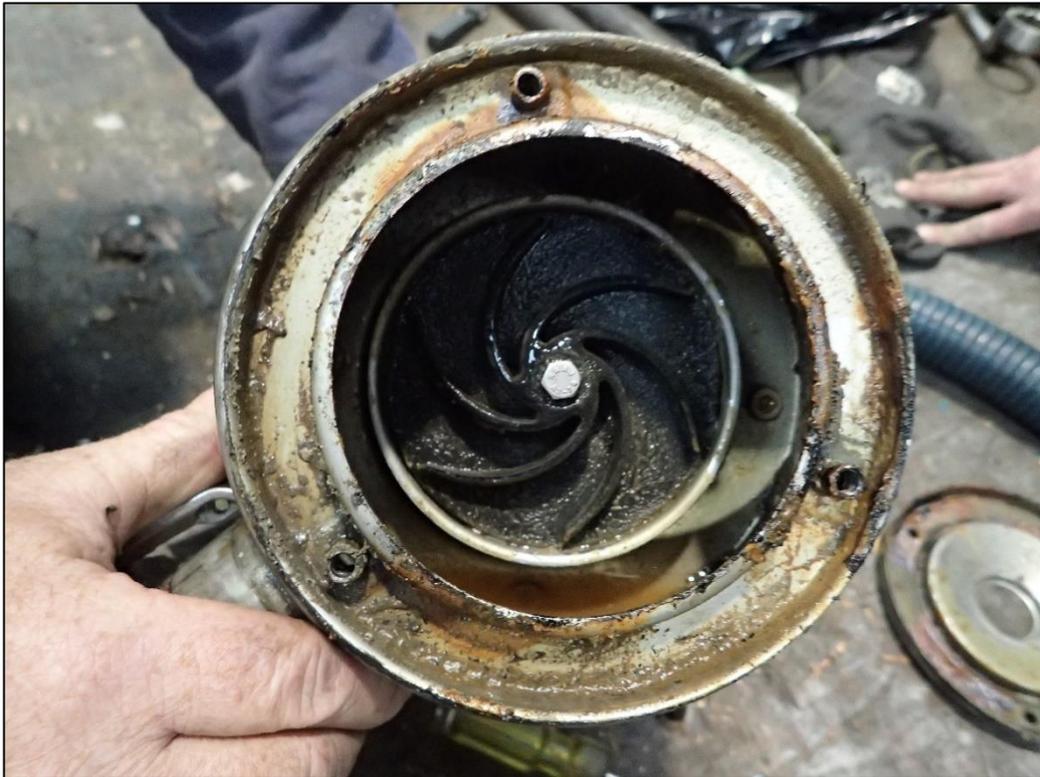
- 4.3.34. During the dive survey the fish hold bilge pump was retrieved from the vessel for further testing. The testing (Figure 11 showed that the pump was not blocked and appeared to be in good working order. The impeller could be rotated by hand. However, it was not possible to test the fish hold bilge pipe to check if it was blocked.

**Figure 11**  
Shore-based examination of the recovered electric bilge pump from the fish hold

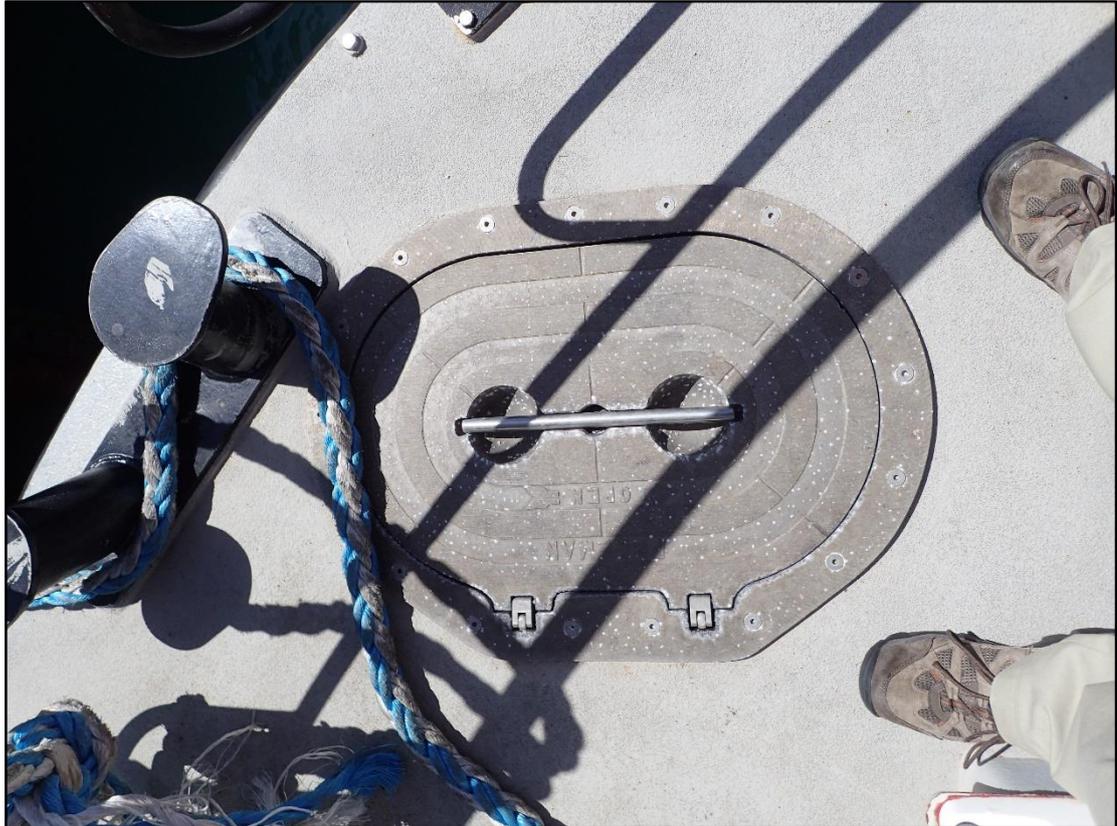
Figure 12

The clear opening of the door does not meet the normal standard minimum opening of at least 600 mm. The attending surveyor is to satisfy himself that the proposed opening of the hatch does not compromise the efficacy and safety of the crew in any event

The attending surveyor considered that this was satisfactory and the hatches were approved in accordance with Maritime Rules Part 40(D).14 – Hatchway openings and covers and other deck openings, section (10) (d) (see Appendix 4).

Watertight hatch to the chain locker as fitted to a sister vessel of the *Jubilee*. This is the same design and size as the hatches fitted to the *Jubilee* between the forecastle space and the chain locker and the chain locker and the deck.
