Final report AO-2016-004: Guimbal Cabri G2, ZK-IIH, In-flight fire,
near Rotorua Aerodrome, 15 April 2016

Aviation inquiry A0-2016-004
Guimbal Cabri G2, ZK-IIH
In-flight fire
near Rotorua Aerodrome
15 April 2016

Approved for publication: October 2017

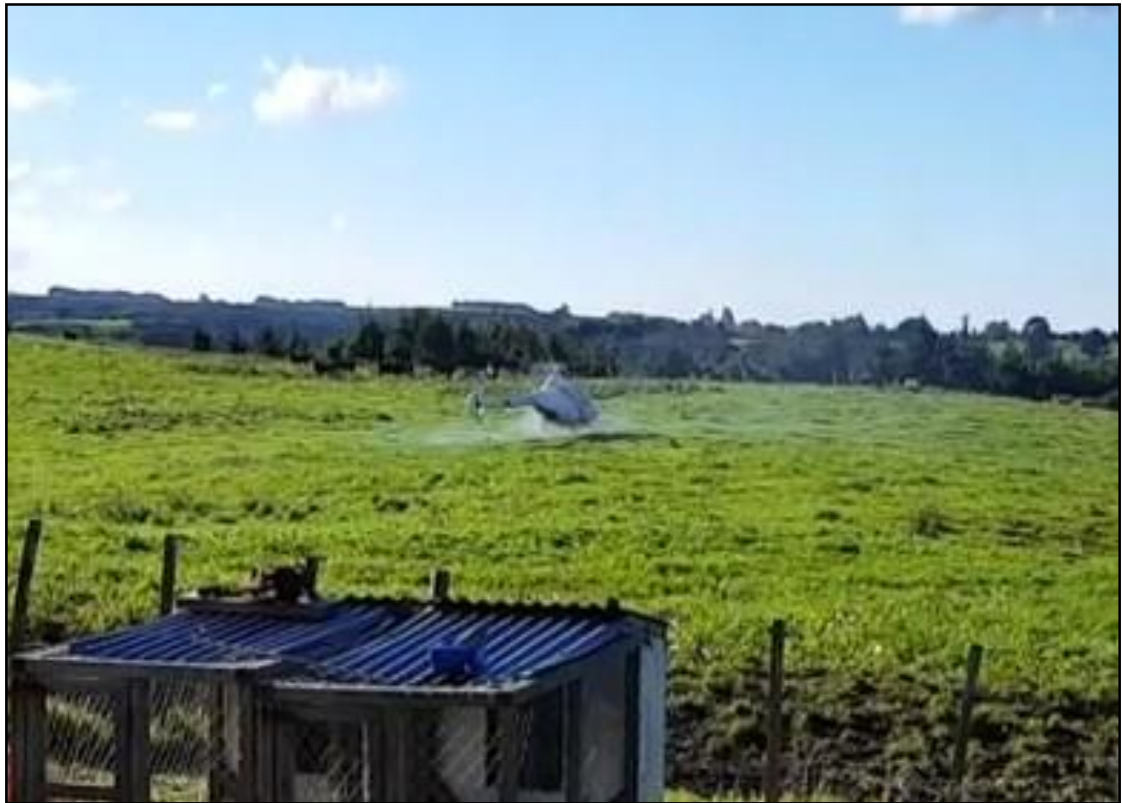
- 3.1.5. Occupants of a house adjacent to the paddock were alerted to the approaching helicopter by the unusual sound it was making. They saw the helicopter fly past the house and heard what they described as a 'clattering' sound. One witness captured a five-second video recording of the helicopter after it landed in the paddock. The witnesses saw smoke being emitted from around the engine area of the helicopter, and the intensity of the smoke increase rapidly around the mast area at the top of the helicopter. After the pilot had escaped, the helicopter was quickly engulfed in flames. The still frames in Figures 2 and 3 are from the video recording.

Figure 2
Light smoke from the helicopter immediately after landing
(courtesy of the witness)

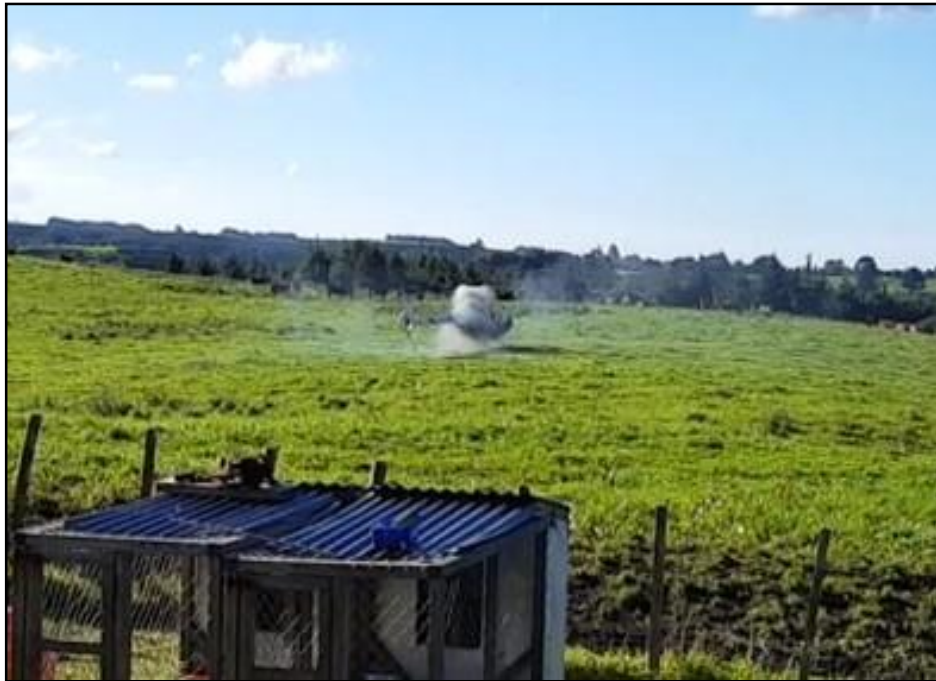
Figure 3
Heavy smoke around the top of the helicopter
(courtesy of the witness)

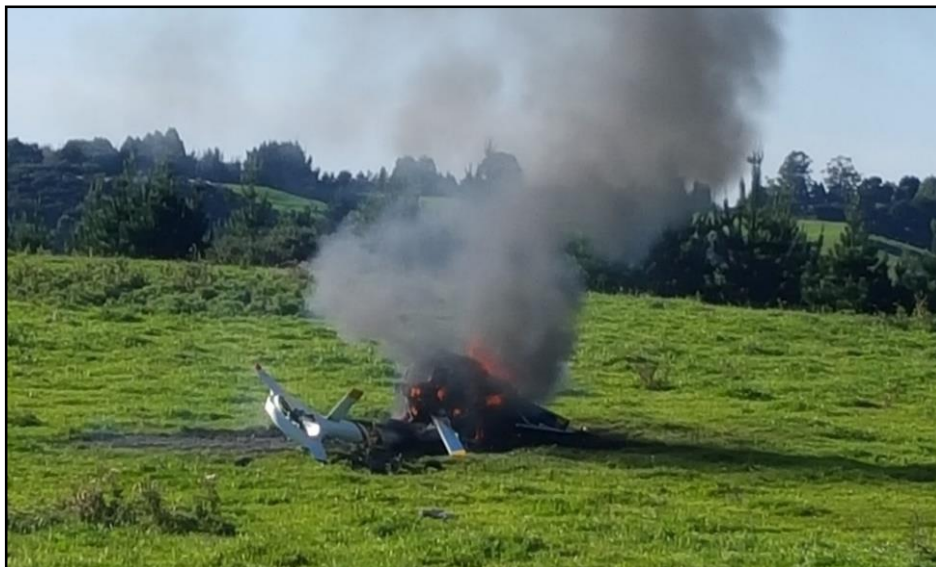
- 3.1.6. A rescue helicopter arrived at 1542, followed at 1554 by Fire Service personnel who extinguished the fire, but not before the helicopter was destroyed (Figure 4).

Figure 4
Helicopter engulfed by fire
(courtesy of the witness)

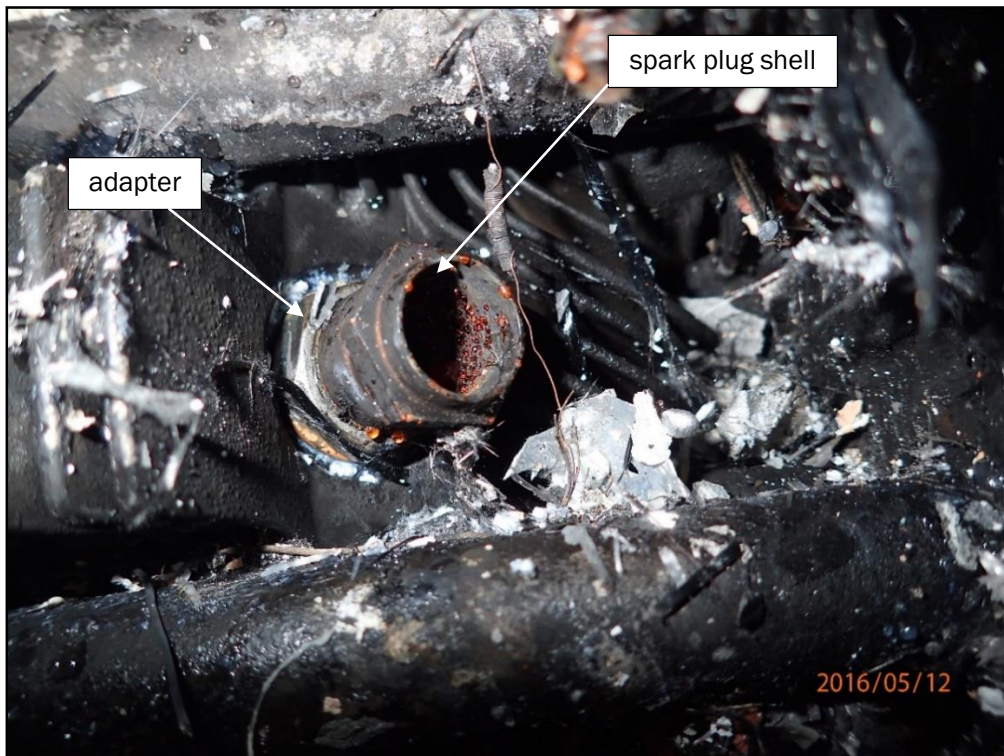
3.4.3. The condition of the wreckage, in particular the state of the carbon-fibre ash, limited the examination of the wreckage at the site. The wreckage was therefore removed and taken to the Commission's technical facility for a more controlled and detailed examination. During this examination it was discovered that the ceramic insulator containing the centre electrode for the number 4 cylinder upper spark plug was missing. Only the spark plug metal 'shell' was left in the cylinder (see Figure 6).

Figure 6
Failed number 4 cylinder upper spark plug shell

- 4.4. The insulator for the number 4 cylinder upper spark plug was not swaged during the manufacturing process, but it was initially held in place by a tight fit and an adhesive compound. However, after 121 hours of service the adhesive compound could not hold against the pressure within the cylinder and the insulator was ejected. The insulator almost certainly penetrated the fibreglass baffling. The insulator from the spark plug was not found.

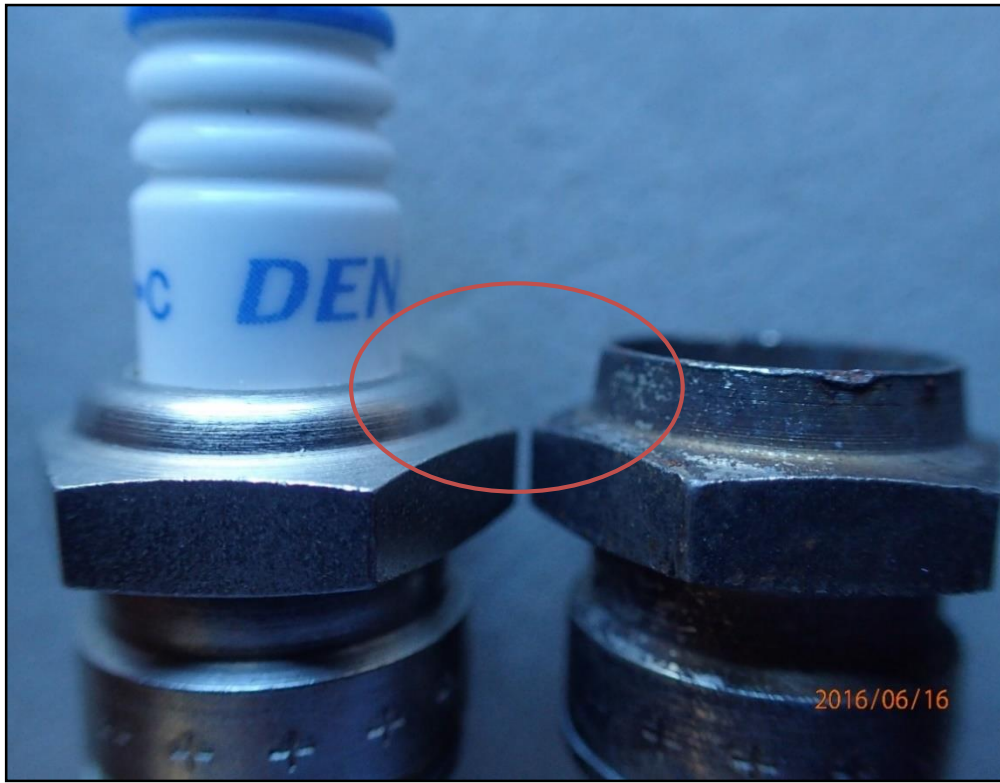
- 3.4.4. A comparison of the spark plug shell in the number 4 cylinder and a new spark plug of the same type revealed a marked difference in the shape of the flange of the shell, which is normally swaged,¹¹ or crimped, around the ceramic insulator (see Figure 7).

Figure 7
Number 4 spark plug shell (on right), flange not formed

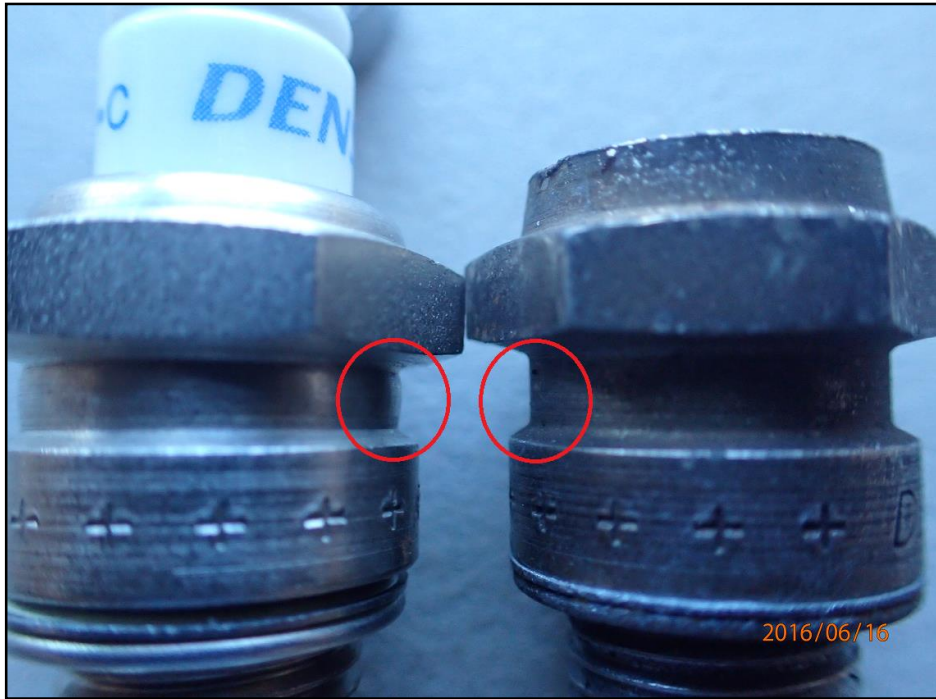
- 3.4.5. Additionally, the spark plug shell was longer than the shell of a new spark plug and did not have the characteristic 'bulge' in the recess in the mid-section of the shell (see Figure 8). This bulge is made during manufacture when the shell is compressed in length by approximately 0.7 mm to form a tight internal seal around the ceramic insulator.

Figure 8
Difference in length compared with a new plug (on left), and comparison of 'bulge' (circled)

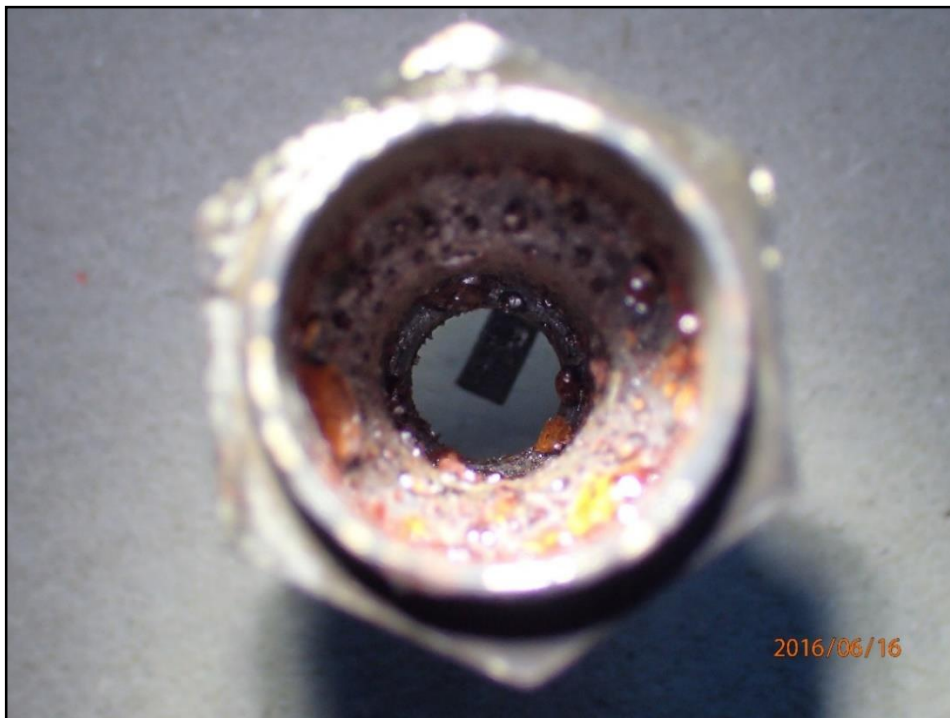
- 3.4.6. The aperture in the spark plug shell, left by the missing ceramic insulator, was of a regular shape and provided an unobstructed passage into the combustion chamber for that cylinder (see Figure 9).

Figure 9
Aperture in failed spark plug shell

- 4.5. Hot combustion gases would have escaped through the hole created by the missing insulator, but the restrictive aperture retained a level of back pressure in the cylinder. This back pressure, coupled with the continuous ignition from the lower spark plug, would have maintained the combustion process in the cylinder. The unmuffled combustion gases would have generated the continuous and regular 'clattering' described by the pilot and witnesses. The same noise was heard during the testing conducted by the Commission.

- 4.6. A jet of flame, at approximately 870°C, would have been emitted from the hole in the upper spark plug shell and have impinged like a blowtorch flame directly onto the fibreglass baffling.¹² Once the fibreglass resin was burning, the air from the engine-driven fan would have provided a continuous source of oxygen to sustain the fire. The carbon fibre fuselage structure, less than 20 cm away, would have ignited readily when it was exposed to the burning fibreglass.

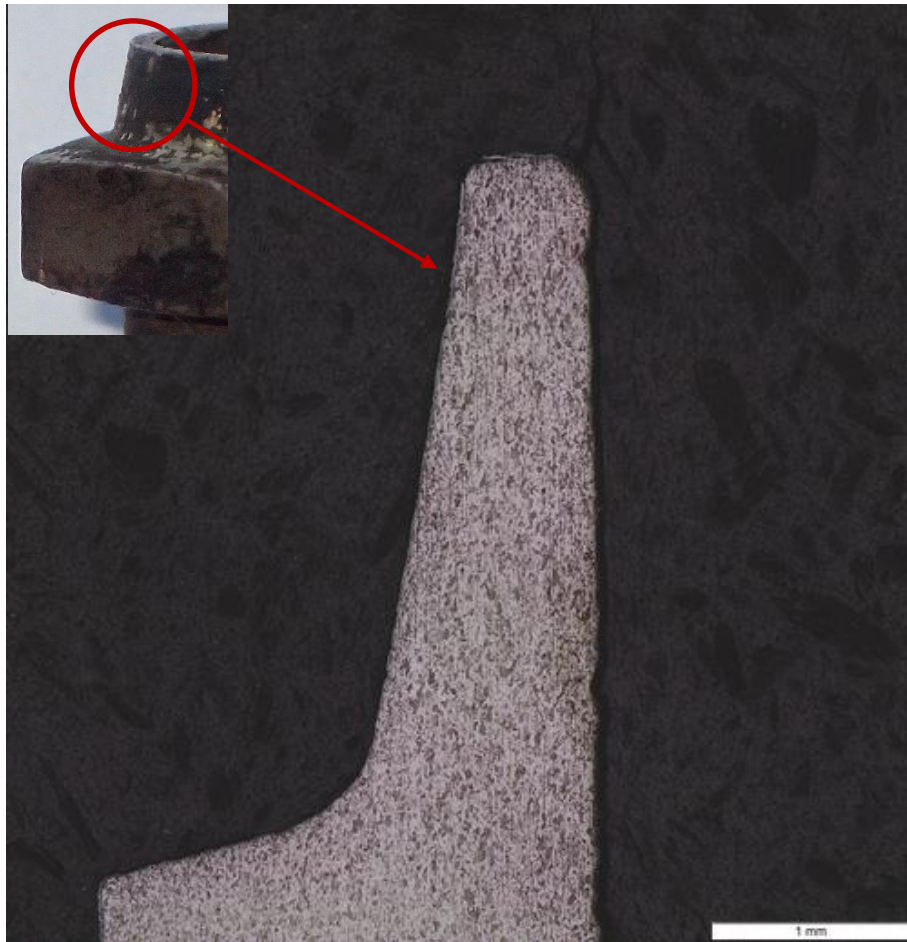
The micro structures of the ex-service [used] and new swaged spark plugs shows vertical grain structure and other microstructural features in the metal forming the hex. This is the original microstructural orientation of the material stock used in manufacture. There is the obvious curvature and microstructural deformation from cold work in the swaged boss. There was no difference in the microstructure for the new and ex-service swaged spark plugs. The microstructure of the failed spark plug shows only the vertical inclusions in the hex material and extending into the tapered boss. No gross curvature or directional grain deformation from cold work was observed in the failed spark plug.

The lack of grain deformation in the failed spark plug provides evidence that the tapered boss at the top of the metal shell had never been swaged prior to service. (See Figures 10 and 11.)

Figure 10
Failed spark plug – unswaged
(showing the original grain structure)

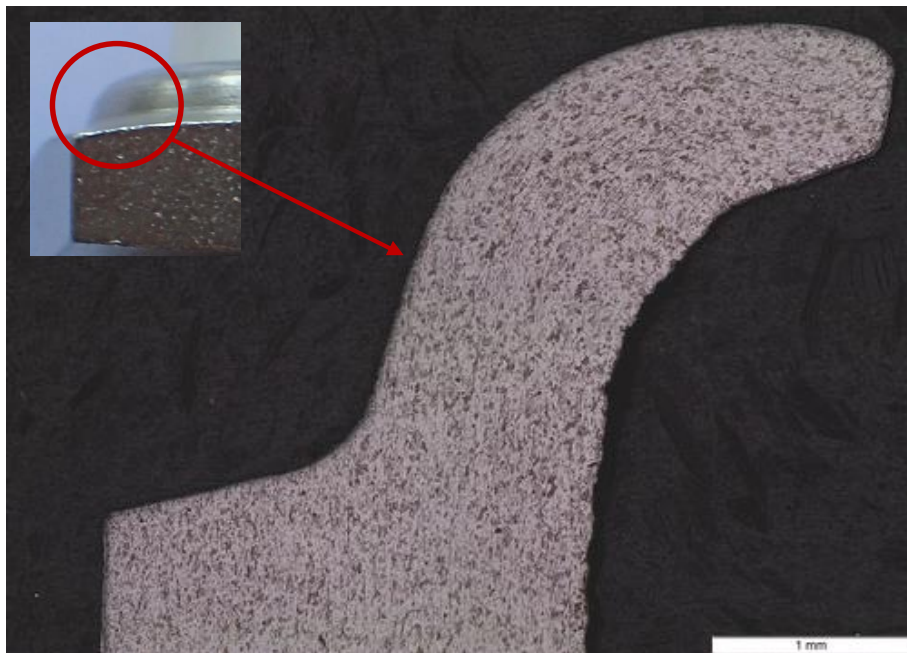
Figure 11
New spark plug – swaged
(showing the bending of the grain structure)

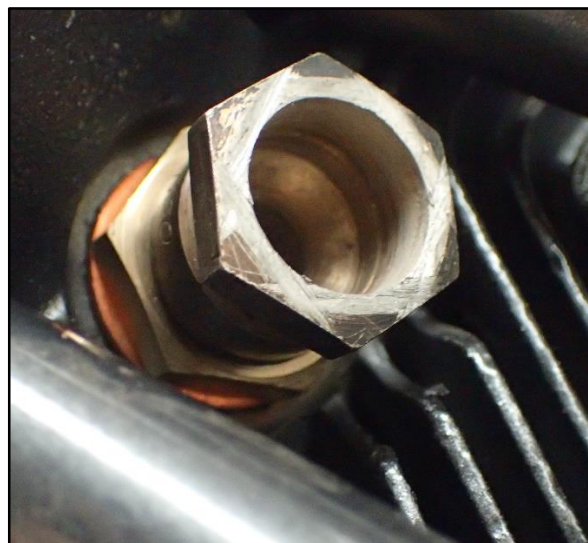
The engine was shut down and the number 4 cylinder upper spark plug was removed. The adapter and the DENSO W24EMR-C spark plug shell with the centre insulator removed were then fitted (see Figure 1).

Figure 1
Modified spark plug shell fitted to test engine

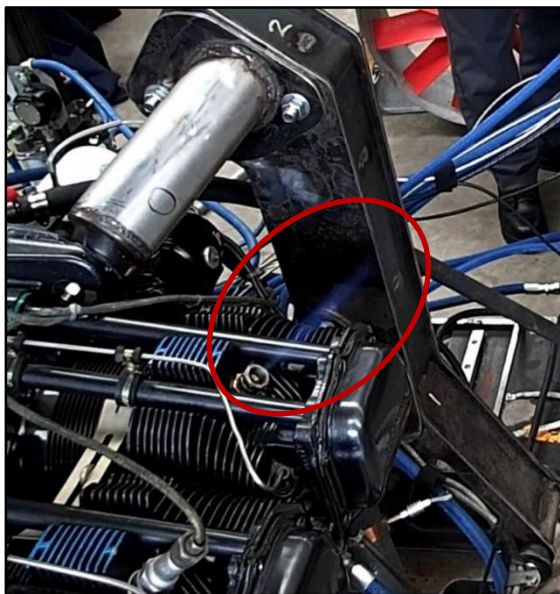
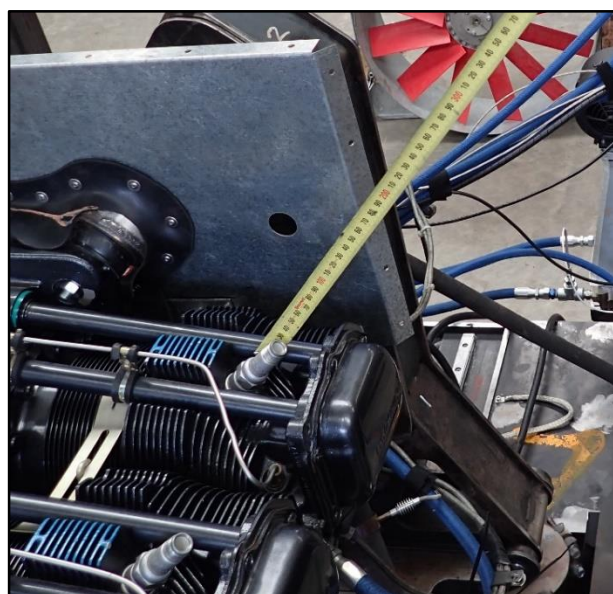
The engine was started again and once stabilised, the throttle was progressively increased. A visible flame emitted from the spark plug body and this was recorded by a video camera mounted to the test rig (see Figure 2).

- The engine was able to be started and run with the defective number 4 cylinder upper spark plug.
- A jet of flame greater than 200 mm in length and at a temperature of approximately 1,600°F (870°C) was emitted from the hole in the number 4 cylinder upper spark plug body.
- The engine was capable of normal operation through the RPM range and the levels of vibration observed when operating with a defective upper spark plug were acceptable.
- The Lycoming field representative estimated that the total engine power loss from the defective spark plug condition was in the order of 15%.

Figures 2 and 3
Visible flame emitted from number 4 upper spark plug
