Final report MO-2016-203: Bulk log carrier *Mount Hikurangi*, Crew fatality
during cargo securing operation, 27 February 2016

Marine inquiry MO-2016-203
Bulk log carrier *Mount Hikurangi*
Crew fatality during cargo securing operation
27 February 2016

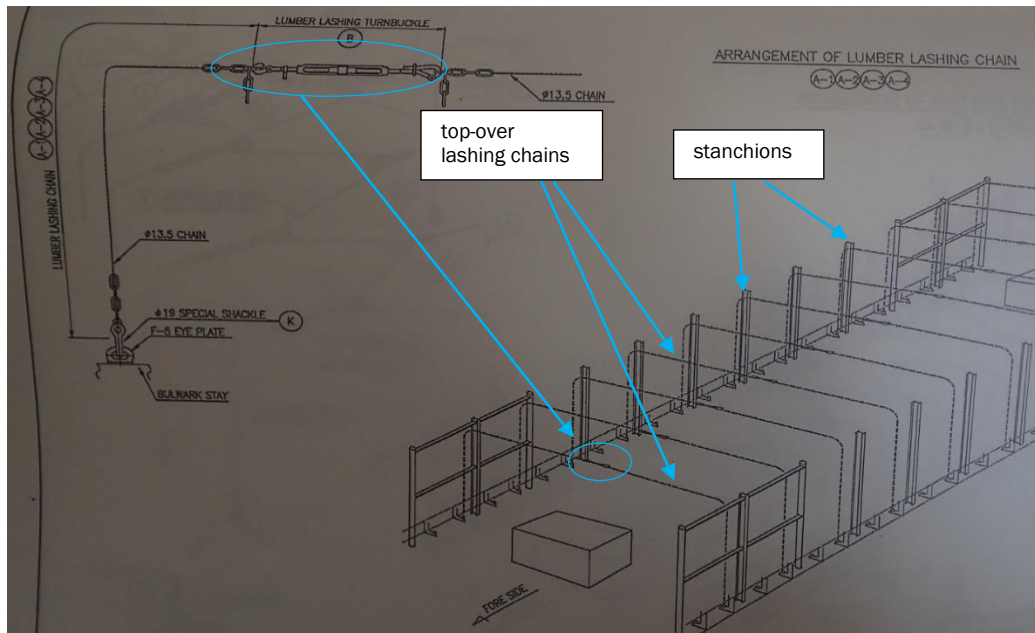
Figure 1
Top-over lashing chain configuration

- 3.1.5 Each top-over lashing chain was shackled to a deck eye-plate³. The other end of the chain had a rope eye attached through the last link. The rope eye was suspended over the top of each stanchion (see Figure 4) so that the chain was easily accessible whilst lashing the logs. At the time of the accident the crew were rigging the chain lashings (see Figures 1 and 2). They used a ship's crane to haul each chain inboard over the logs.

- 3.1.6 One at a time, the port and starboard lashing chains were lifted across the logs by the ship's crane. They were connected near the centreline with a turnbuckle⁴, which was used to increase the tension in the chains. The tension increased the vertical friction force between the logs at the outer part of the stow and, together with other types of lashing, helped to achieve a secure stow. The final lashing configuration was the same at all hatches (see Figures 1 and 2).

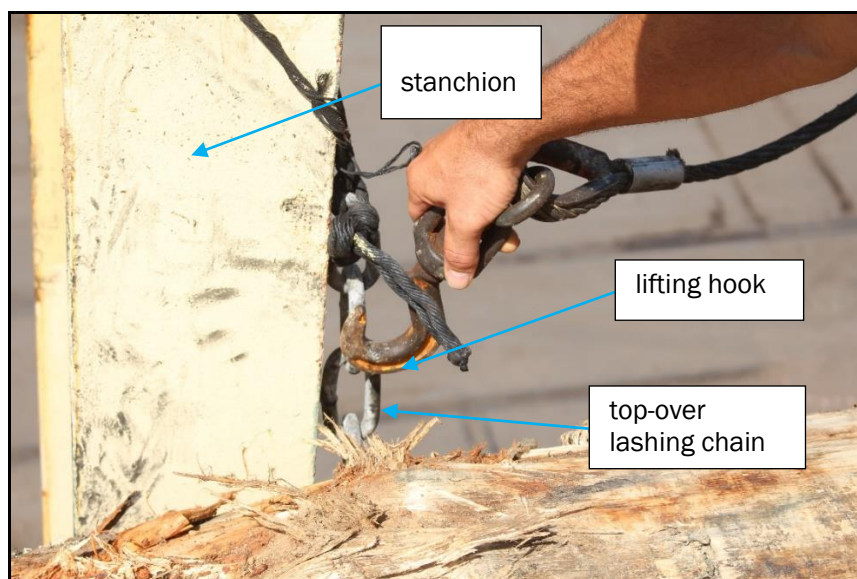
Figure 4
Hook and wire strop fitted to crane hook and rope eye attached to top-over lashing chain
 (Photo courtesy of Maritime New Zealand)

- 3.2.7 The crew used a short wire stop and small hook attached to the main crane hook to drag the chains across the logs. The bosun had tasked the deck cadet with hooking each lashing chain on to the small hook (see Figure 4).

- 3.2.8 At about 0911 the deck cadet positioned himself adjacent to the aftermost stanchion on the port side of number 2 hatch in preparation for hooking on the lashing chain. He was standing at the edge of the log cargo about eight metres above the ship's main deck, which was 10 metres above the quay and 12 metres above the waterline. As the lifting hook was lowered in front of him he bent down to hook on the lashing chain, which had been hung over the top of the stanchion with the rope eye (see Figure 4). Once the cadet had hooked the chain on to the lifting hook he stood up and remained next to the stanchion whilst the crane driver hoisted and slewed the crane to drag the chain across the logs, where it was unhooked by the bosun. The crane hook was then returned to the port side to receive the second lashing chain.

- 3.2.9 The cadet grabbed the wire and bent down to hook on the second lashing chain. He stood up momentarily before bending down again. About four seconds later, as the main crane hook was being raised, the cadet fell overboard, striking the quay and falling into the water. The bosun raised the alarm on his portable radio.

- 4.2.3 It cannot be determined with certainty what caused the cadet to lose his balance and fall. The video footage showed that before the cadet had time to step clear and signal the crane driver, the main crane hook was already swinging and moving upwards. It is possible that the wire came under tension and caught on some part of his body or clothing, or equally possible that he just lost his balance and fell.

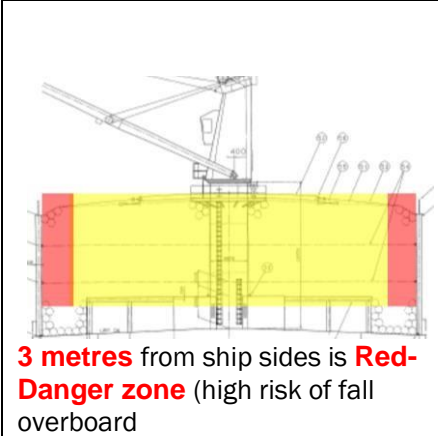
<p align="center">Yellow Zone</p> <p align="center">More than 3 metres from ship sides</p>	<p align="center">Red Zone</p> <p align="center">Less than 3 metres from ship sides</p>
	<ul style="list-style-type: none"> <input type="checkbox"/> Overall and leather gloves <input type="checkbox"/> High visibility vest Safety shoes with spike soles <input type="checkbox"/> Helmet with strap <input type="checkbox"/> Full-body safety harness with lanyard 	<ul style="list-style-type: none"> • All the gear for Yellow zone • + • Fall Prevention Device (FPD) • Lightweight Flotation Device <p>No more than 2 persons allowed to work in red zone per hatch</p>

- A red danger zone within three metres of the ship side where only two persons per hatch may work at any one time. This zone carries a high risk of falling overboard and the operator requires that anybody working in the red zone wear the full PPE prescribed for the yellow zone plus a fall prevention device and a lightweight flotation device.
