Final report MO-2016-205: Fatal fall from height on bulk carrier,  
New Legend Pearl, 3 November 2016

Marine inquiry MO-2016-205  
Fatal fall from height on bulk carrier

*New Legend Pearl*

3 November 2016

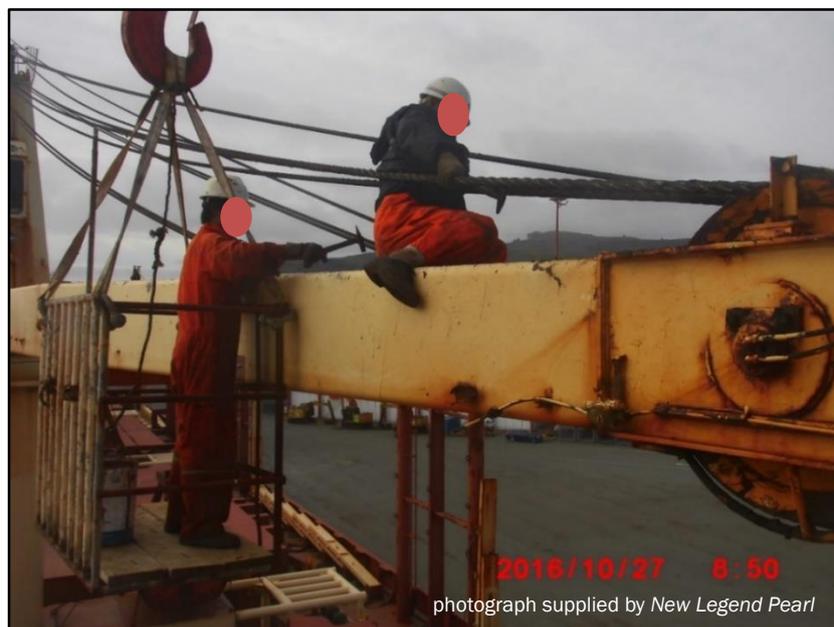
- 3.1.5. At about 1015 on 27 October, the port facility's health and safety team were advised by stevedores that the crew on board the *New Legend Pearl* were not working safely. The health and safety officers boarded the vessel and witnessed the crew working at height, on the cranes, without full fall-protection equipment (see Figure 1). The ship's duty officer was informed of their concerns and work on the cranes ceased.

**Figure 1**  
Crew working at height without full fall protection

- 3.1.6. At about 1730 on the same day, one of the port health and safety officers witnessed the crew once again working at height on the cranes without fall protection. The health and safety officer informed the master that under no circumstances should the crew be working without the proper personal protective equipment. The health and safety officer sent an online report on the unsafe work to MNZ.

- 4.5.5 Working at height without wearing fall-protection equipment had been observed on board on two occasions when the vessel was in Bluff. The second occasion was in spite of the crew having been previously warned against the poor practice.

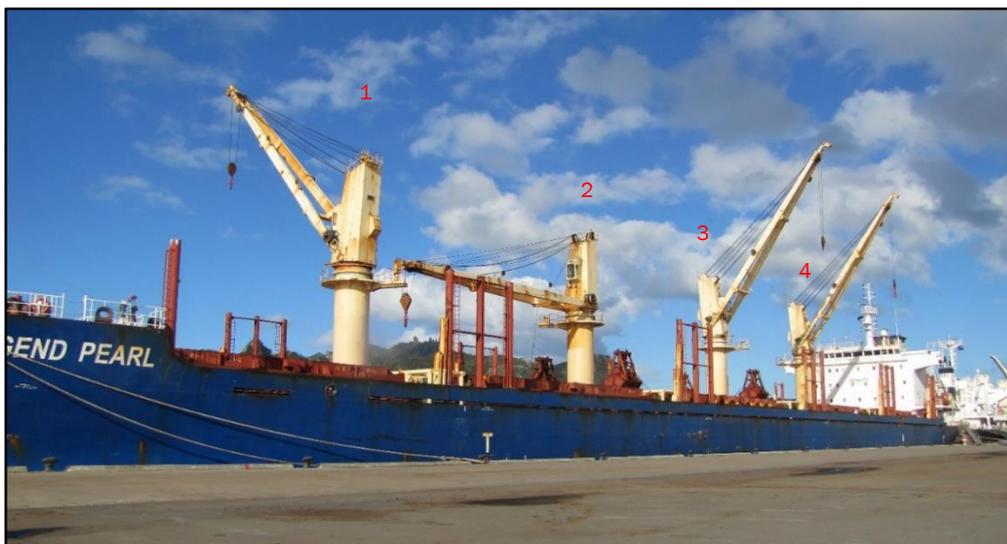
- 3.1.10. At about 1900 on 29 October, cargo operations resumed. However, the stevedores were unhappy with the condition of the hoisting wires on numbers 2 and 4 cranes (see Figure 2).

Figure 2  
The *New Legend Pearl* at Marsden Point

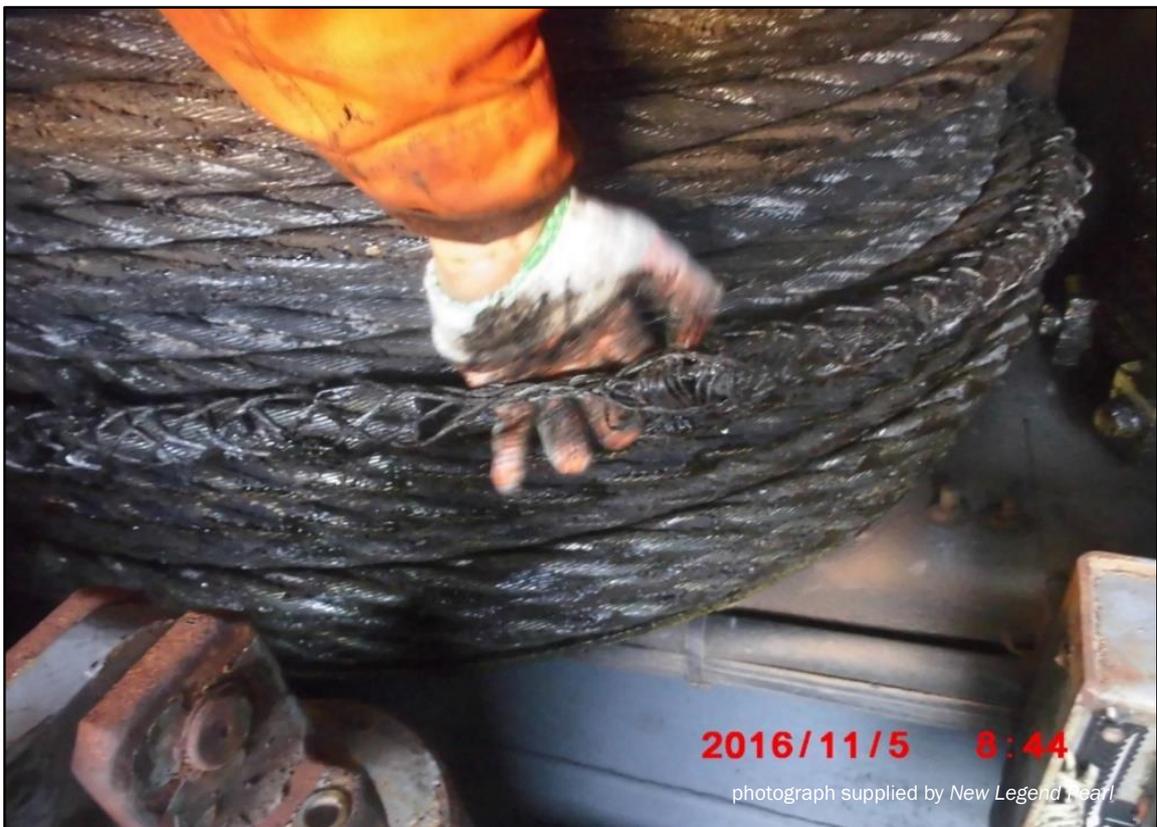
- 3.2.4. The carpenter and two able seamen climbed onto the crane-house to release the old wire at its termination point. The wire was lowered to the deck, where the end was cut off neatly so that it could be connected to the new wire with a cable sock<sup>11</sup> (see Figure 3).

**Figure 3**  
**Cable sock joining the old wire and the replacement wire**

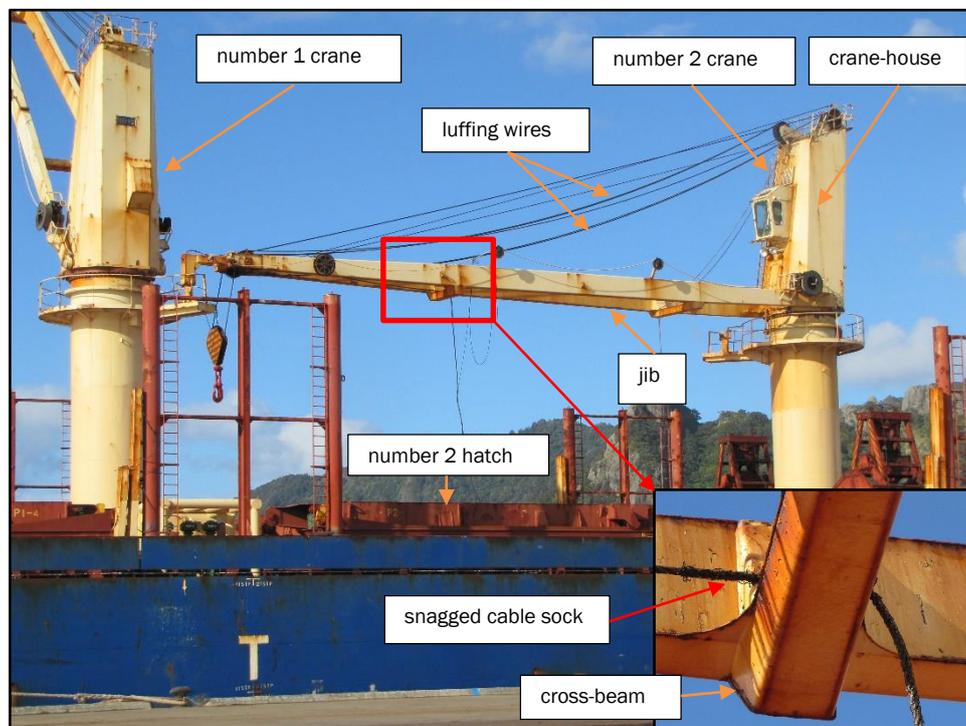
- 3.2.5. The crew commenced heaving the connected wires through the hoisting-wire sheaves, but stopped when the cable sock snagged on the crane-jib<sup>12</sup> cross-beam (see Figure 4).

**Figure 4**  
Number 1 and 2 cranes and the position of the snag (inset)

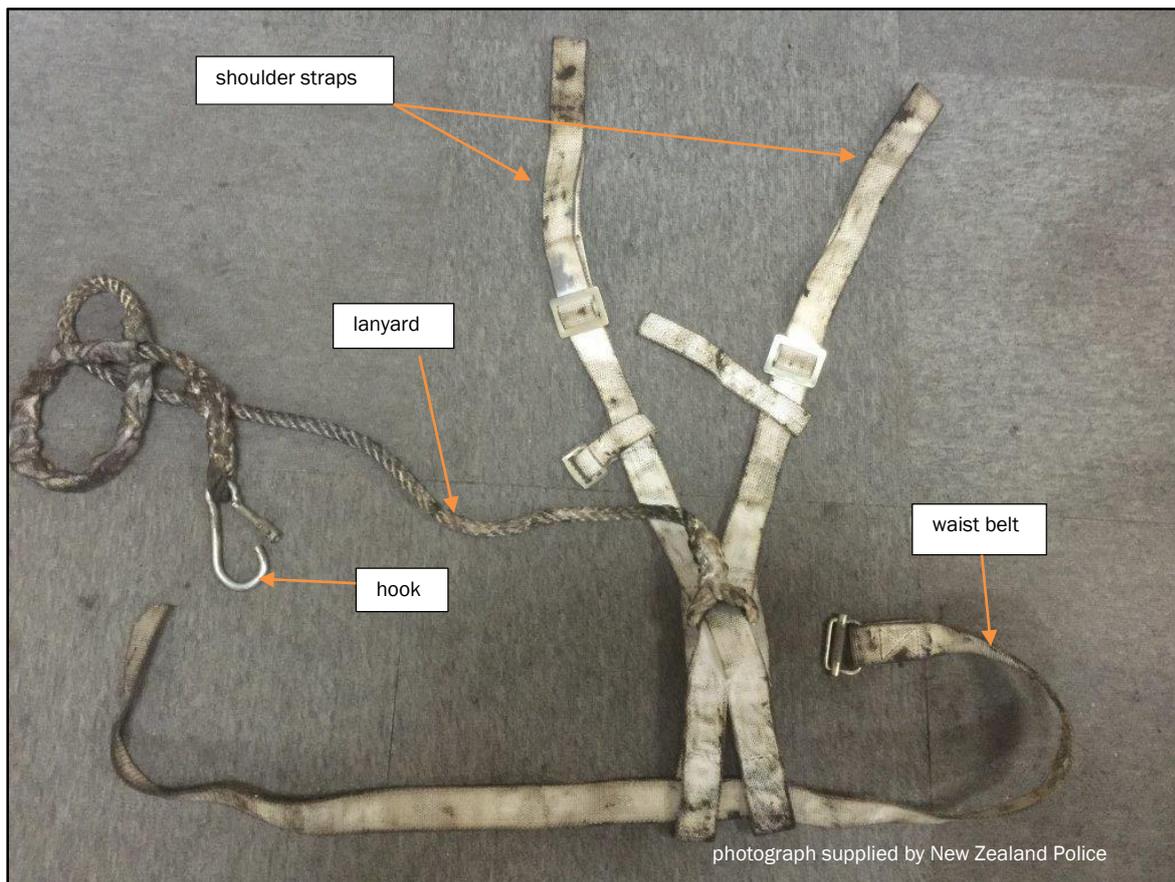
**Figure 5**  
Safety harness worn by the bosun

- 3.6.2. The lanyards were made of 14-millimetre, soft polyester, three-strand, right-hand-lay rope, eye-spliced with three tucks. There was no marking to indicate that the lanyard met the mandatory Chinese standard for lanyards used in personal fall-protection systems.

- 3.6.3. The hooks attached to the lanyards were mild-steel carbine hooks with manually lockable gates. The hooks were not stamped with any identification, safe working load or indication of meeting the recommended Chinese standard for connectors used in personal fall-protection systems.

- 4.3.5 The harness that the bosun was wearing had only one lanyard. The sample harness that the Commission removed from the vessel was fitted with two lanyards. The two-lanyard type was

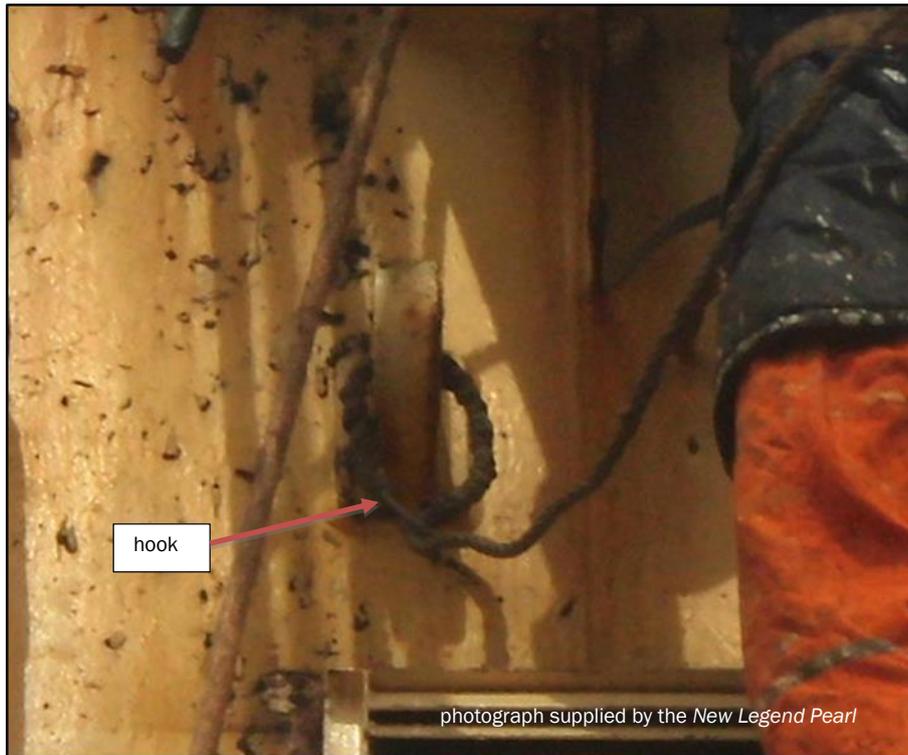
**Figure 6**  
Safety harness lanyard hooked back onto itself

- 4.2.4 The practice of hooking a lanyard back onto itself is not recommended unless the lanyard and hook have been specifically designed for that purpose. This practice prevents the hook aligning with the force applied in the event of a fall, which means that it can also expose the gate of the hook to side-loading forces. The force required to roll out<sup>17</sup> or burst out<sup>18</sup> the gate of a hook is significantly less than the force the hook can withstand when pulled in direct alignment with the long axis of the hook.

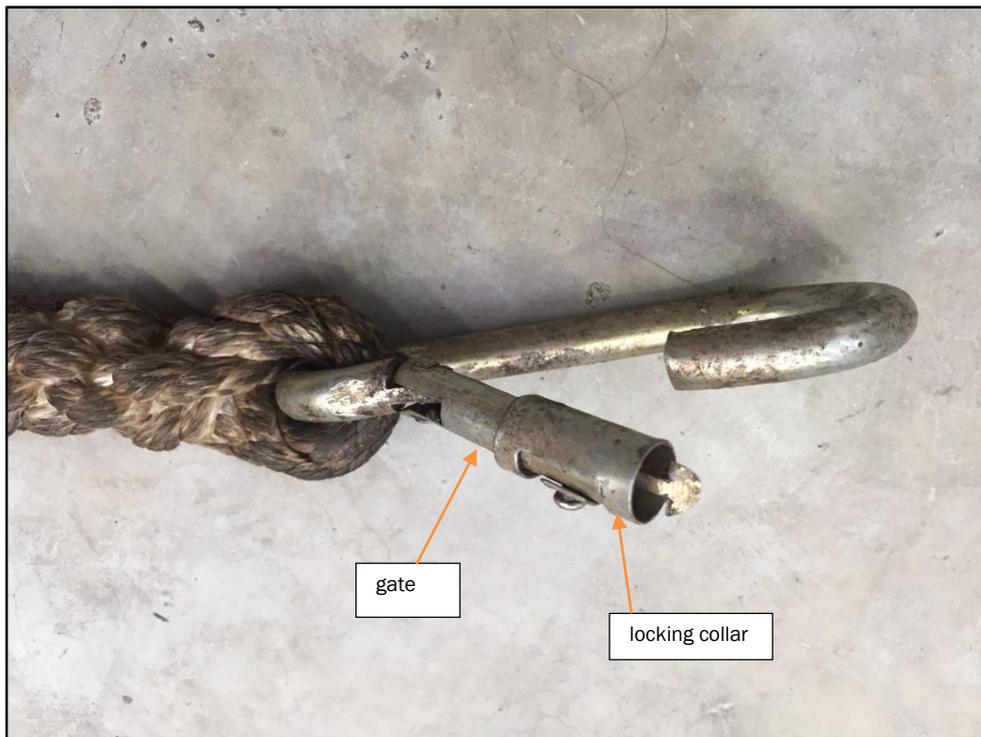
- 3.2.8. At some point in the process of moving the lanyard between the luffing wires, he lost his balance and fell eight metres onto number 2 hatch cover. None of the crew could say for sure whether the bosun was clipped onto a luffing wire when he fell. The safety harness was intact but the gate (see Figure 8) of the securing hook was damaged.

- 4.2.5 After the accident the gate on the bosun's safety harness hook was found bent sideways and it no longer married up with the end of the hook (see Figure 8). The crew said that the safety equipment had been checked before they started changing the wire and had been found to be in a satisfactory condition. If this damage occurred during the fall, then the locking collar<sup>19</sup> on the end of the gate should have been damaged as the gate was pulled sideways. However, the locking collar was not damaged. Therefore it is about as likely as not that when the bosun fell he had either removed the locking collar in preparation for removing the hook from the upper luffing wire, or had clipped onto the lower luffing wire but had yet to engage the locking collar. Any sideways force on the gate as the shock-load came onto the lanyard could have caused the gate to burst out and disconnect the harness from the anchor point.

**Figure 8**  
The damaged safety hook
