Final report MO-2016-205: Fatal fall from height on bulk carrier,
New Legend Pearl, 3 November 2016

Marine inquiry MO-2016-205
Fatal fall from height on bulk carrier

New Legend Pearl

3 November 2016

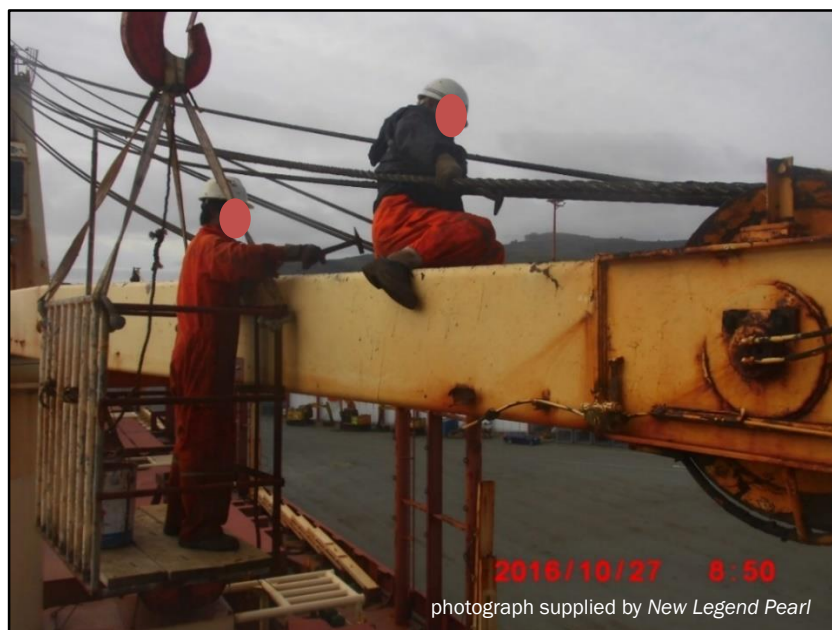
- 3.1.5. At about 1015 on 27 October, the port facility's health and safety team were advised by stevedores that the crew on board the *New Legend Pearl* were not working safely. The health and safety officers boarded the vessel and witnessed the crew working at height, on the cranes, without full fall-protection equipment (see Figure 1). The ship's duty officer was informed of their concerns and work on the cranes ceased.

Figure 1
Crew working at height without full fall protection

- 3.1.6. At about 1730 on the same day, one of the port health and safety officers witnessed the crew once again working at height on the cranes without fall protection. The health and safety officer informed the master that under no circumstances should the crew be working without the proper personal protective equipment. The health and safety officer sent an online report on the unsafe work to MNZ.

- 4.5.5 Working at height without wearing fall-protection equipment had been observed on board on two occasions when the vessel was in Bluff. The second occasion was in spite of the crew having been previously warned against the poor practice.
