Interim Report AO-2017-001: collision with terrain, Eurocopter AS350-BA, ZK-HKW,
Port Hills, Christchurch, 14 February 2017

Interim Report

Aviation inquiry AO-2017-001
collision with terrain
Eurocopter AS350-BA, ZK-HKW
Port Hills, Christchurch
14 February 2017

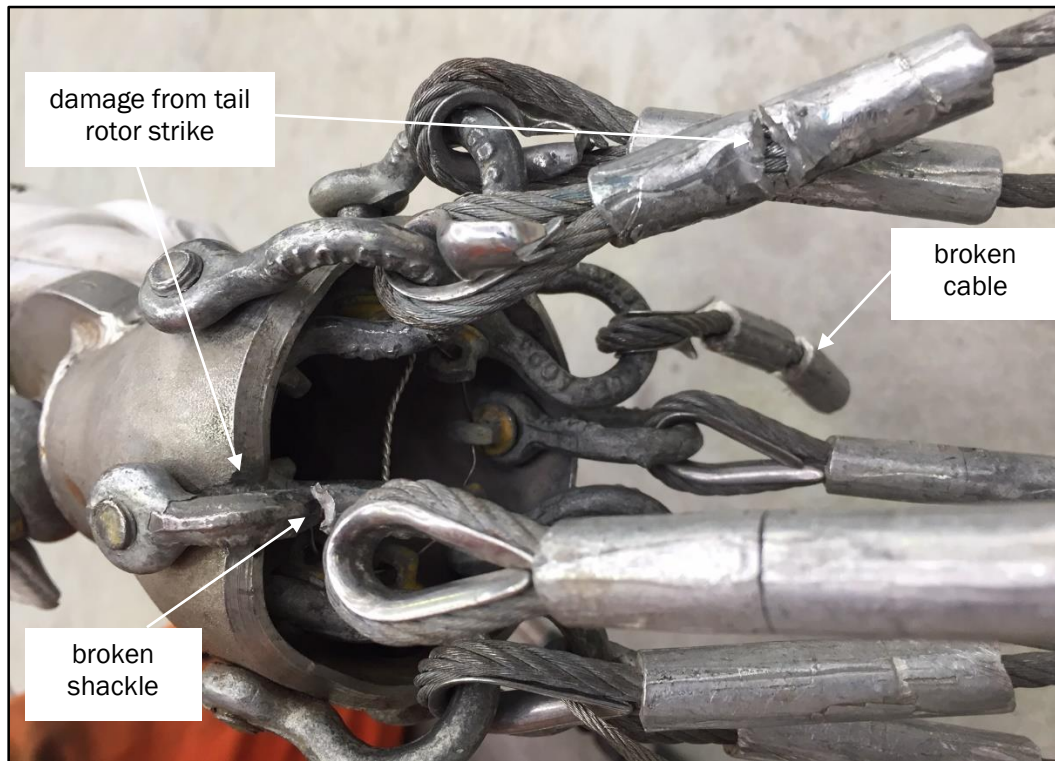
Figure 2
Damage to the monsoon bucket cables

- 3.10. The damage to the tail rotor blades was consistent with their having struck the wire suspension cables of the monsoon bucket⁸ where the cables were joined to the lifting strop. There was corresponding damage on the cable cluster (see Figures 2 and 3). The bucket and the strop remained attached to the helicopter's fixed hook.

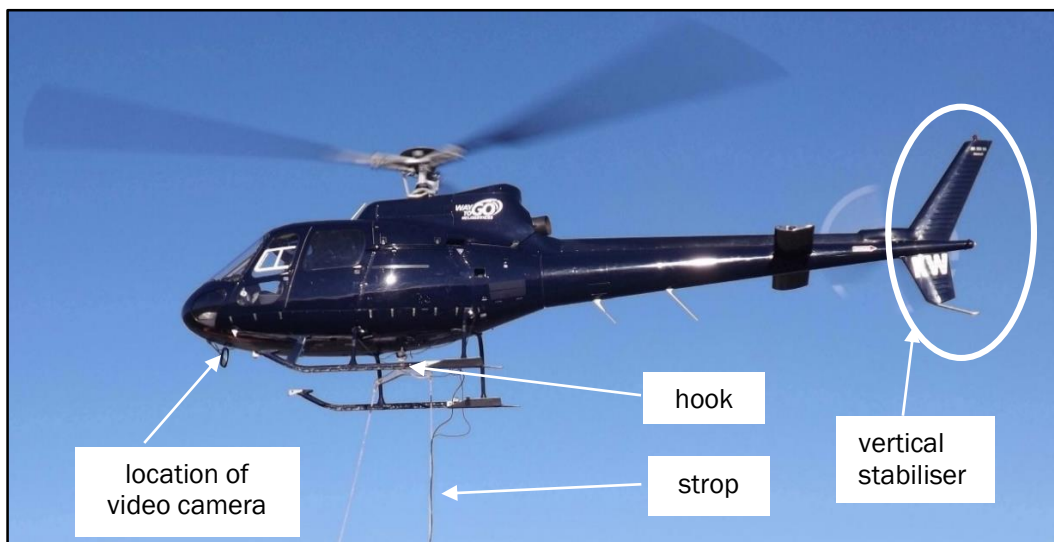
Figure 4
Locations of significant items mentioned

- 3.11. The vertical stabiliser had separated from the tail boom and was found approximately 300 metres before the main wreckage.
- 3.12. The fuel tank remained intact and appeared to be approximately a quarter full. There was no leaking fuel at the site and no fire.
- 3.13. All major components of the helicopter were accounted for (see Figure 4).
