Final report MO-2017-201: Passenger vessel *L'Austral* contact with rock Snares Islands,
9 January 2017

Marine inquiry MO-2017-201
Passenger vessel *L'Austral* contact with rock Snares Islands,
9 January 2017

Approved for publication: February 2018

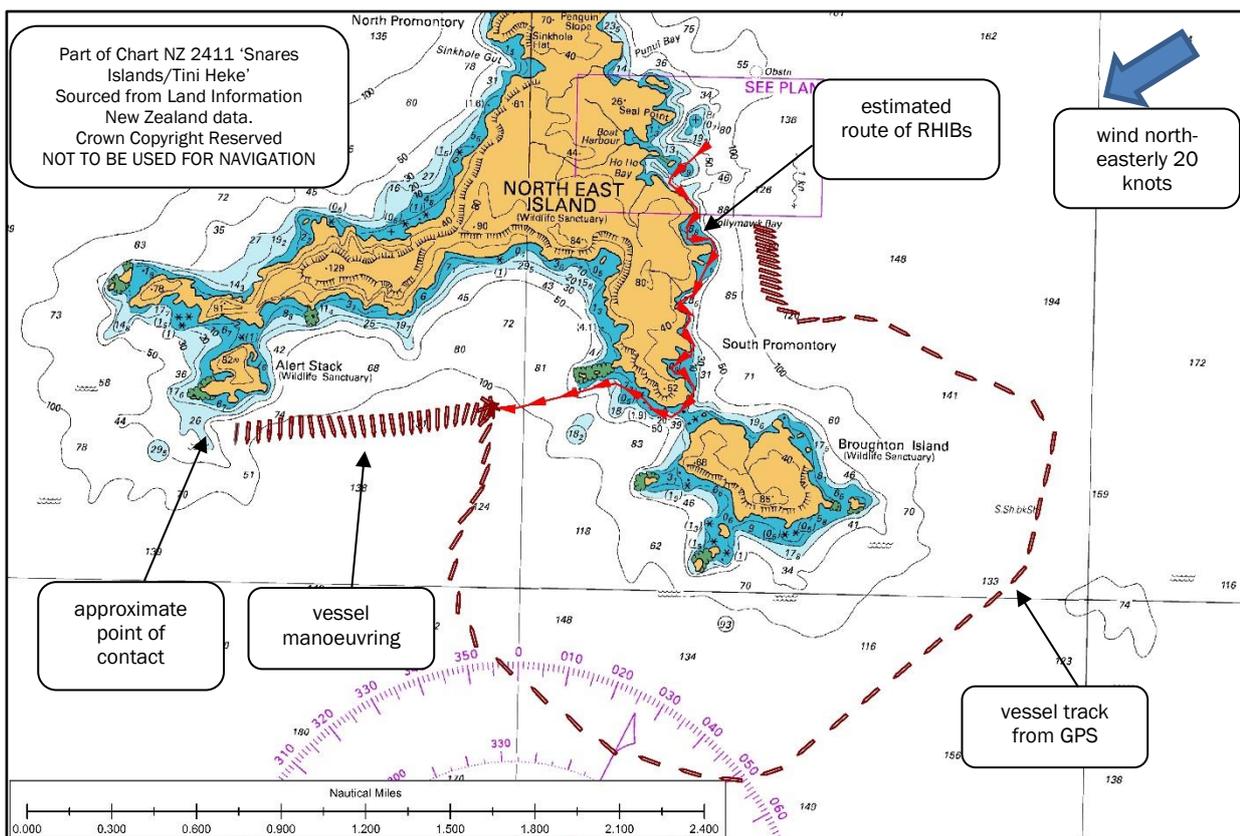
Figure 3
GPS position of *L'Austral*, ship delineation to scale

- 3.2.8. However, the weather conditions were deteriorating, so the master cancelled the post-lunch passenger excursions. *L'Austral's* crew then started to recover the RHIBs back on board, but due to the prevailing weather conditions the recovery took longer than normal. To obtain the best sea conditions for recovering the RHIBs, the master manoeuvred the ship to maintain a southerly heading whilst drifting sideways to the west, as shown in Figure 3.

- 3.2.9. *L'Austral* eventually drifted into an area marked on charts as overfalls, eddies and breakers⁶ south of Alert Stack. At about 1508 the master and the navigation officer both heard an unusual sound at the stern, but thought it was caused by a wave “slamming” under the boarding platform at the stern. The navigation officer plotted the ship’s position on the paper chart at this time.

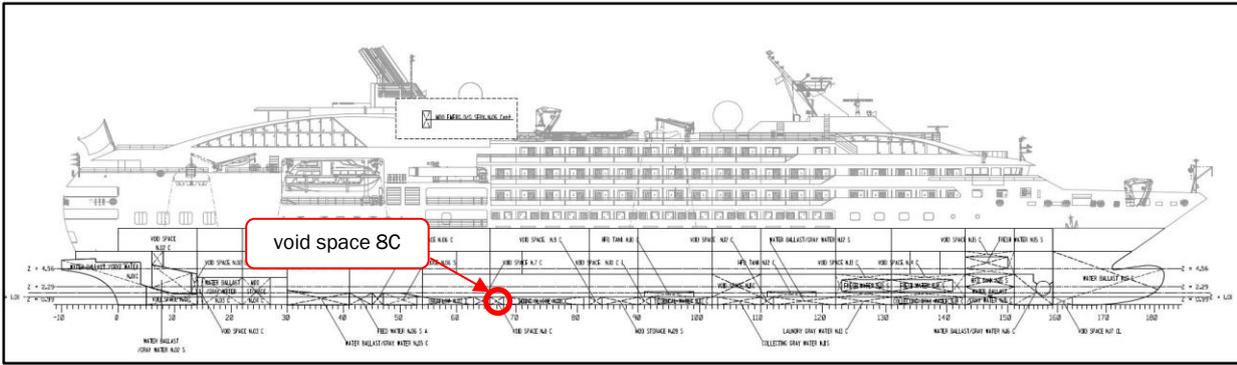
Figure 5
Location of penetrated void space

- 3.5.1. The accident resulted in a number of penetrations to the hull, the main one being 600 x 80 millimetres in size. Two keel plates were slightly bent. One frame was distorted inside the penetrated void space.
- 3.5.2. The penetration damage was confined to void space 8C (Figure 5) in the vessel's double-bottom¹³ arrangement. There was no pollution reported.

3.5.3. Whilst in Bluff, divers conducted temporary repairs to the outside of the hull and sealed the damaged internal compartment with cement. They also added baffles¹⁴ to the void space to reduce its size in the event of re-flooding. The classification society carried out a hull occasional survey and issued two recommendations before the vessel sailed.

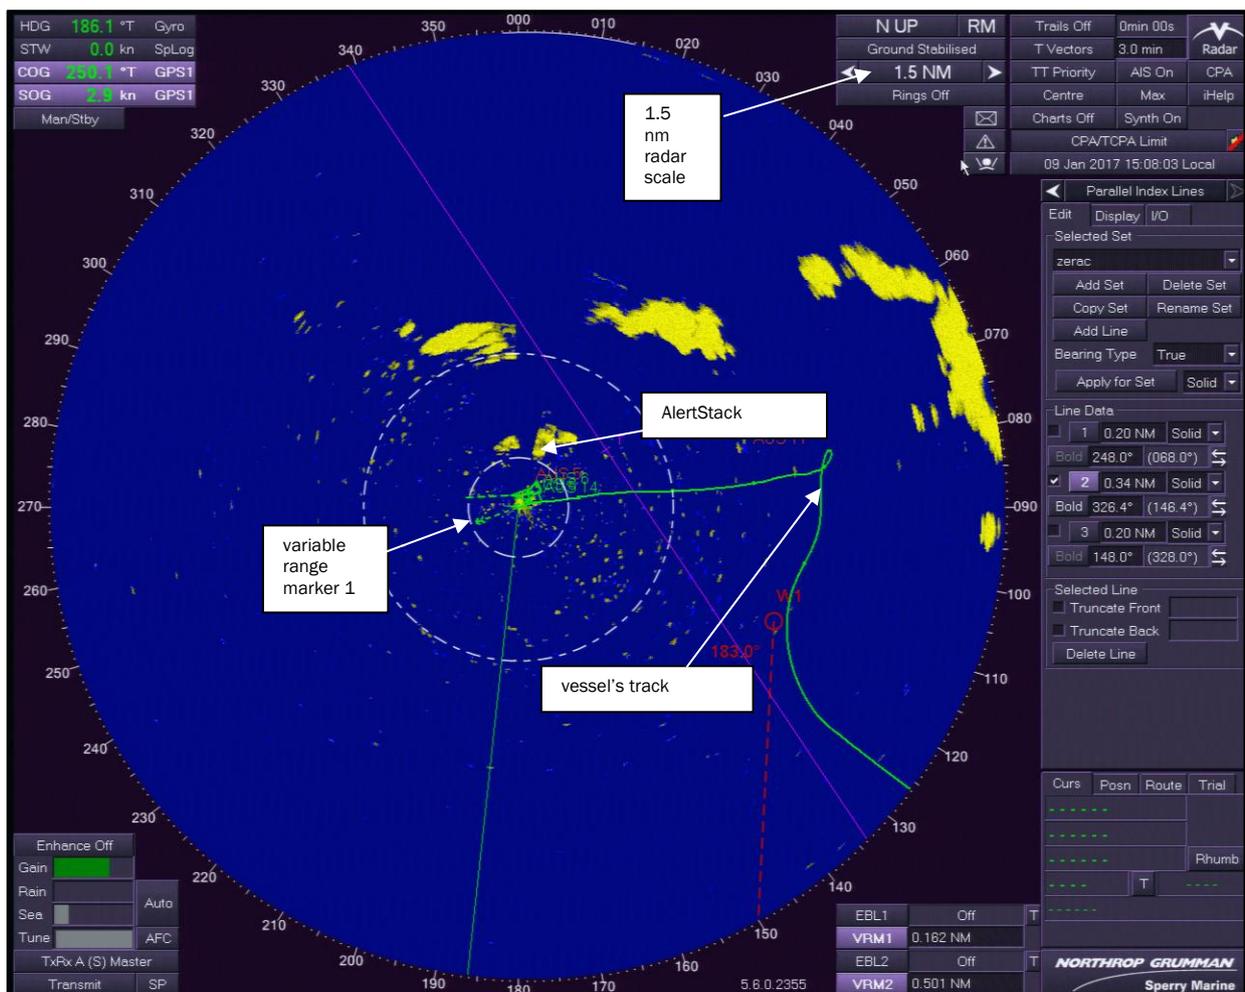
Figure 7
Radar screenshot from the time of the accident stored in the voyage data recorder

4.3.11. While the radar gave an indication of the ship's distance from the shoreline, it alone was not a definitive tool for continuously monitoring where the ship lay in relation to navigational hazards not detectable by radar. A more appropriate tool for position monitoring would have been the ECDIS and the paper chart. The use of these is discussed below.

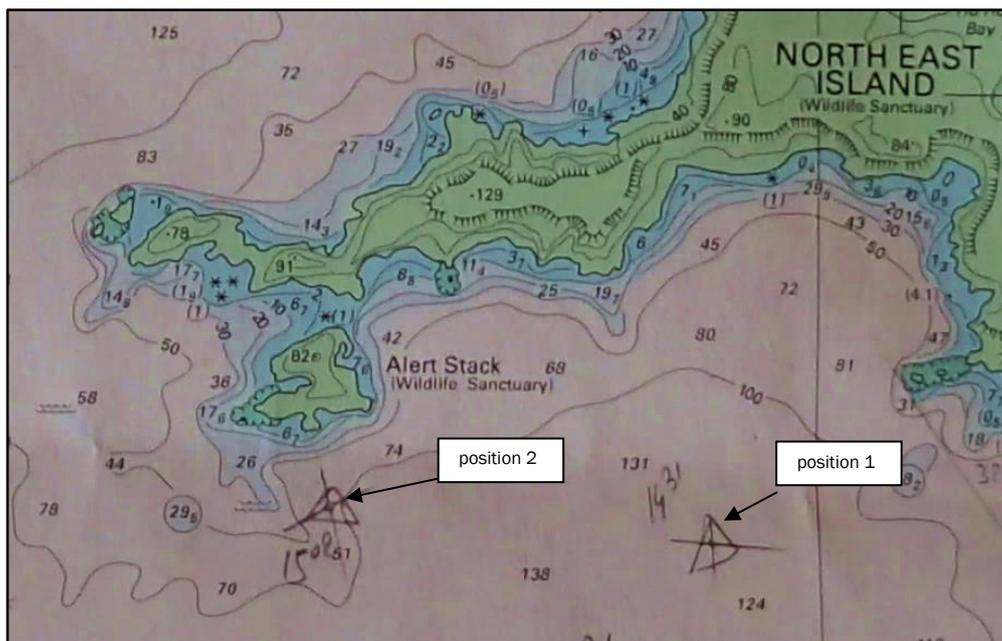
Figure 8
Extract of paper chart NZ 2411, in use at the time of the accident

- 4.3.15. Figure 8 shows two position fixes on the paper chart that was in use at the time of the accident. The operator's safety management system stated that the officer of the watch shall "plot the ship's position on the appropriate chart and check at sufficiently frequent intervals depending on the prevailing conditions".

- 4.3.17. An activity requiring constant manoeuvring of a ship close to a shoreline would normally be subjected to almost constant monitoring of the ship's position. This can be achieved with a combination of monitoring by radar, backed up by frequent fixing of the ship's position on a paper chart. Apart from the position fix at 1431 (see Figure 8), the radar was only being used to monitor the ship's distance off the shoreline to ensure there was no breach of the coastal permit restrictions, rather than to monitor the ship's position in relation to navigational hazards.

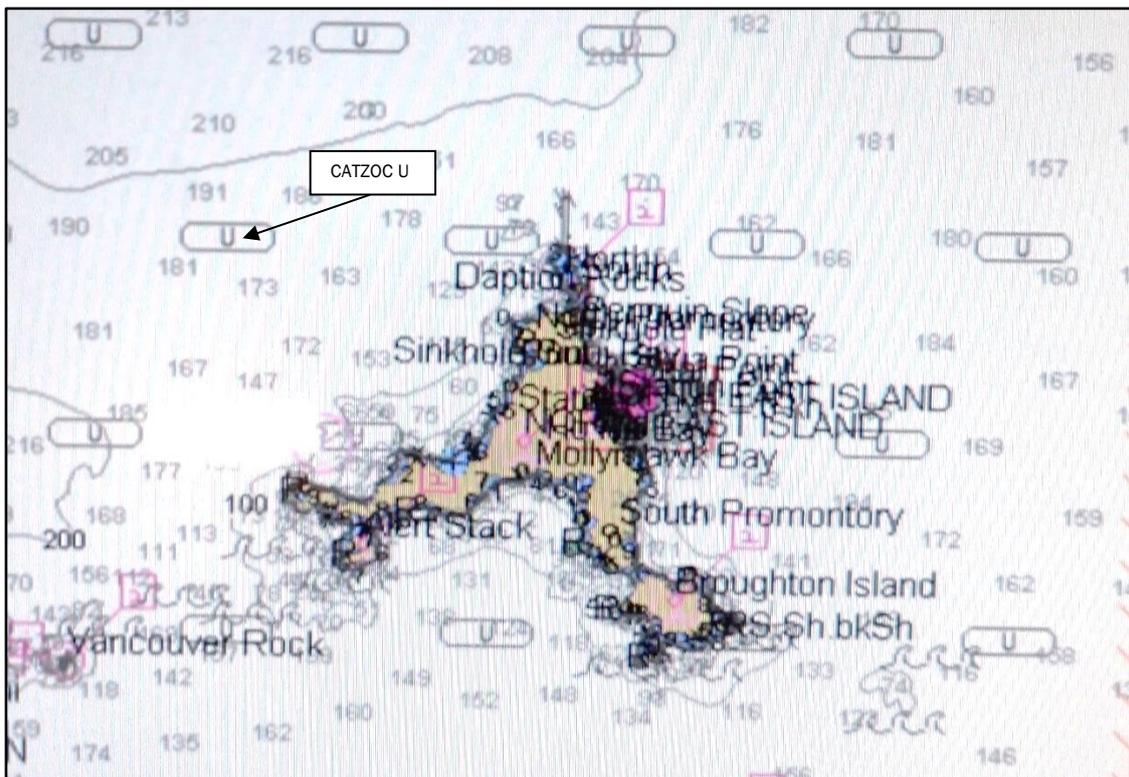
Figure 9
Photograph showing the CATZOC of the unofficial ENC loaded in *L'Austral's* ECDIS

- 4.4.6. There is a requirement for shore-based personnel who have a responsibility to outfit ships with ECDIS ENCs to have undergone the IMO generic ECDIS training, to ensure they are familiar with the IMO requirements. The provision of the C-MAP chart portfolio containing unofficial ENCs for loading into *L'Austral's* ECDIS should have been accompanied by an alert, warning that some of the charts had not been produced by official hydrographic sources.

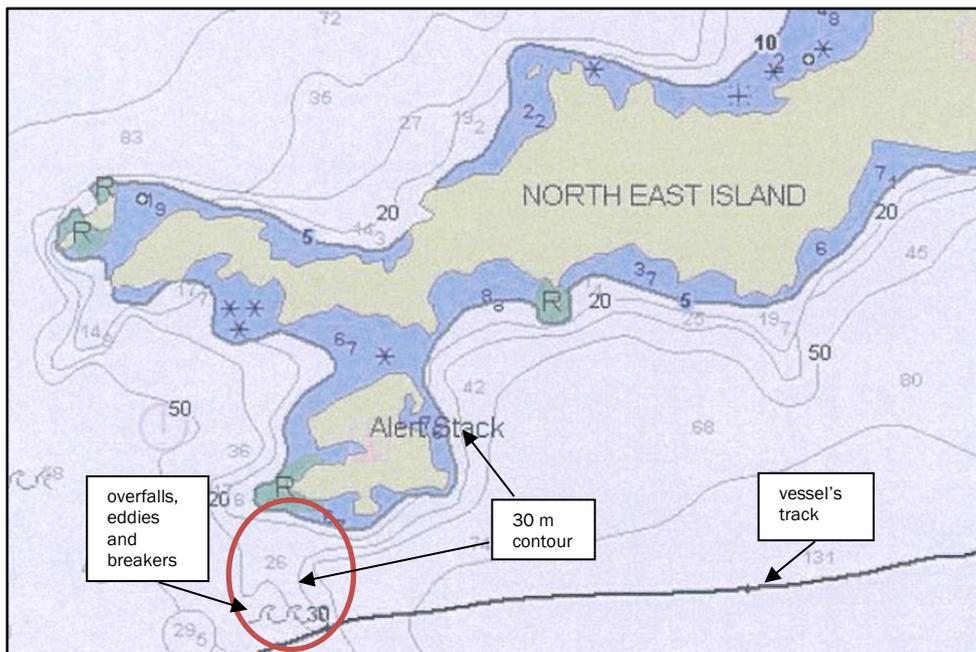
Figure 13
Screenshot from vessel's ECDIS after the accident

4.4.17. There were no prohibited areas defined in the ECDIS to the south of North East Island. User-defined prohibited areas are areas where the navigation officer does not wish the vessel to enter, similar to a no-go zone²⁴ on a paper chart. The master said that he did not want the vessel to enter the area indicated in Figure 13 as the chart showed the ‘overfalls, eddies and breakers’ symbol. Had this area been identified as a no-go area, the ECDIS would have alarmed as the vessel manoeuvred, affording the bridge team time to take avoiding action.

- 4.4.18. In summary, the ECDIS would have been an ideal aid to navigation when manoeuvring close to the Snares Islands. It could have been used to monitor the ship's position continuously in relation to chosen parameters, could have warned the bridge team that the ship was not where they wanted it to be, and drawn the master's attention away from the task of recovering the RIHBs to the more immediate concern – preventing the ship grounding.
- 4.4.19. Although the ECDIS was designated as the ship's primary navigation system, it was not being used as such and not being used to its full potential. It is likely that this was in part due to the concept of ECDIS not being fully understood by both the operator and the bridge team on the day.
