Final report MO-2017-202: Passenger vessel *L'Austral*, grounding,
Milford Sound, Fiordland, 9 February 2017

MO 2017-202
Passenger vessel *L'Austral*,
grounding,
Milford Sound, Fiordland
9 February 2017

Approved for publication: June 2018

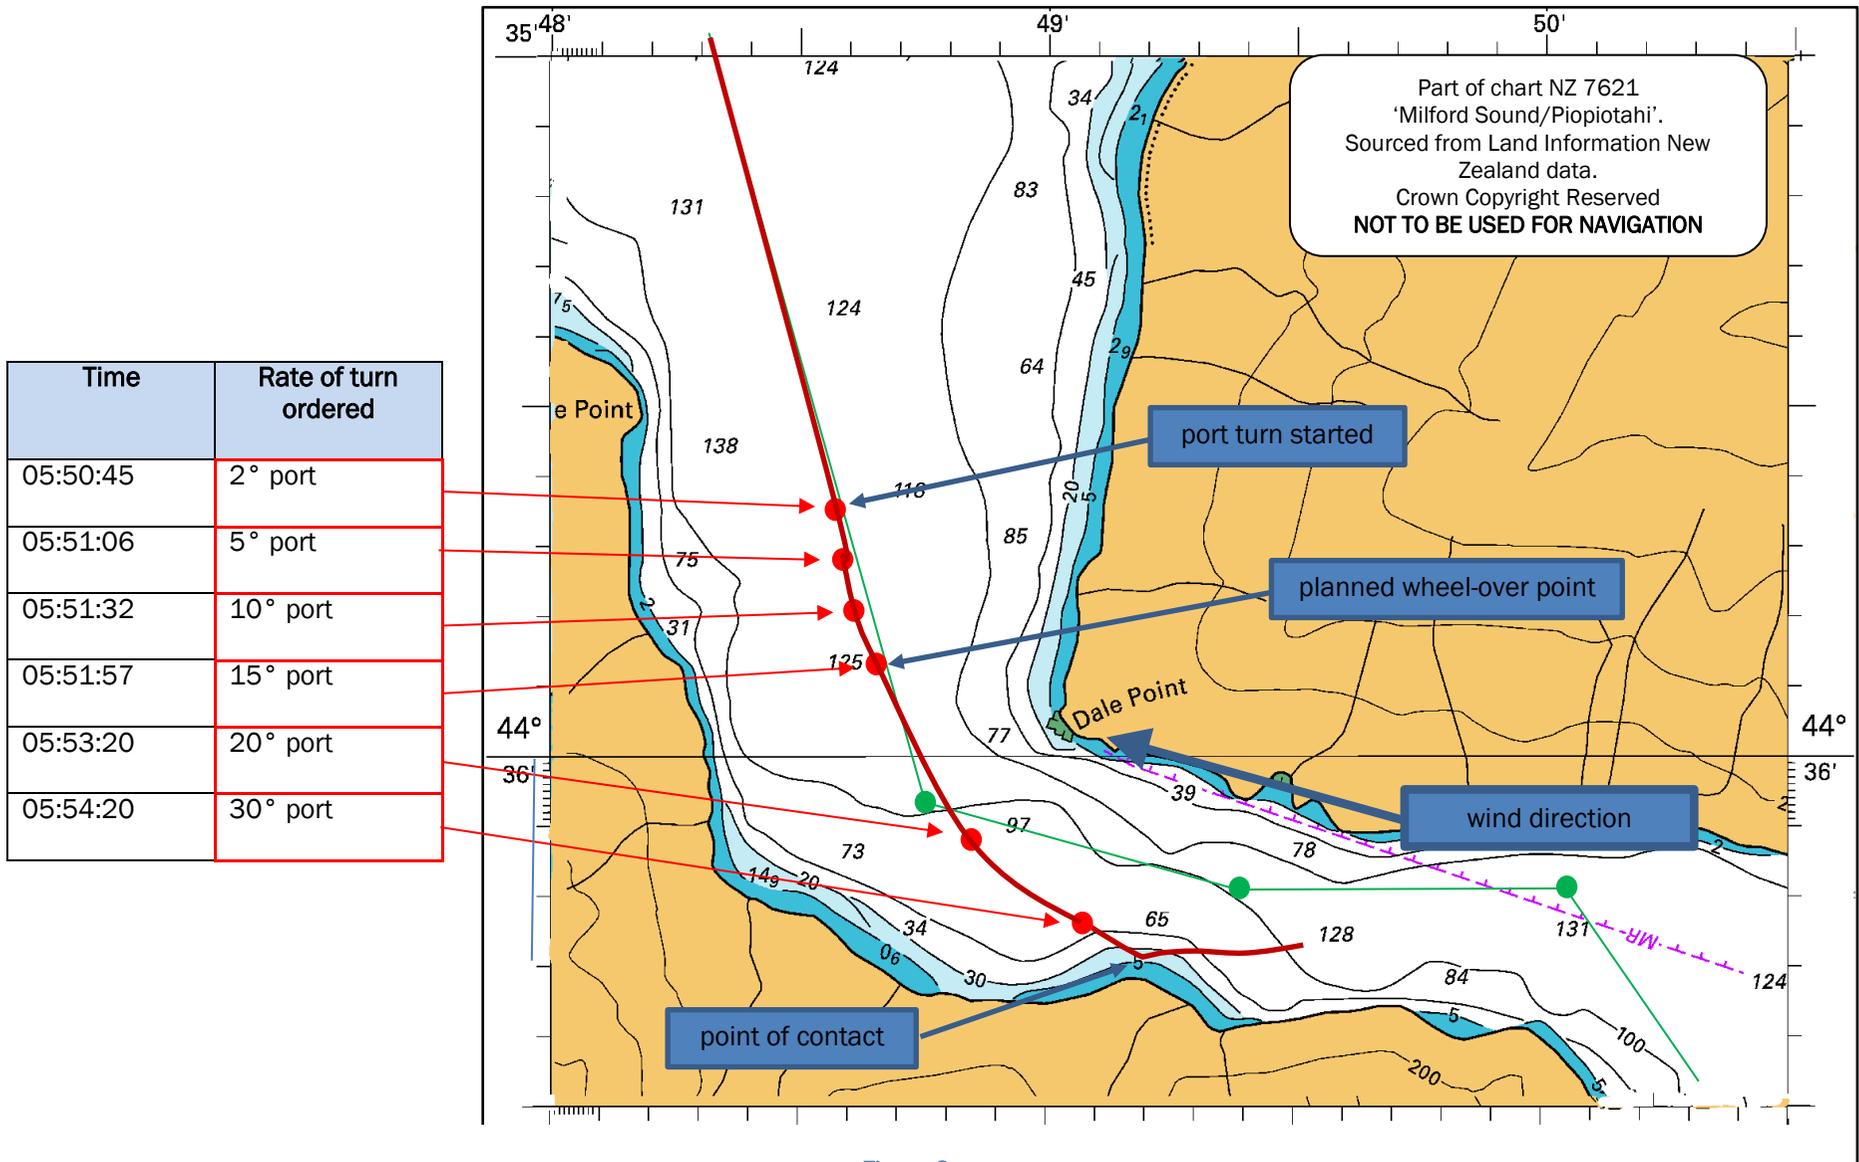
Figure 3
 The L'Austral's course around Dale Point with rates of turn as ordered

- 3.2.6. At some time after the pilot ordered a 30° rate of turn to port, the officer of the watch became aware that the vessel was close to the shoreline of Milford Sound. He moved to the starboard⁶ bridge wing⁷ and looked aft to see if the stern⁸ of the vessel was clearing the shoreline. The master also went to the starboard bridge wing, and when he realised how close the vessel was to the shoreline he exclaimed to the pilot, “L’arriere – L’arriere” (meaning “the stern” in French) from his position at the bridge wing. At 05:54:40 the *L’Austral* collided with a stony bank that extended from the shoreline. As the vessel cleared the bank the pilot ordered amidships⁹ on the wheel and then a helm order of 20° to starboard in an attempt to carry the stern of the vessel away from the shoreline.

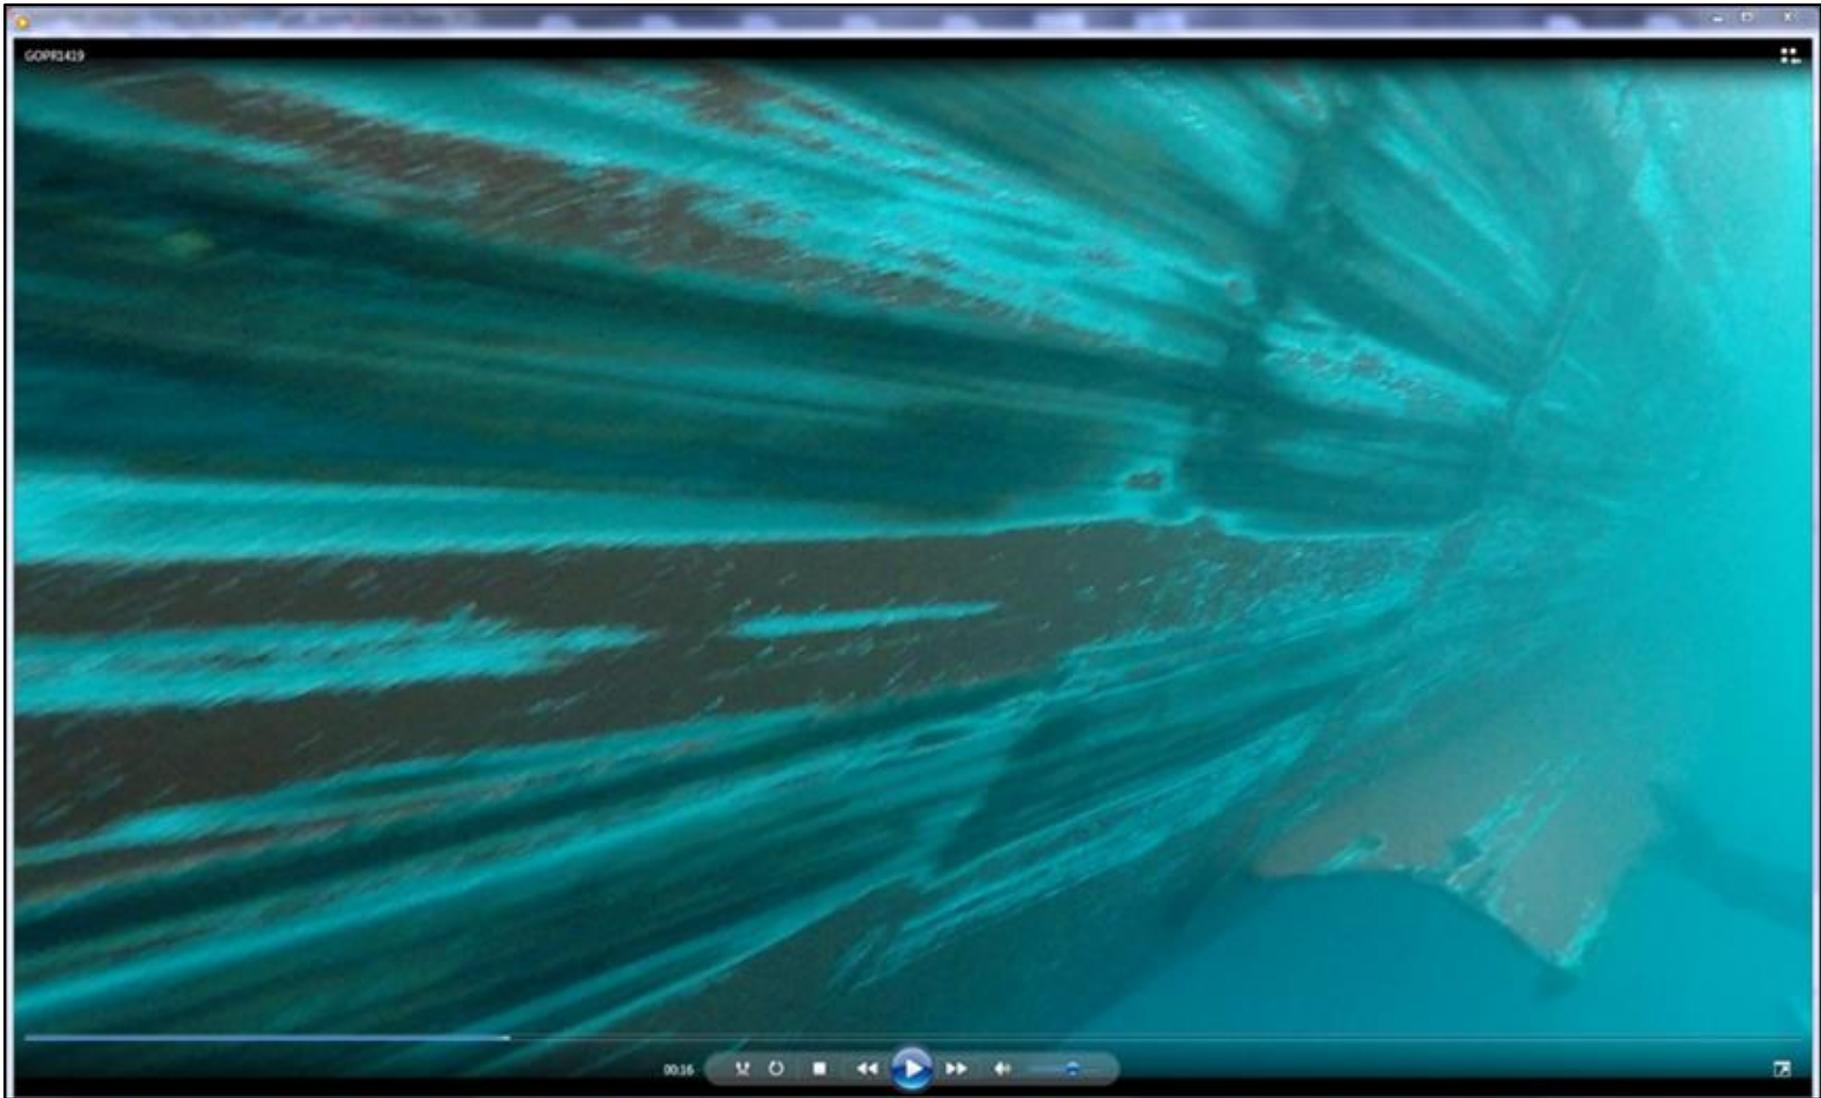
Figure 4
Damage to the starboard side of the hull and bilge keel

- 1.3 The *L'Austral* deviated well off the planned track and struck a stony bank near the shoreline of Milford Sound. The ship suffered scraping and indentation of the hull on its starboard side, but the hull was not breached and nobody on board was injured.

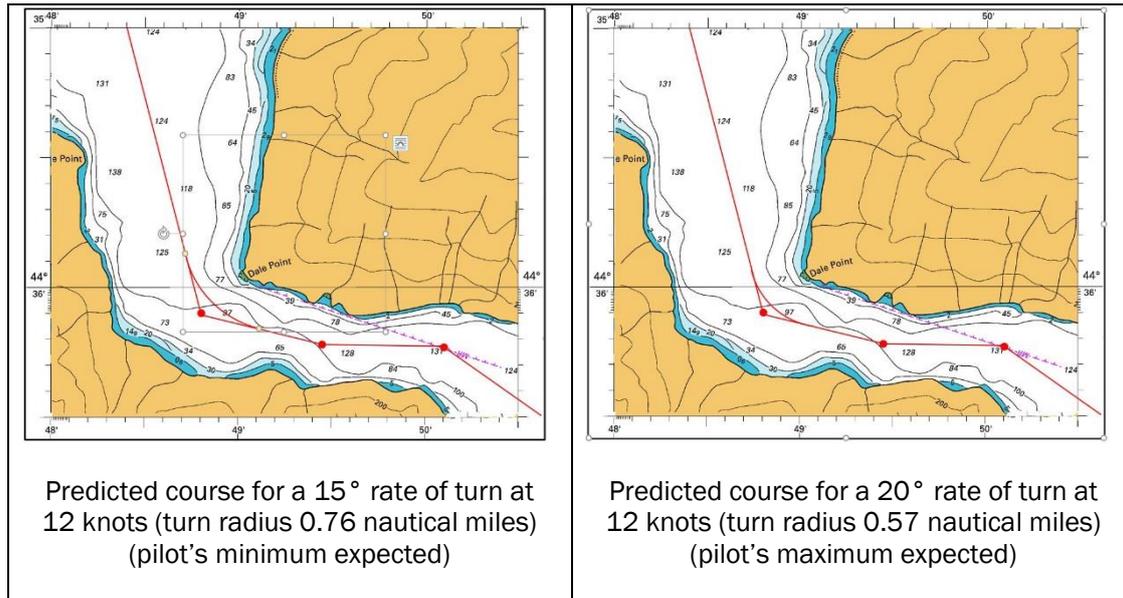
Figure 5
Chartlets showing typical tracks for rounding Dale Point

- 4.2.4. When the master arrived on the bridge, the master/pilot information exchange took place with the officer of the watch close-by while still maintaining the navigational watch. The pilot informed the master that he would require a vessel speed of 12 knots when they approached the turn at Dale Point and that the rate of turn would be between 15° and 20° to achieve the turn. These rates of turn would give turn radii of 0.76 and 0.57 nautical miles respectively (see Figure 5).

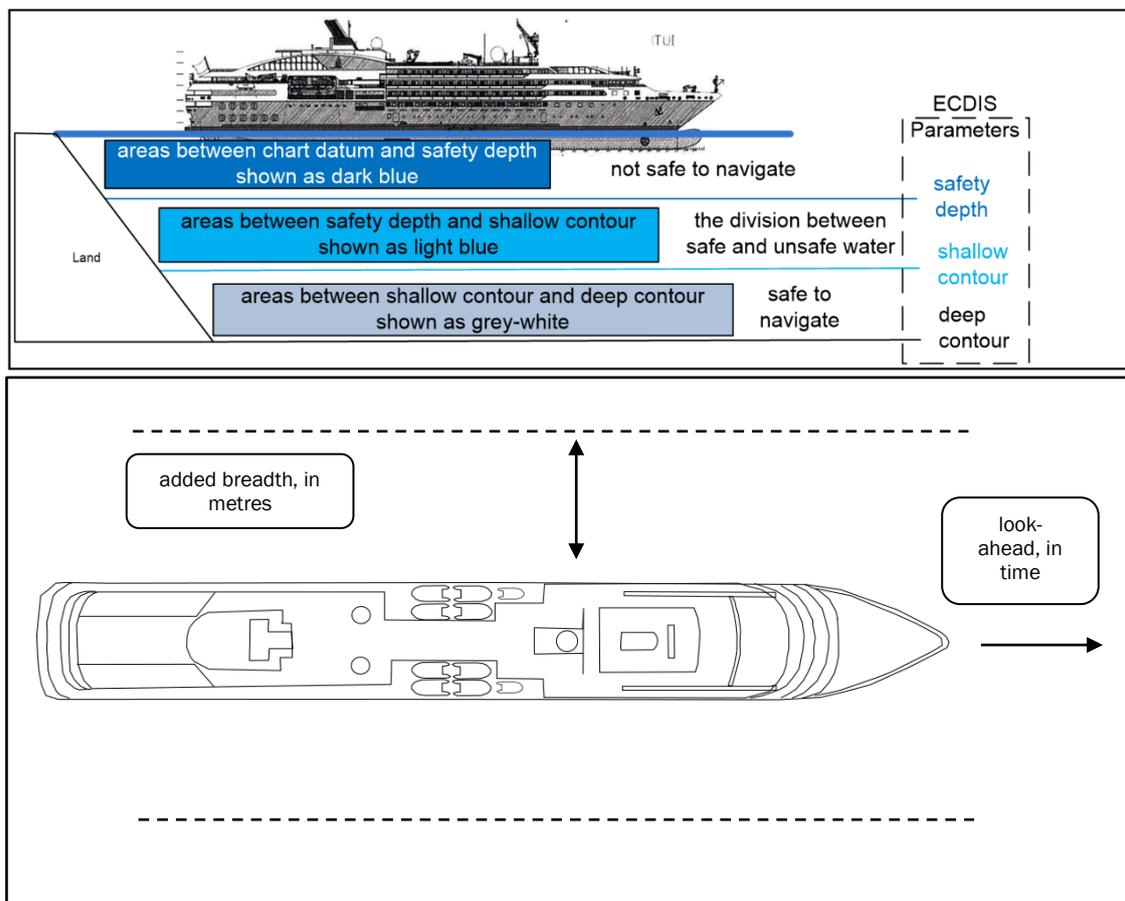
Figure 6
Diagram showing ECDIS safety parameters

- 4.2.23. User-defined safety settings are a safety function when using an ECDIS. A failure to enter the correct safety settings can allow a vessel to enter unsafe waters without alerting the operator. To achieve a safe passage plan, users of ECDISs must understand how to determine accurately the correct value for a safety setting (see Figure 7).

4.2.25. The vessel's passage plan included safety parameters that had been uploaded into the vessel's ECDIS. The operator's safety management system required that the ECDIS safety parameters, or the "antigrinding [sic] settings" be adapted to the type of navigation: offshore, coastal or port approach. However, permanent safety parameters had been set in the *L'Austral* ECDIS regardless of the phase of the ship's voyage (see Figure 7). Not changing safety parameters to match the mode of navigation degraded the usefulness of the ECDIS as a system for monitoring the progress of the ship in a confined channel.

On 28 February 2018 the Commission recommended that the Directeur D'exploitation at Ponant review the procedures for the setting up, training in and ongoing support for ECDISs on all of its ships, and ensure that all comply with mandatory requirements and that the ships' crews are fully conversant with good industry practice for the use of ECDISs. (003/18)
