# AIRCRAFT ACCIDENT REPORT

**No. 89-039**

**Fletcher FU 24-300**

**Near Moa Creek, Central Otago**

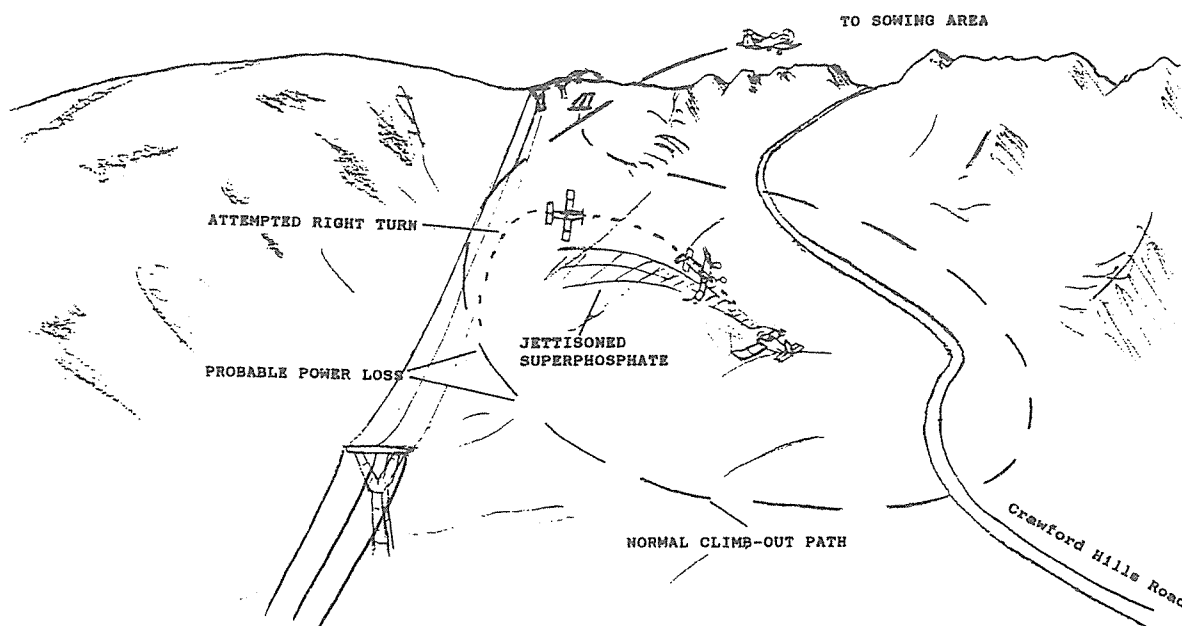
FIGURE 1

1.5 The departure procedure for ZK-CTO was to turn left about  $30^\circ$  after take-off, then make a right procedure turn between the south side of the valley and the power line while climbing to cross the saddle to reach the sowing area to the east (See Fig.1). The instructor's procedure was to turn right, as the aircraft was climbing to cross the power line.

Sketch of the probable flight path of ZK-CTO, looking North-East.

1.9 The right (lower) wing of the aircraft had struck the hillside, causing it to cartwheel to rest upright (See Fig. 1). The wreckage trail converged with the general hillside by about 20°. A curving trail of superphosphate about 200m long led to the wreckage. Some 2/3 of the hopper load remained in the aircraft.
