# AIRCRAFT ACCIDENT REPORT

**No. 89-047**

**HUGHES 369HS ZK-HXA  
Upper Icefall, Fox Glacier  
2 May 1989**

**Transport Accident Investigation Commission  
Wellington • New Zealand**

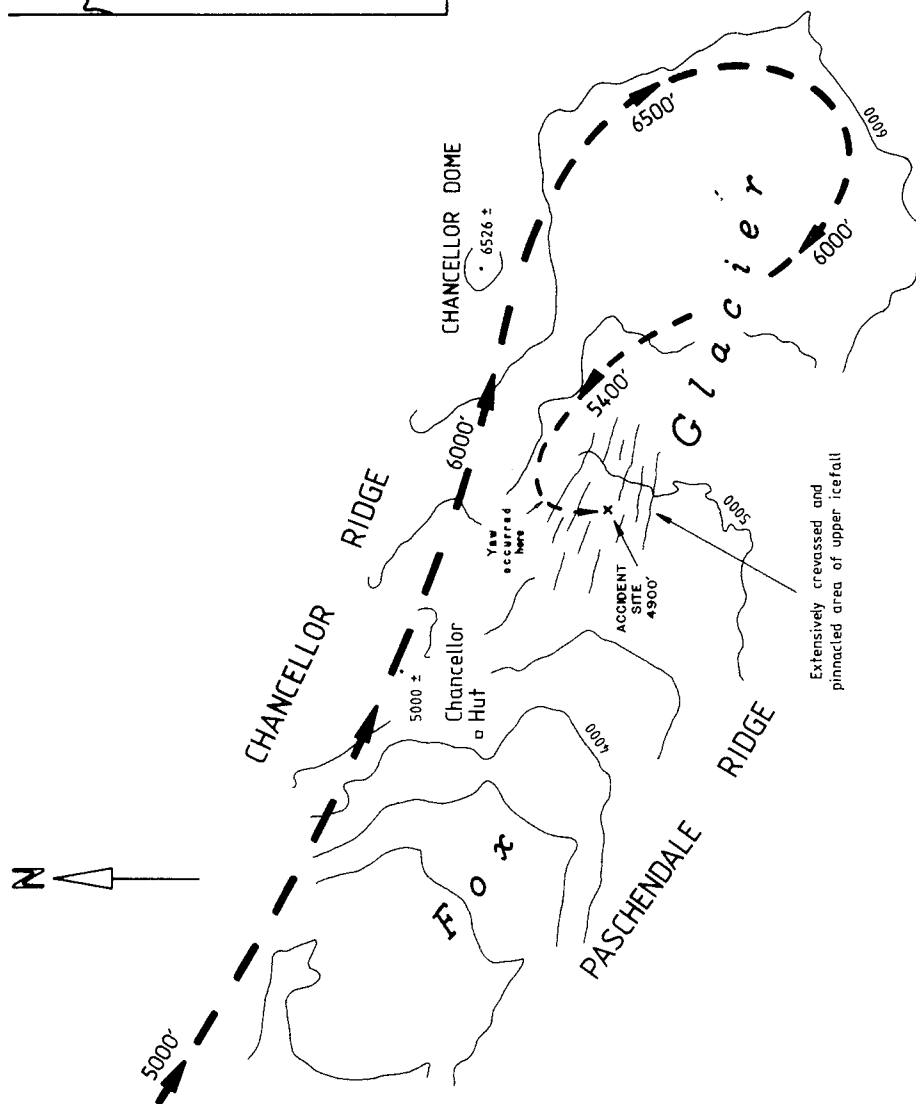
ZK - HXA FLIGHT PATH

1.1.3 In conjunction with the Department of Conservation, local helicopter operators had developed a "standard route" for scenic flights over the glacier. This involved flying up the true right (northern side) of the glacier, climbing to an altitude of some 6500 feet, dependent upon conditions and overflying the upper snowslopes in an orbit to the right before descending the face of the glacier in a zig-zag pattern, then returning to the township. (See Appendix 1).
