AIRCRAFT ACCIDENT REPORT

No. 89-053

Beechcraft 95-A55 Baron

ZK-SUN

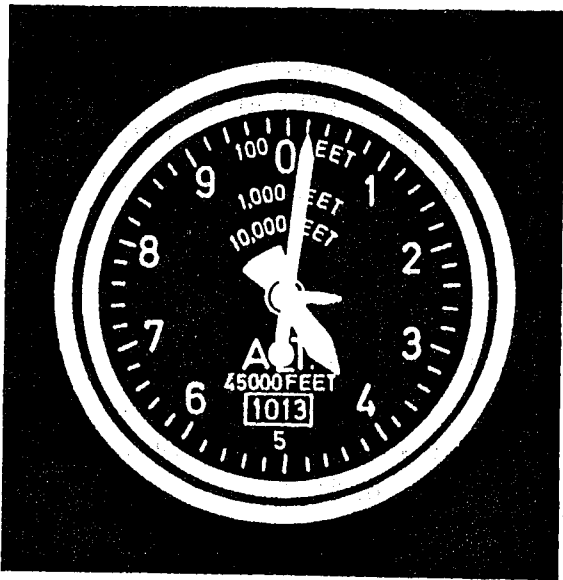
(a) 3 POINTER ALTIMETER

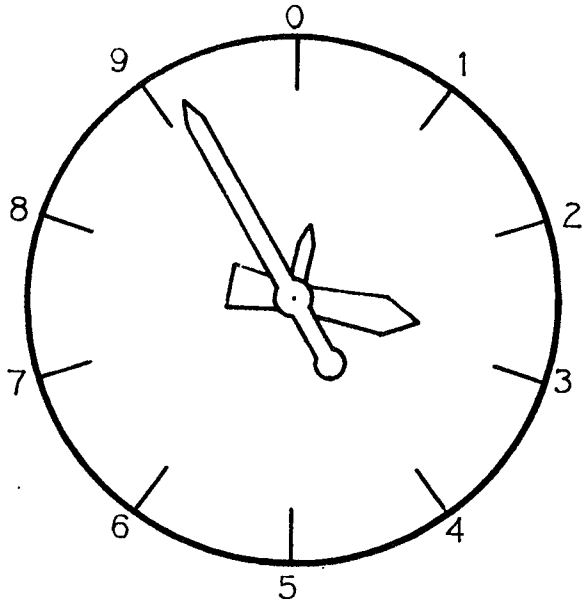
(c) 2920 CAN BE READ AS 3920

1.17.23 Before being superseded for airline use, three-pointer altimeters were responsible for a number of accidents, because they were easy to misread. While most of the major accidents were caused by misreading the altitude by 10 000 feet (so that the aircraft was 10 000 feet lower than the crew believed to be the case), trials showed that it was even easier to misread the altitude shown by 1000 feet.

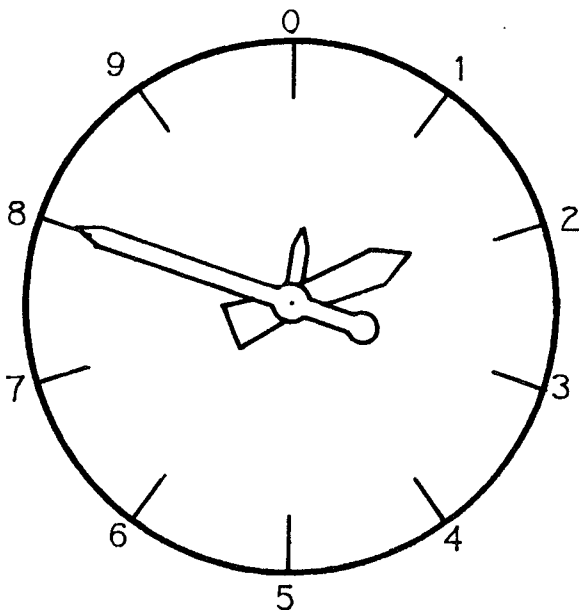
(d) "APPROACHING 2500"
IN DESCENT
