REPORT

No. 89-063

Two Piper PA38-112 Tomahawks

Transport Accident Investigation Commission
Wellington - New Zealand

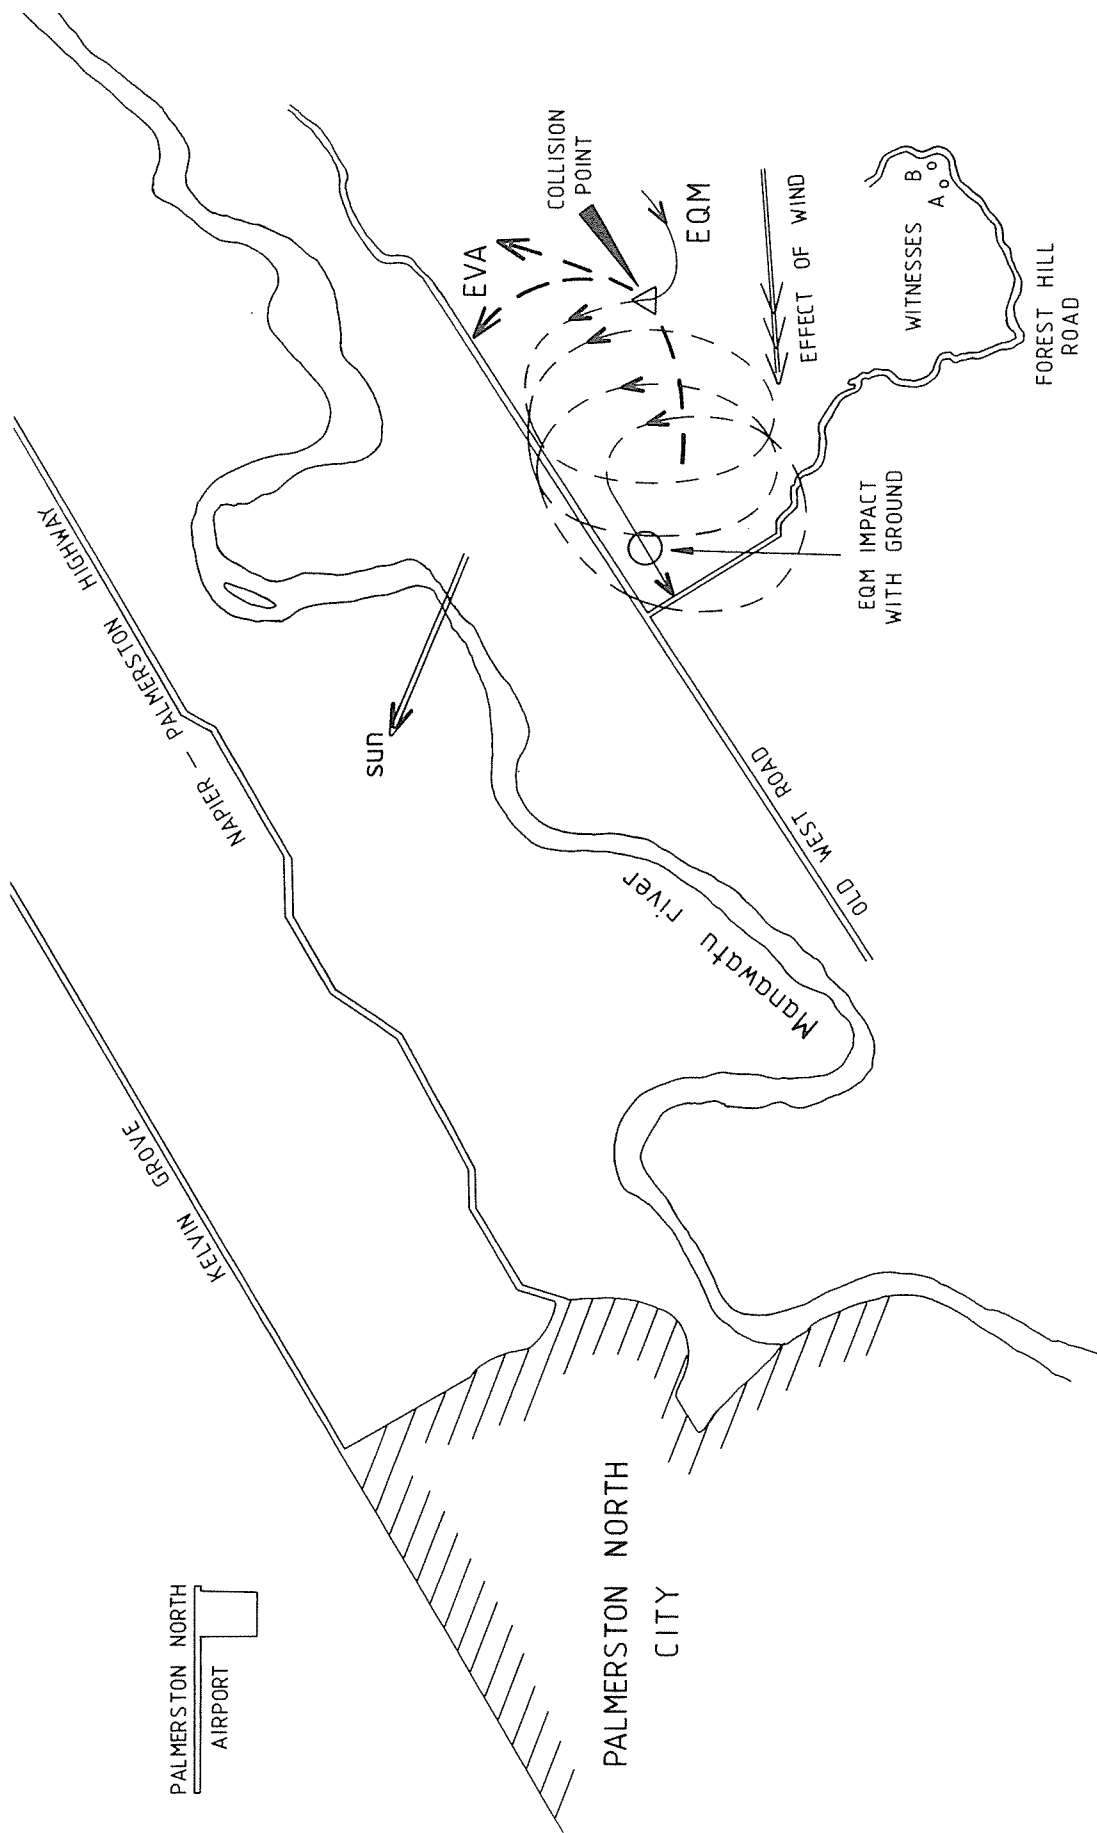
DIAGRAM 1

1.1.3 Mr Nicholson stated that he saw ZK-EQM "near the Manawatu Gorge" at two to three thousand feet amsl (see Diagram 1). He flew towards it intending to join formation in echelon port, i.e. to the left rear of ZK-EQM. ZK-EQM was in a steep turn to the right at the time, so Mr Nicholson dived ZK-EVA towards it and transmitted "tack tack tack" (simulating gunfire) on the radio telephone (RTF). He estimated the range at the time as 400 to 500 feet (122 m to 152 m).

1.1.9 Two witnesses (A and B, Diagram 1) heard the impact and saw the two aircraft immediately afterwards. Both thought that one of the aircraft (ZK-EVA) had flown straight on after the impact, in a northerly direction. The other (ZK-EQM) was seen to dive straight at first and then settle into a wide spiral descent at a moderate nose-down angle. One witness thought it made three to four circles before disappearing from view over the brow of the hill; the other thought six turns, possibly steepening towards the end. Both remarked on the lack of engine noise.

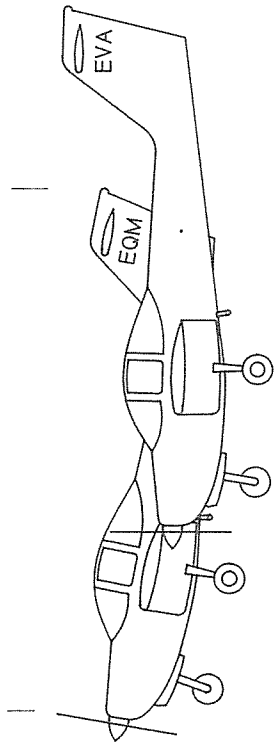
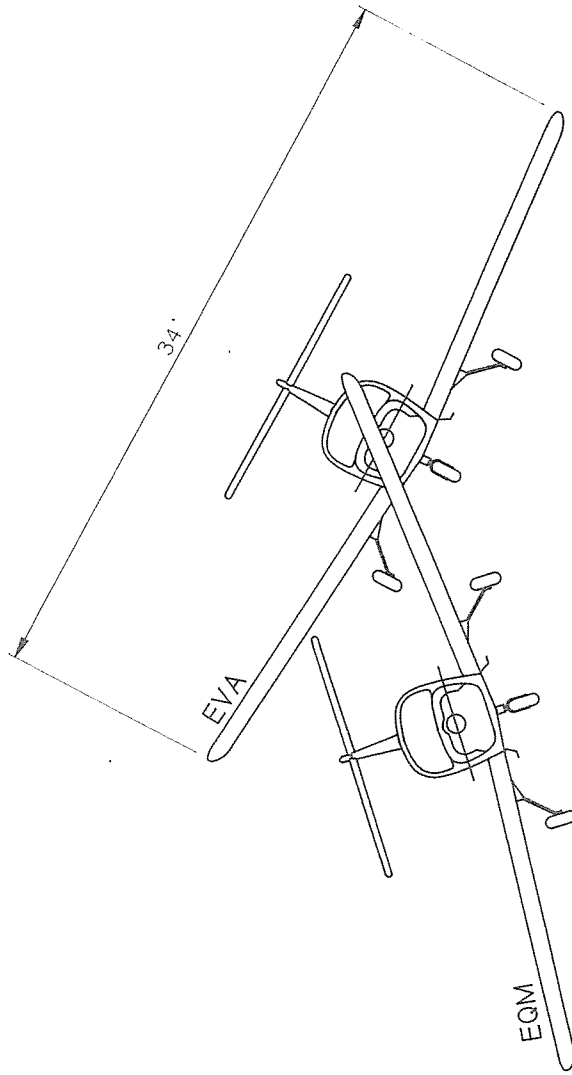
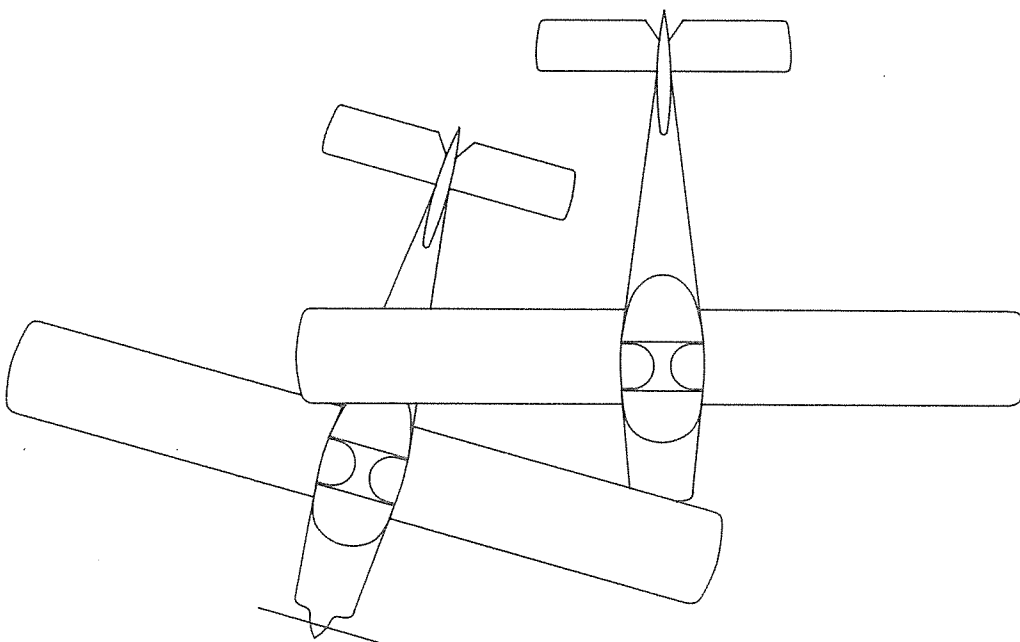
MID - AIR COLLISION ZK-EQM / ZK-EVA RECONSTRUCTION DIAGRAM 2

1.16.6 ZK-EVA was jacked up and the left wing of ZK-EQM was reassembled on trestles with the moulded area near the tip against the spinner of ZK-EVA. The plan layout was determined by fitting the propeller of ZK-EVA to the principal cut in the left wing of ZK-EQM. The fuselage and tail of ZK-EQM were then placed in appropriate positions. The reconstruction is shown in Diagram 2. The relative bank angle of ZK-EVA to ZK-EQM was the minimum necessary for the wing of the former to clear the tail of the latter. (There were no scratch marks under the right wing of ZK-EVA, showing that it had not touched the tailplane tip of ZK-EQM).

1.16.7 The pitch difference shown in elevation is fortuitous, being the relative angles adopted by the aircraft when jacked and the wreckage as laid out. However:

- (a) The difference in pitch angle is consistent with Mr Nicholson's statement that he was diving ZK-EVA towards ZK-EQM.
- (b) The difference is consistent with the vertical cut in the spar of ZK-EQM. In flight, a propeller describes a helix through the air, and also relative to another aircraft with which it is closing, so if the aircraft pitch attitudes were the same, the cut would have been downward and forward.

2.1.3 If the relative bank angles were as shown in diagram 2, continued relative forward speed must inevitably have resulted in the wing of ZK-EVA striking the wing of ZK-EQM.

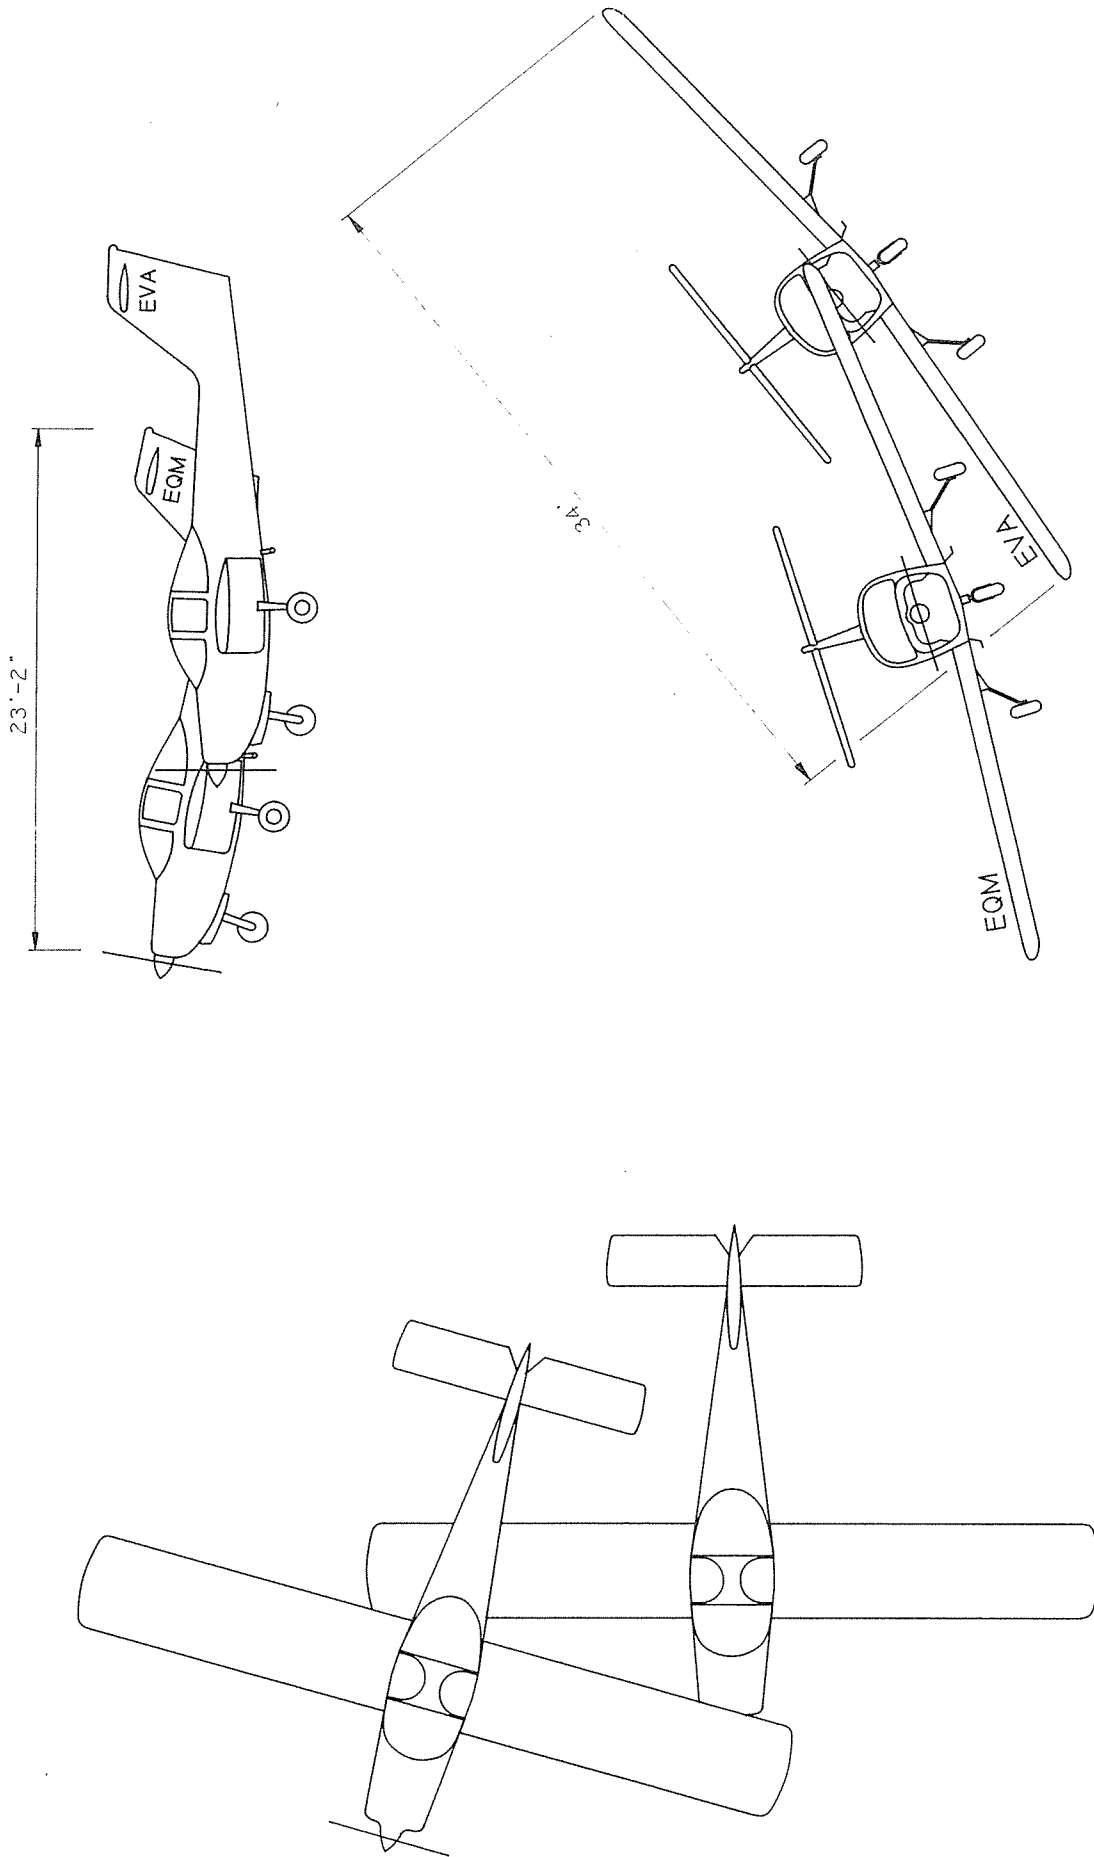
DIAGRAM 3

1.16.8 An alternative layout is shown in diagram 3, where ZK-EVA is banked towards ZK-EQM instead of away from it. This layout would also fit the wreckage pattern.

2.1.4 The relative bank angles shown in diagram 3, by contrast, allow for the glancing blow from ZK-EVA's spinner to deflect ZK-EQM's wingtip over the cowling of ZK-EVA, and the two aircraft could then part without further contact, as in fact happened. Diagram 3 is therefore representative of the relative attitudes of the two aircraft at impact.

2.3.1 The relative attitude shown in diagram 3 implies that ZK-EVA and ZK-EQM were turning towards each other. Mr Nicholson advised that when he detected the excessive closing speed, he rolled ZK-EVA away from ZK-EQM. If the two aircraft were at the same bank angle initially (i.e. with wings parallel) it follows that ZK-EQM must have banked towards ZK-EVA. This would be consistent with the complete overlap of one semi-span, when the pilots had intended to have 1 m clear between their wingtips.
