AIRCRAFT ACCIDENT REPORT

No. 89-066

**BRITTEN NORMAN BN2A-26
ISLANDER, ZK-EVK**

**NEAR BLUE DUCK GLACIER,
UPPER DART VALLEY**

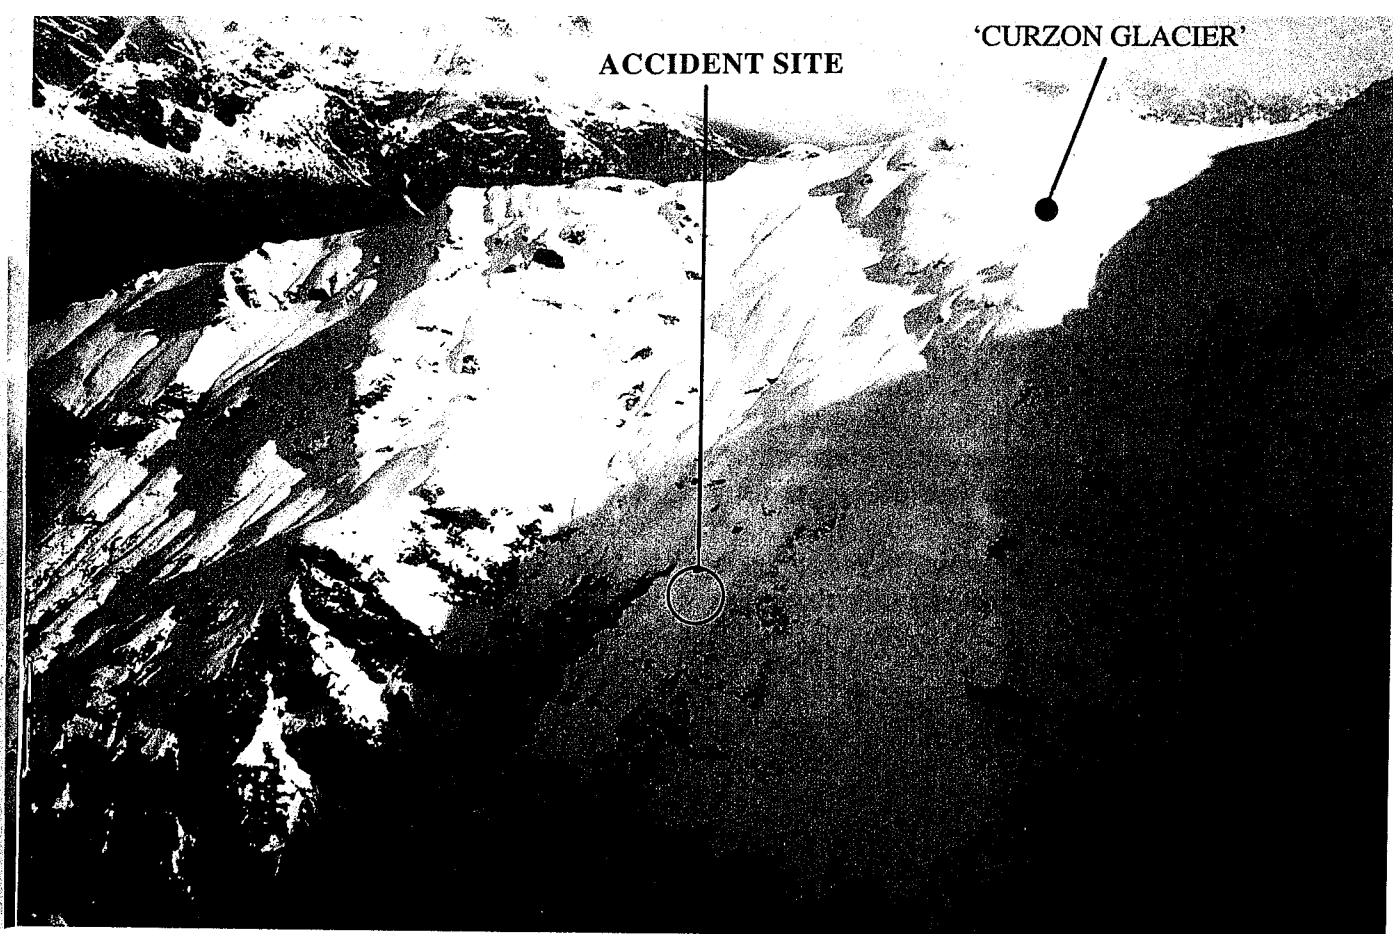
FIG 3. THE ACCIDENT AREA — VIEWED FROM THE EAST

1.12.10 Due to the nature of the terrain, surveys of the impact area were carried out by helicopter. Aerial inspection indicated that ZK-EVK had struck the slope between 5300 and 5400 feet amsl on a south-westerly to southerly heading. The impact crater suggested that the aircraft was banked steeply to the left, possibly beyond the vertical, when it struck the snow. It was probable that the severe forces resulted in a cartwheel sequence involving separation of the outboard portion of the left wing, deformation of the right wing and complete separation of the whole wing assembly from the fuselage at the time of the initial impact. Extensive disruption to the cabin area of the fuselage was likely to have occurred during the impact sequence.
