AIRCRAFT ACCIDENT REPORT

No. 89-088

Cessna A188-B

ZK-CSC

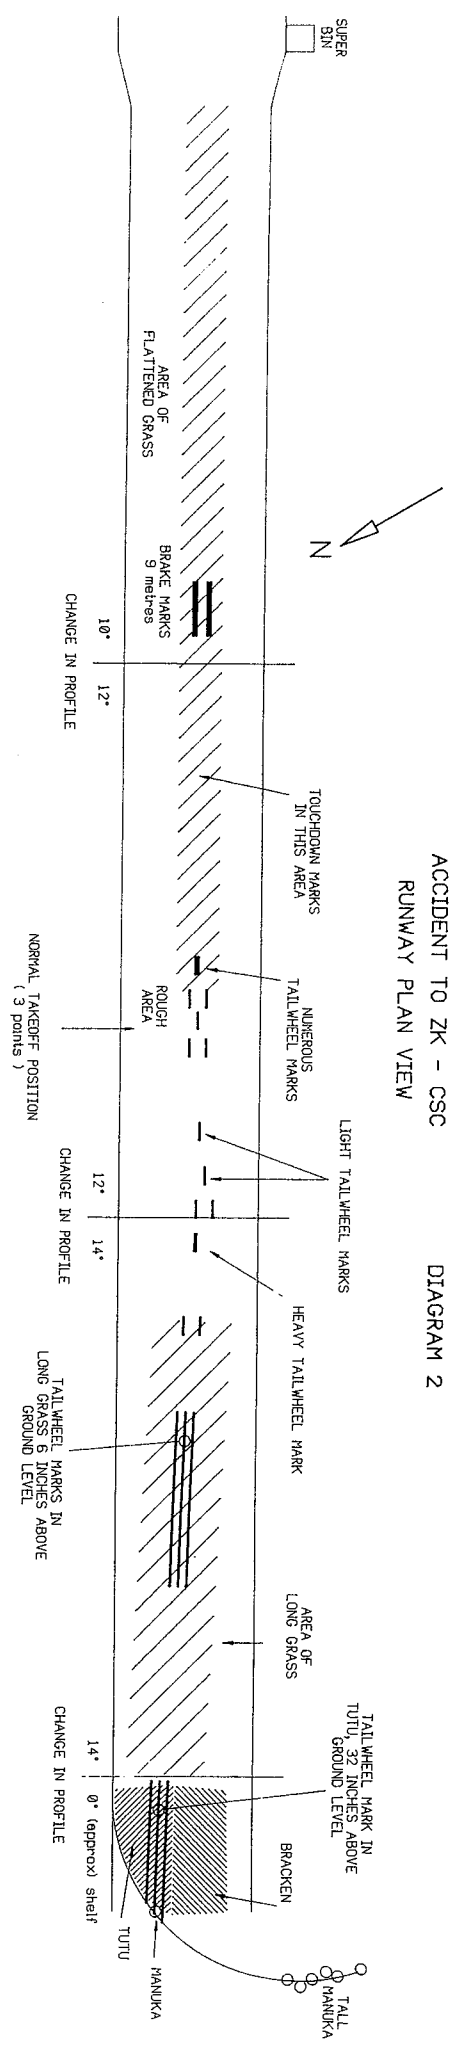
ACCIDENT TO ZK - CSC
 RUNWAY PLAN VIEW
 DIAGRAM 2

1.9 About halfway down the rolled take-off path there were a pair of marks 9 m long where both of the mainwheels had been braked heavily. (See Diagram 2). The marks were similar for each wheel, centred on the rolled area, straight along it and made while the aircraft was going downhill. The spacing was consistent with the aircraft being laden. The marks did not appear to have been rolled over after they were made.

1.31 However, this did not explain the heavy brake marks made by both wheels, half way down the normal take-off roll. These brake-marks, indicating firm application of brake for about half a second, could only be explained in

terms of a decision to abandon the take-off, followed by a decision to continue. They could not be explained by a need for directional control as only one brake would have been applied in that case; besides, full rudder authority would have been available at that stage.

1.32 The pilot had no recollection of making the brake application; the brake marks were fresh and did not appear to have been rolled over subsequently. Both of these facts argued that the marks had been made on the take-off roll leading to the accident flight.

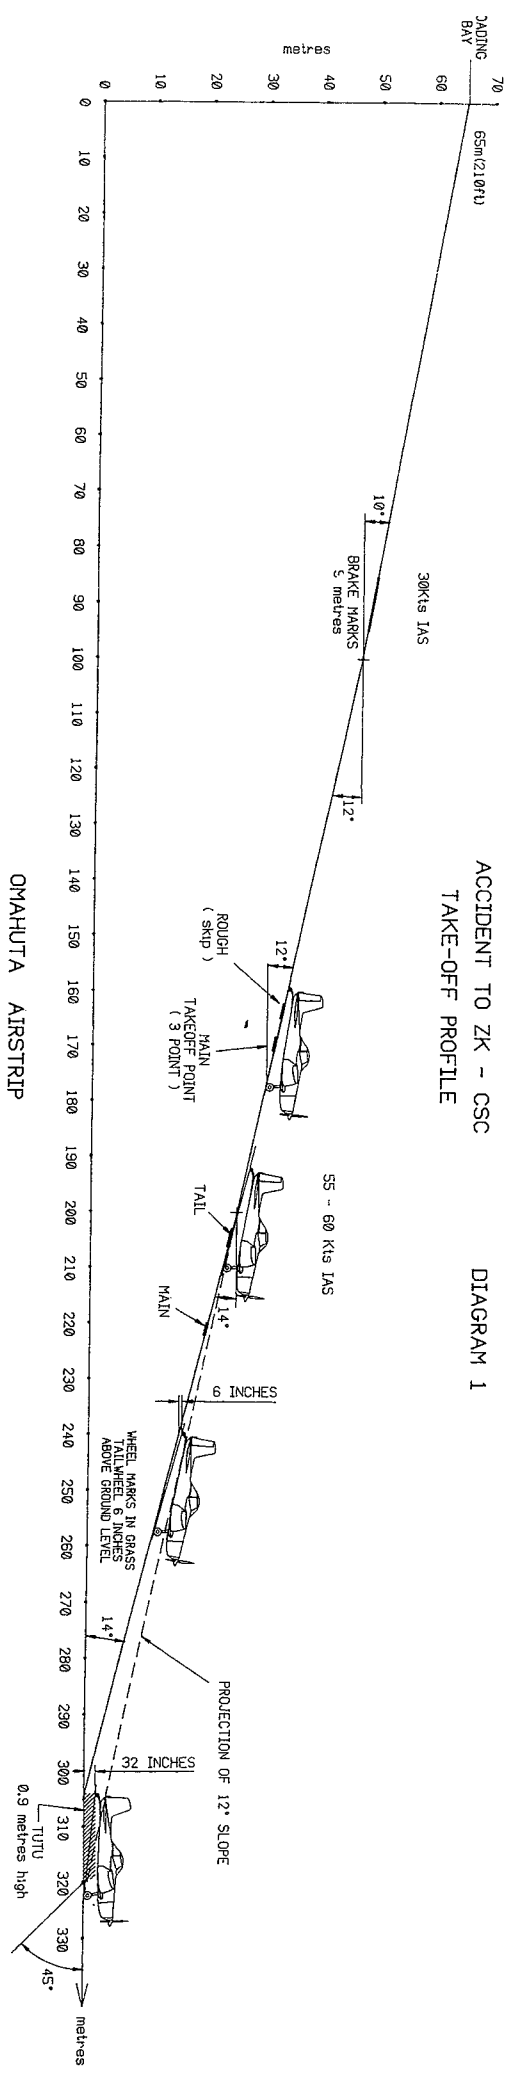
ACCIDENT TO ZK - CSC
 TAKE-OFF PROFILE
 DIAGRAM 1

1.1 The aircraft was spreading granulated fertilizer on properties adjacent to the Omahuta State Forest; the airstrip was situated on a ridge within the forest, some 300 feet higher, at an elevation of 1050 feet amsl at its top end. The 300 m long airstrip, which faced north-west, had three distinct sections of 100 m each, progressively increasing in downslope from 10° to 12° and then to 14°; there was a small flat shelf at the bottom and after that the hillside sloped down at about 45° to the valley floor. (See Diagram 1).

1.36 The aircraft was just able to become airborne with an angle of attack of about 12° . Had it remained airborne its trajectory would have been on or above the projected slope (which was also 12°) and diagram 1 shows that this would have just about cleared the shrubs at the end of the strip. However, when the tailwheel struck the ground beyond the point at which the slope changed, the angle of attack was reduced as the tailwheel rebounded into the air. The aircraft therefore sank, and the mainwheels touched the ground.

1.37 Had the aircraft again been rotated to the three-point attitude, its initial trajectory would have been parallel to the steeper slope, until it was sufficiently clear of the ground that it could be rotated to its original climbing attitude. The clearance margin at the end of the strip would therefore have been reduced.
