AIRBRIFT ACCIDENT REPORT

No. 90-039

HAVARD 2A* (AT6)

ZK-ENN

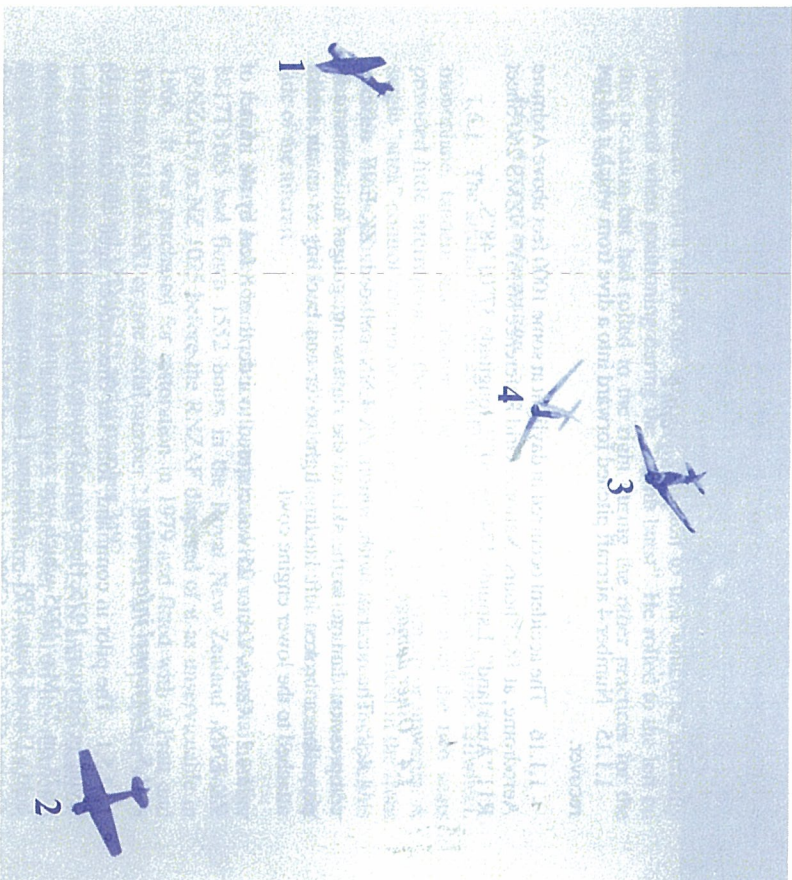
Photograph 1

1.1.13 The resultant flight path caused number 4 aircraft (ZK-ENN) to overtake number 3 (ZK-ENE) from behind while still rolling and pitching up towards the horizontal. (See *photograph 1*)

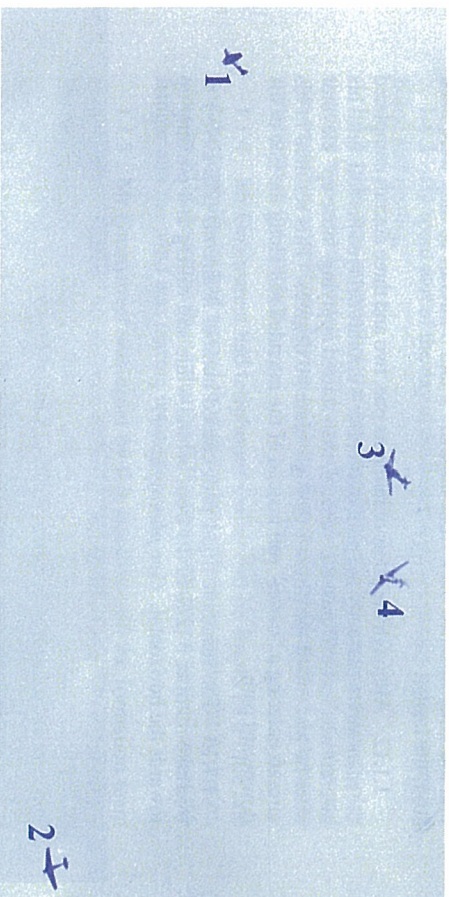
Photograph 2

1.1.14 As number 4 aircraft overtook number 3 it was banked at 90° relative to ZK-ENE and converging on it in a curved flight path. As a result it collided with ZK-ENE and its right hand elevator and horizontal stabiliser were knocked off by that aircraft's right wingtip (*See photograph 2*). Subsequently ZK-ENN slid beneath ZK-ENE and the propeller of the number 3 aircraft sliced through both elevator control cables and one rudder cable of ZK-ENN.

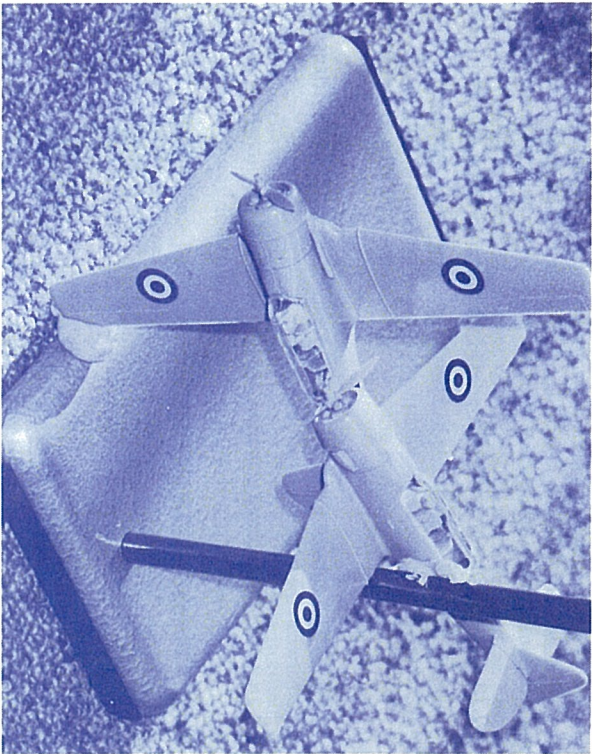
Photograph 3

1.16.3 This analysis showed that number 2 and 3 aircraft initiated their roll for the bomb burst slightly before their aircraft were vertical and number 4 aircraft continued slightly beyond the vertical before rolling. The pilot of number 4 rolled it through 90° then started applying up elevator and the consequent flight path lead number 4 aircraft to intercept number 3 as it crossed number 3's flight path in a 90° banked attitude (*See photographs 3, 4 and 5*).
