# AIRCRAFT ACCIDENT REPORT

**No. 91-003**

**CESSNA 421C ZK-WLG**

**Auckland Airport Apron**

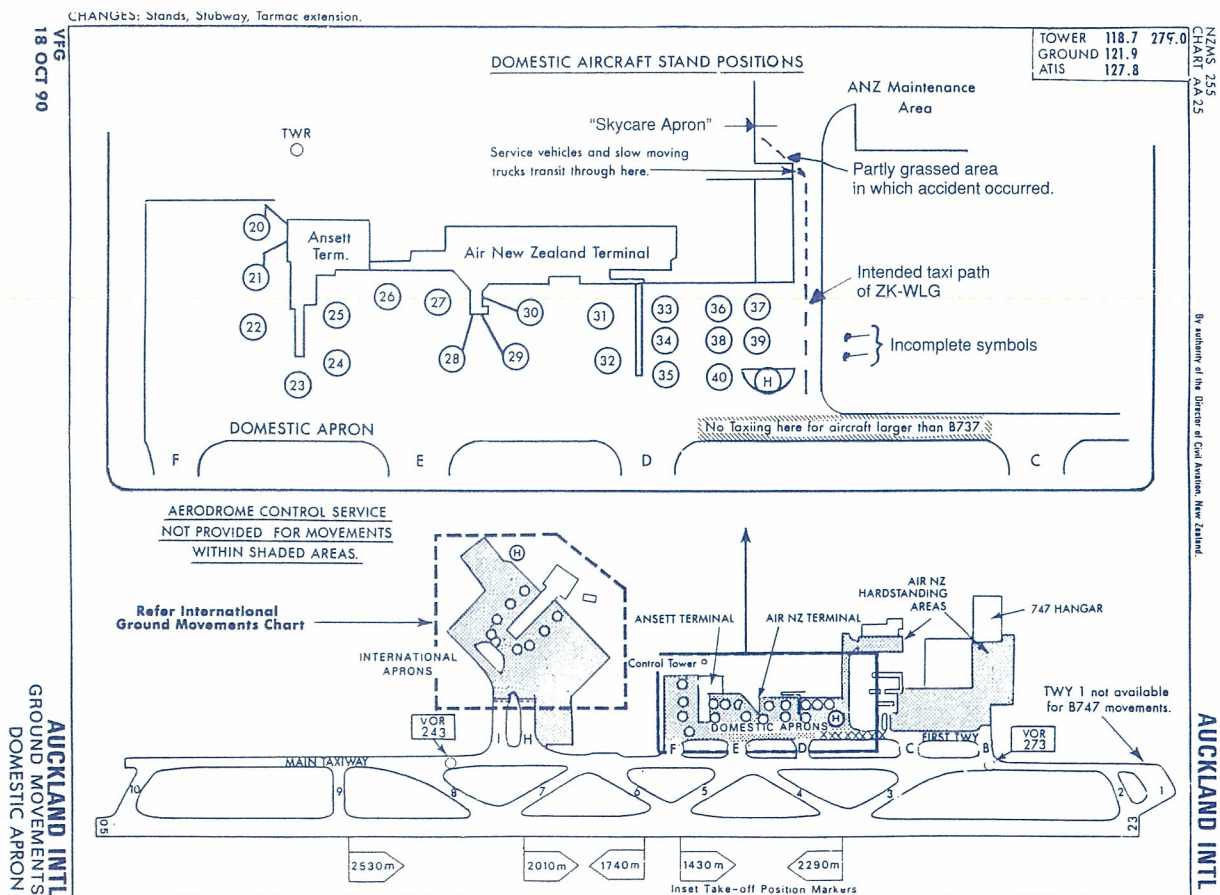
## AUCKLAND INTL

1.10 The area of ground into which the aircraft's mainwheel sank was first disturbed on 2 November 1989 to repair an underground watermain fault at that location. The repairs were completed in December 1990 but the subsequent backfill in the unstable ground did not compact successfully so frequent topdressings with loose soil were made to compensate for the continual subsidence in the area.

1.12 The Chart (AA 25 "Auckland Intl: Ground Movements: Domestic Apron") in the Visual Flight Guide of the NZAIP had several shortcomings. It was intended to show the location of the domestic apron on a small scale chart and then depict that apron in detail on a larger scale. The area boxed off on the smaller scale plan view of the airport, with the words "Domestic Aprons" did not coincide with the expanded chart of the area in that the "Skycare" apron was not included in the boxed off area but was included in the blown up section of the chart. This larger scale section did not depict the grass area into which the aircraft taxied or have any indication that the whole area was not available for aircraft movements. Whilst an area with two incomplete helicopter symbols was available for parking fixed wing aircraft this was not shown as such on the chart. No taxiway number or letter was allocated to the taxiway into the "Skycare" area and the "Skycare" area itself was not depicted as a parking area.

2.6 The chart which depicted the domestic aprons was deficient in that it indicated the area as an extension of the domestic apron but did not give any detail about its status or restrictions on its use; such as the grass/dirt area which was not intended for aircraft movements. It was also lacking in detail on the parking area to the north-east of the taxiway into the area.

Liaise with the Air Transport Division of the Ministry of Transport to have a more informative and accurate depiction of the areas adjacent to the taxiway to the "Skycare" apron and the purpose of these areas.
