AIRCRAFT ACCIDENT REPORT

No. 91-004

Robinson R22 Beta

ZK-HDD

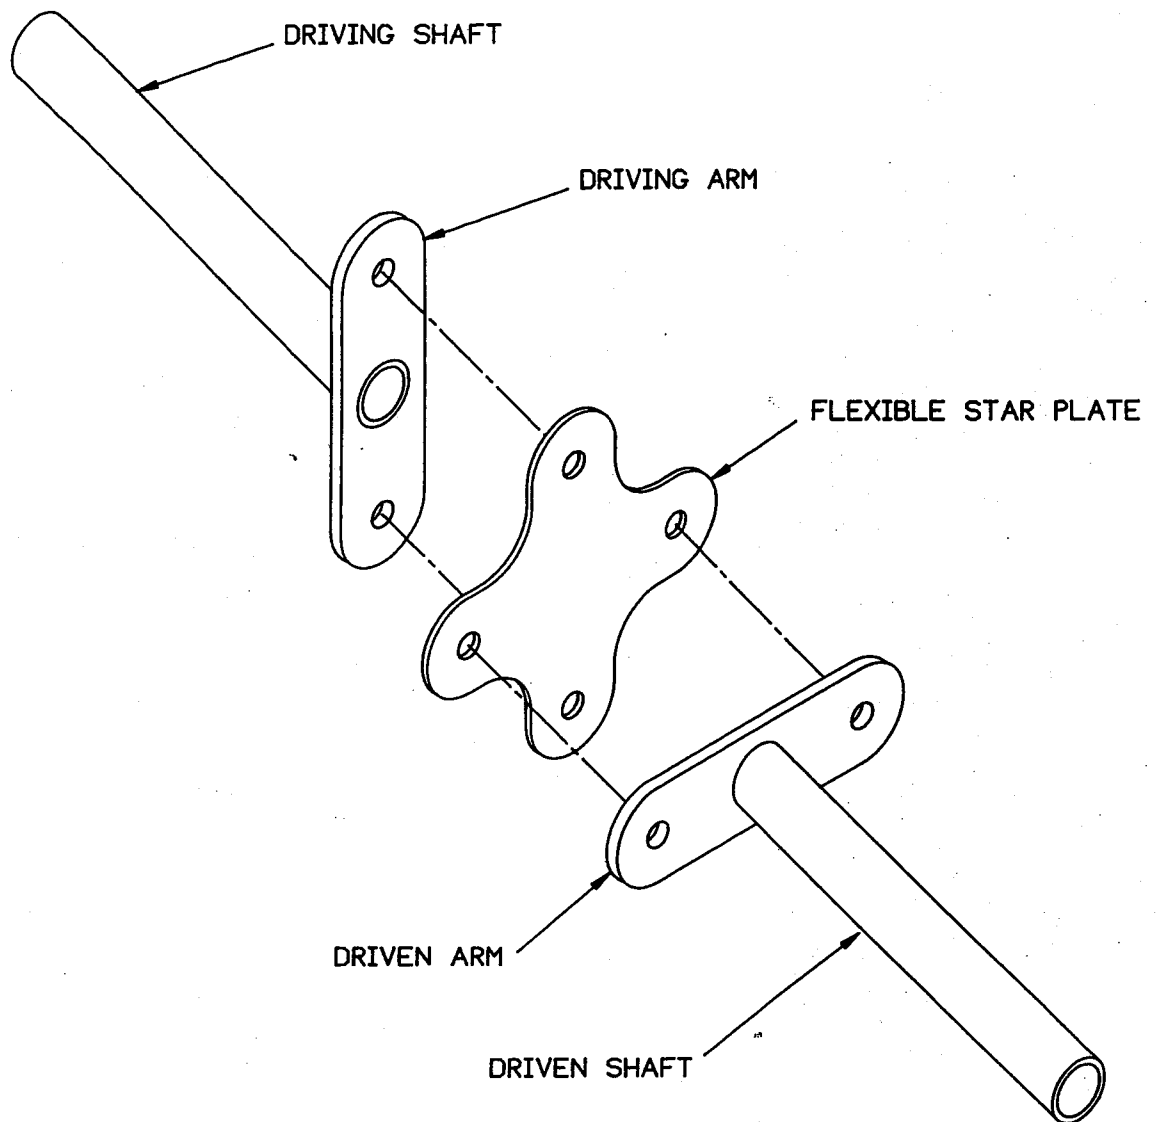
Diagram 2 — Layout of Starflex Coupling

1.12.10 The starflex coupling between the main driveshaft and the tail rotor driveshaft had failed. One arm of the star plate had broken and the plate was twisted between the driving and driven arms which were themselves bent. Nevertheless, the coupling still connected the driving and driven shafts. When it failed, the coupling had hammered against the tubular steel tailboom mounting structure and produced deformation of the order of 9mm. The tail rotor driveshaft was running eccentrically at its forward end, but was centred at its rear starflex coupling which was unaffected.

1.16.8 The star plate of the failed coupling appeared to have broken in two distinct stages. However, examination under an electron microscope showed an absence of polishing in the outer part of the break. This indicated that the two events were closely related in time.

2.2.3 When ZK-HDD was recovered from the water, the star-flex coupling between the main driveshaft and the tail rotor driveshaft exhibited damage similar to that resulting from an attempted start with the clutch engaged.

2.2.17 In the state in which the star-flex coupling was recovered, it was unlikely that it could have provided the torque to cause the driveshaft failure without itself separating completely. It was thus deduced that the star-flex coupling partial failure occurred at the same time as the partial failure of the tail rotor driveshaft and that both the complete tailboom and the drive mechanism were intact until impact with the sea.
