NO. 91-007

BOEING 767-219

Runway 03, Nandi Airport, Fiji

AIRCRAFT ACCIDENT REPORT NO. 91-007

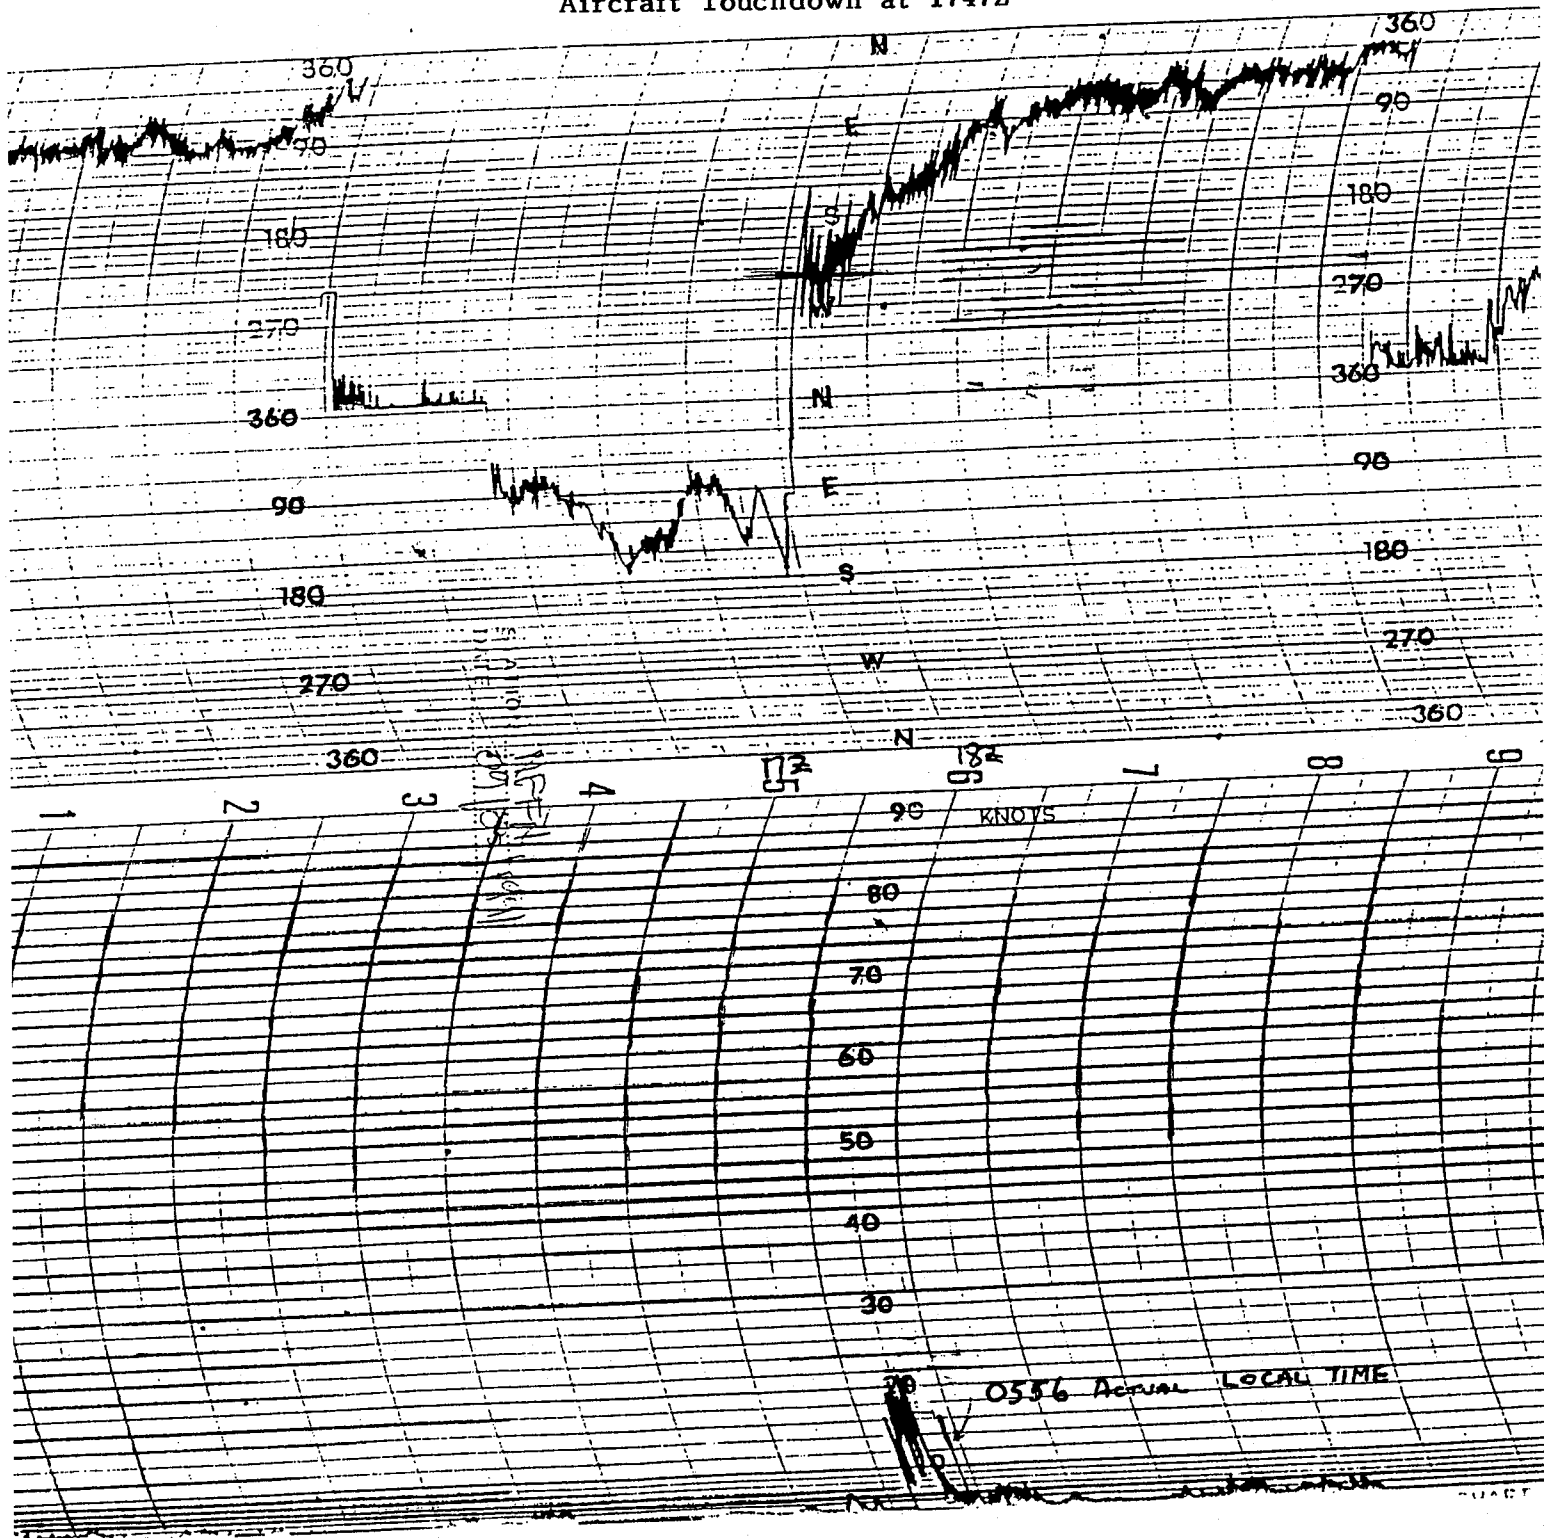
FIGURE 1

1.7.10 As ZK-NBC approached Fiji a squall line was moving towards the threshold of runway 03 at Nandi. The trace from the recording of the mid-field anemometer, situated 2900 m to the north of the runway 03 threshold indicated a drift of insufficient strength for either direction or speed to be recorded until 0537 hours when a sharp edged gust ranging between 16 and 21 knots arrived from the south-west and lasted for some 15 minutes (See Figure 1).

1.7.11 This squall probably arrived at the threshold just ahead of the aircraft and persisted beyond the time of the aircraft's arrival.

Centrefield Anemograph Trace, Nandi

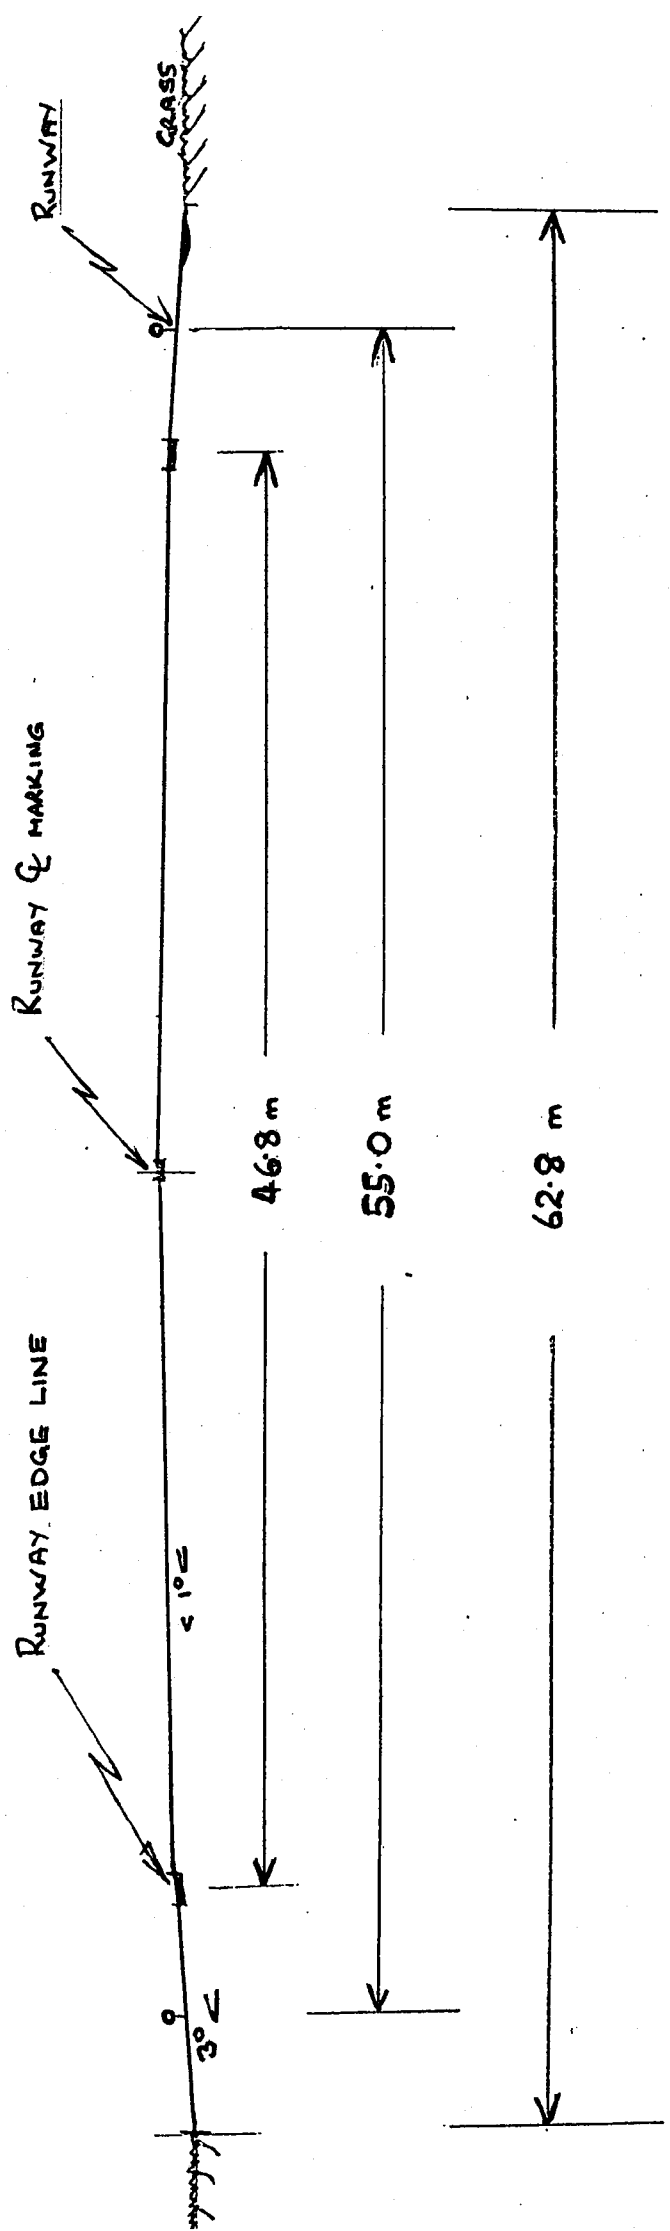
FIGURE 2

1.10.5 The runway measured 27 m from the centreline to the runway edge lights and sloped laterally at less than 1° to a point 5 m inside these lights at which point a white edge line was painted. From this edge line, the edge of the concrete was 8 m distant at a slope of 3° down. (See Figure 2)

Cross Section of Runway 03, Nandi

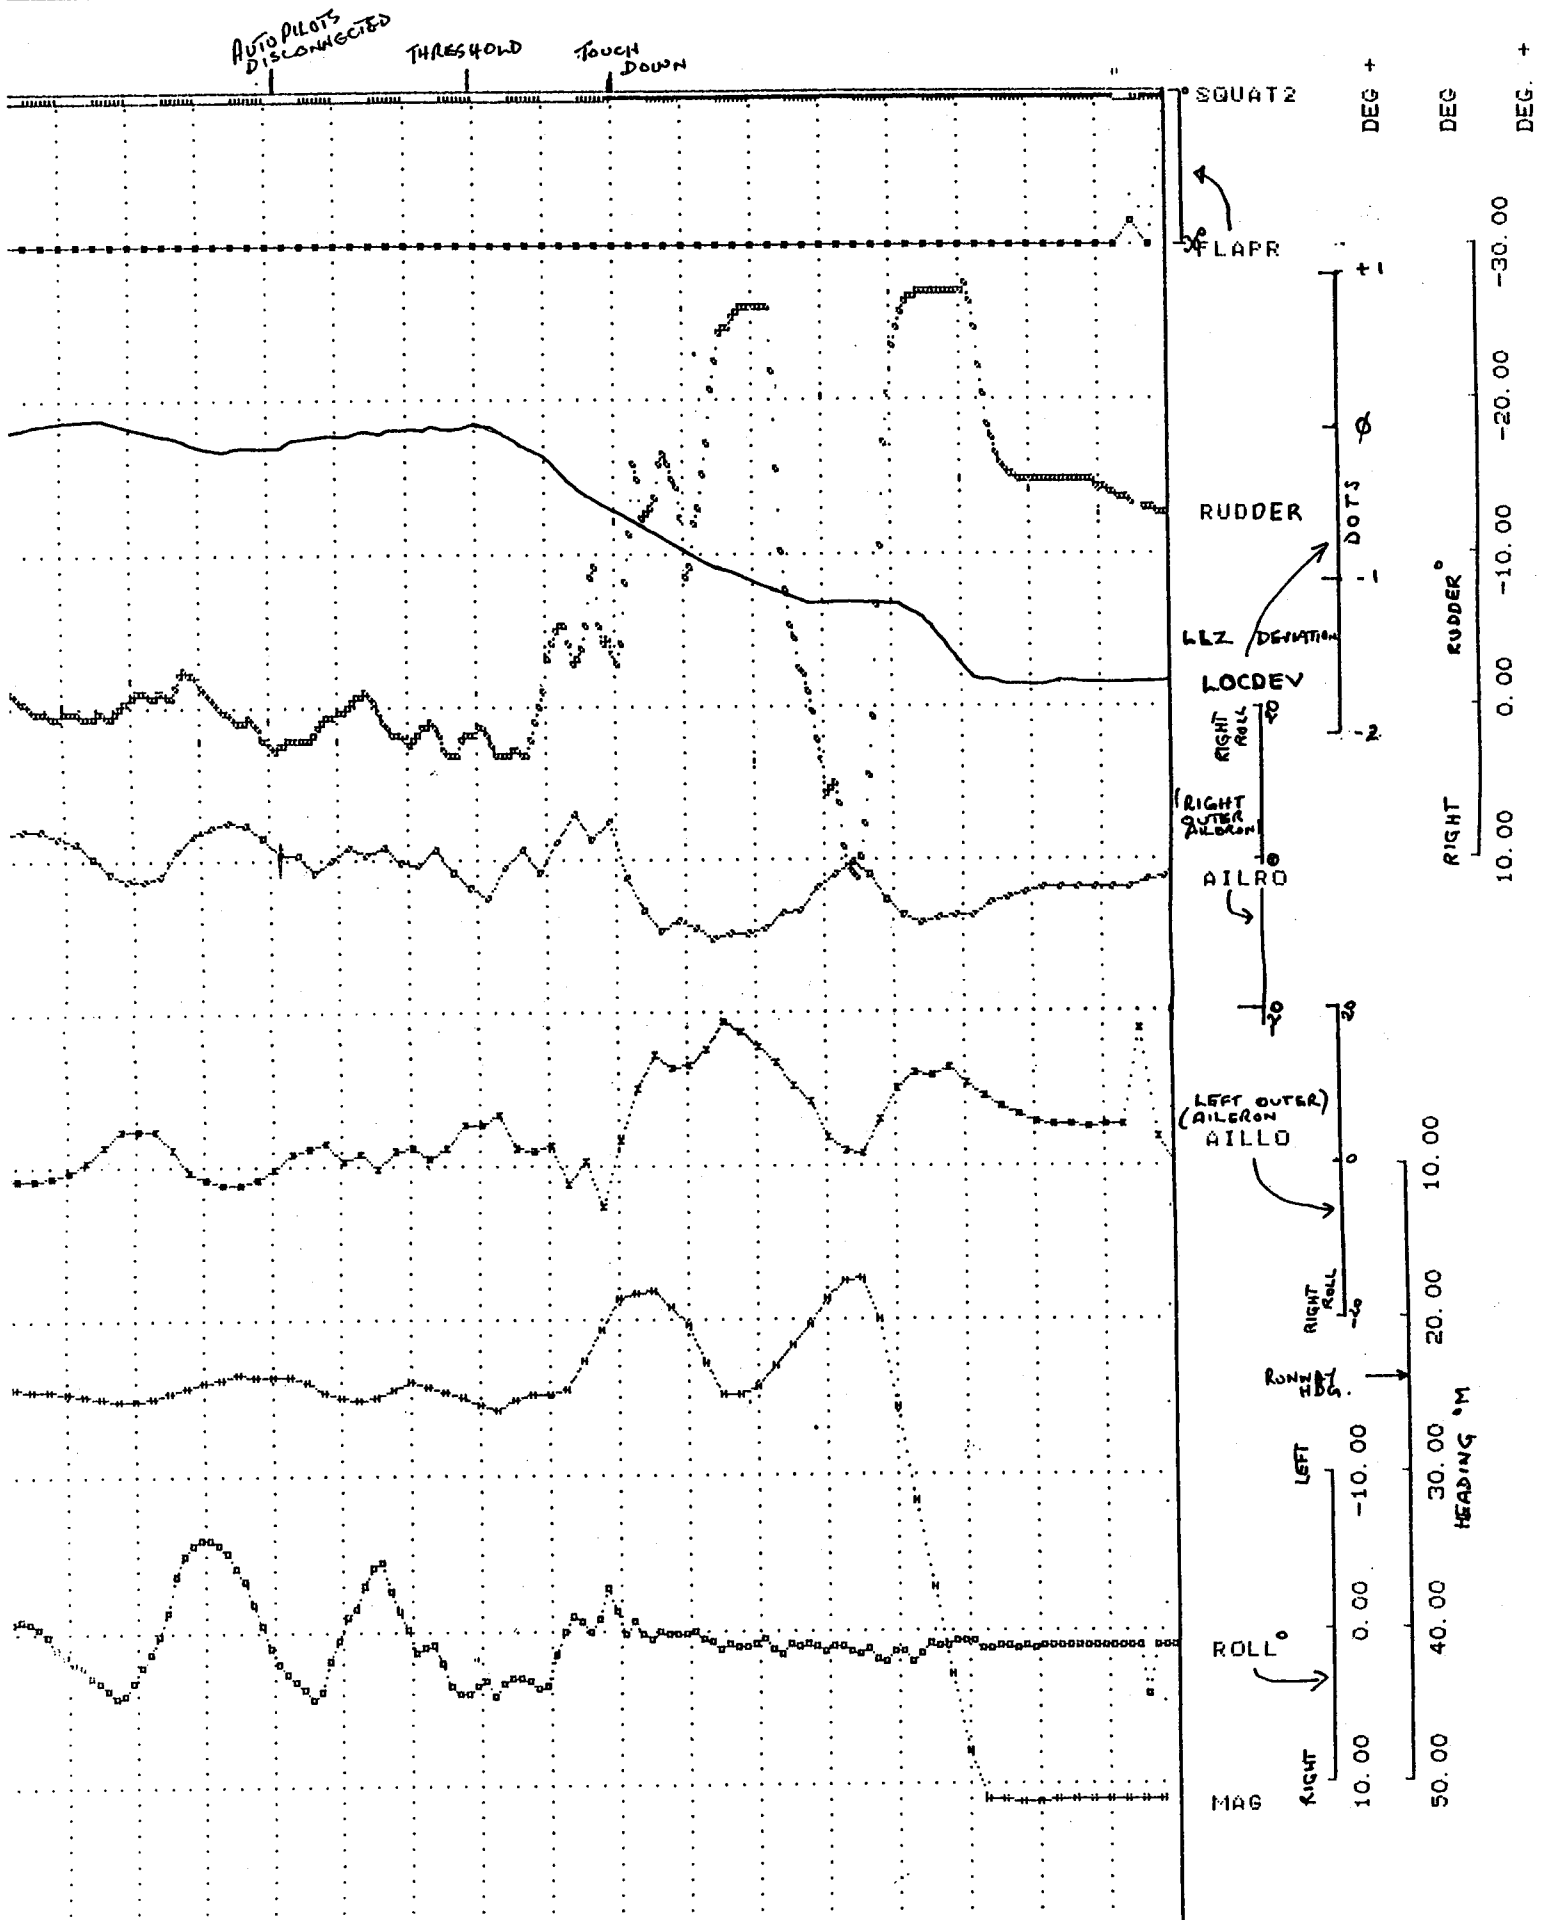
FIGURE 3
UFDR Record

1.11.11 The aircraft then rolled through level to 5° left before resuming 4° of right bank, for some seven seconds despite the application of opposite aileron. The aircraft maintained the localiser centre line track until it was over the threshold 3 seconds after the roll to the right occurred. After this the aircraft drifted to the right of the centre line. The pilot applied some 9° of left rudder for 5 seconds prior to touchdown which failed to slow the rate of the drift to the right. (See Figure 3)

1.11.12 The aircraft was tracking along the centreline as it crossed the threshold but drifted 27 m to the right from that alignment in the eight seconds prior to touchdown despite the Captain's corrections.

1.11.13 An analysis was made by the manufacturer's, of the information recorded by the UFDR and the lateral displacements which occurred after the aircraft crossed the threshold. This study established that the aircraft had encountered a sharp edged gust similar to that recorded on the mid-field anemograph, as it crossed the threshold.
