# AIRCRAFT ACCIDENT REPORT

**No. 91-011**

**Rotec Rally 3 Microlight**

**ZK-WAC**

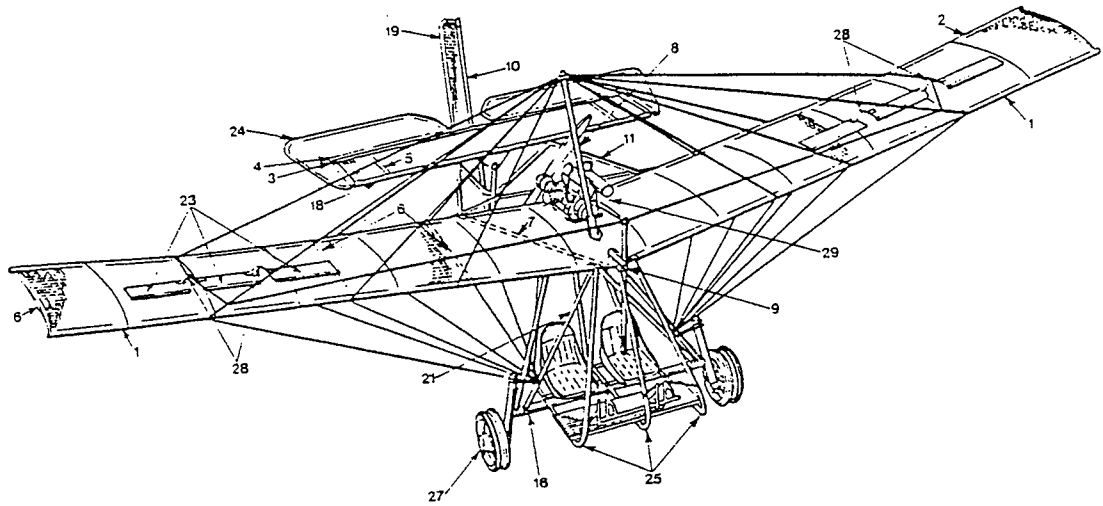
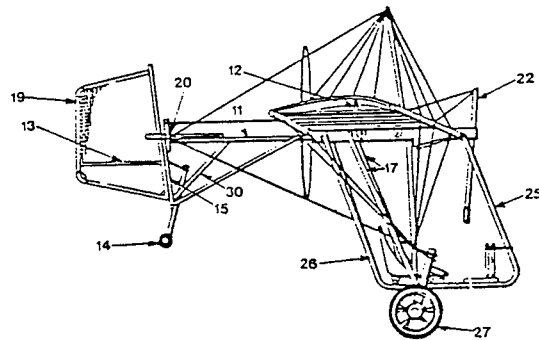
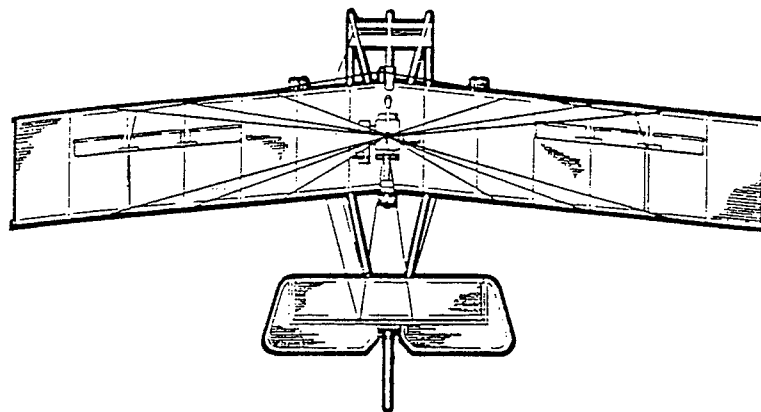
# Diagram 1

**ZK - WAC  
ROTEC RALLY - GENERAL ARRANGEMENT**
