AIRCRAFT ACCIDENT REPORT

No. 91-012

Gardan GY20 "Minicab"

ZK-DAG

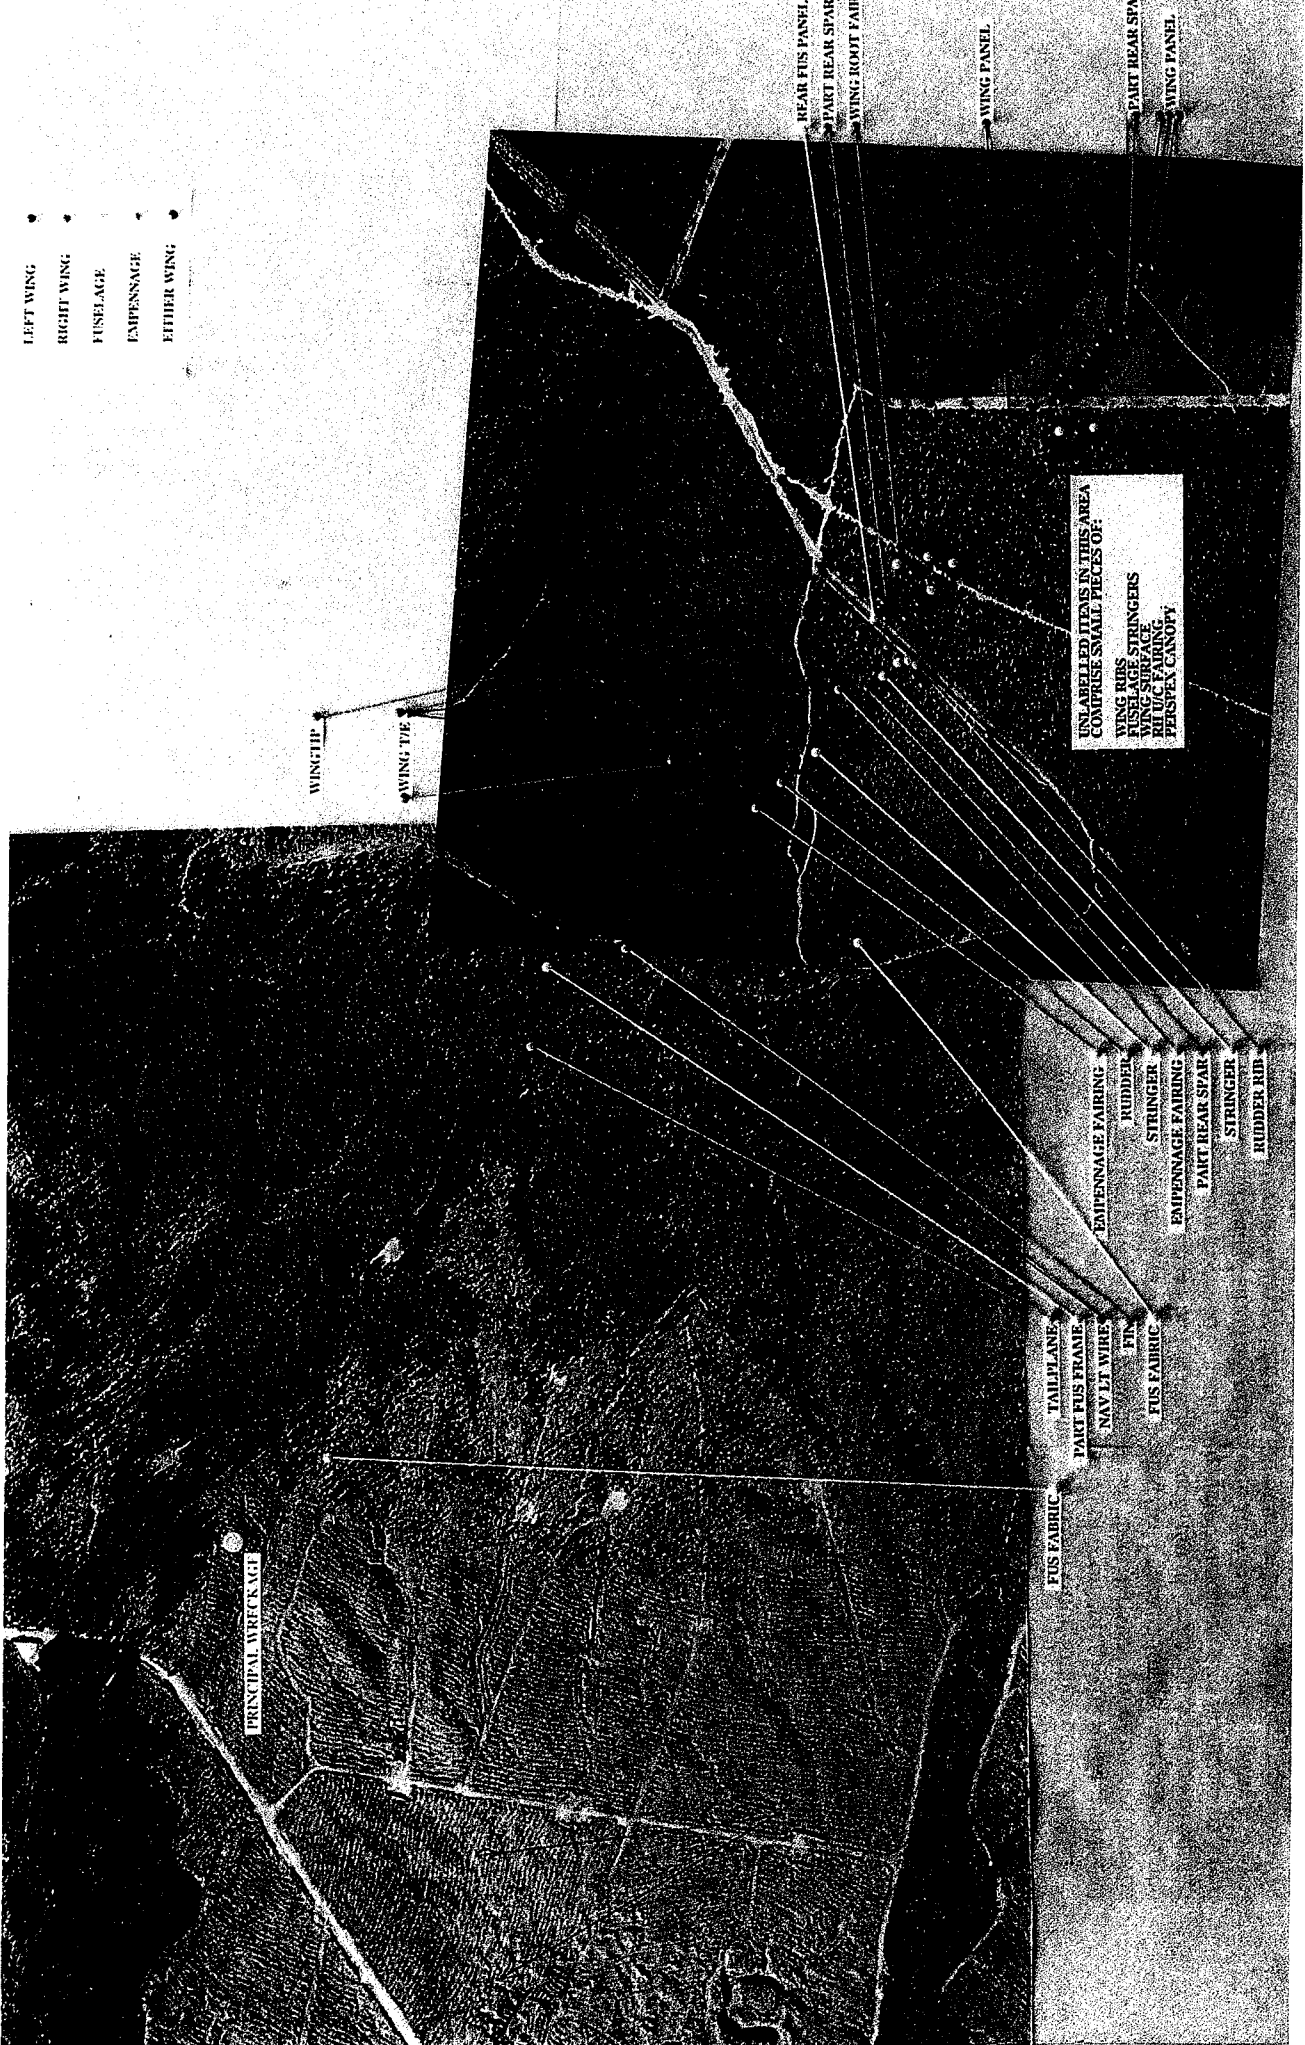
Diagram 1

1.12.2 The wreckage trail is illustrated at Diagram 1. The tailplane and elevators, apparently intact, lay about 1 km to the south-east of the principal wreckage, while the fin and rudder were found further down the wreckage trail. Thereafter the trail comprised smaller items, some as small as 2 cm square, and in general progressively lighter with increasing distance from the principal wreckage. For the most part of the trail lay through mature pine forest, but the far end stopped at a tract of native forest which was too dense for a search on foot. The trail lay on a heading of 150°T from the principal wreckage and was 2.5 km in length.

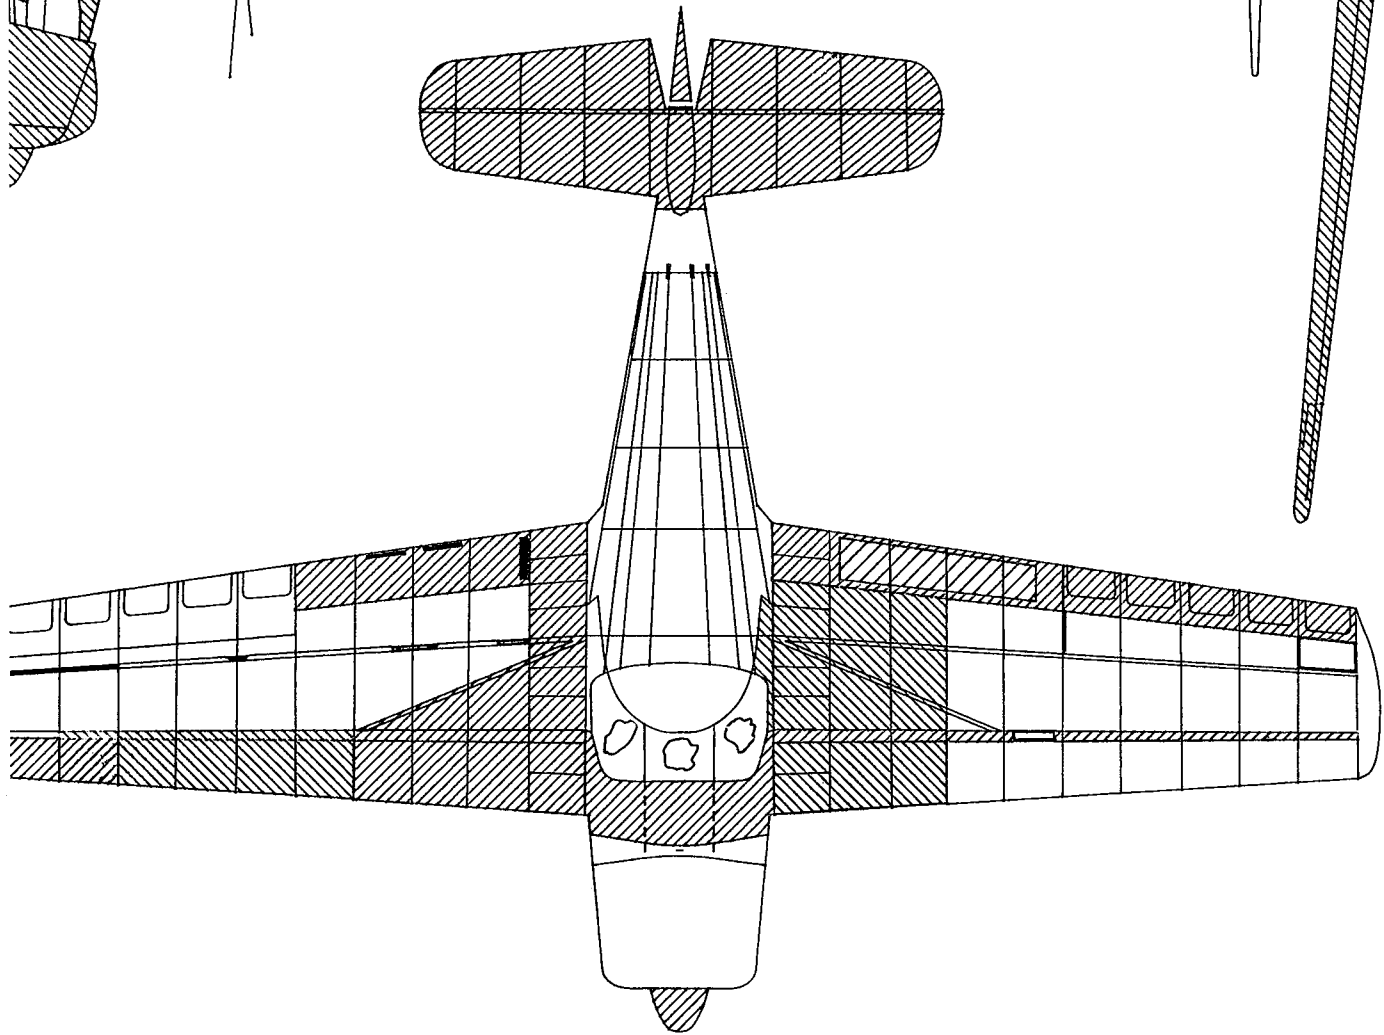
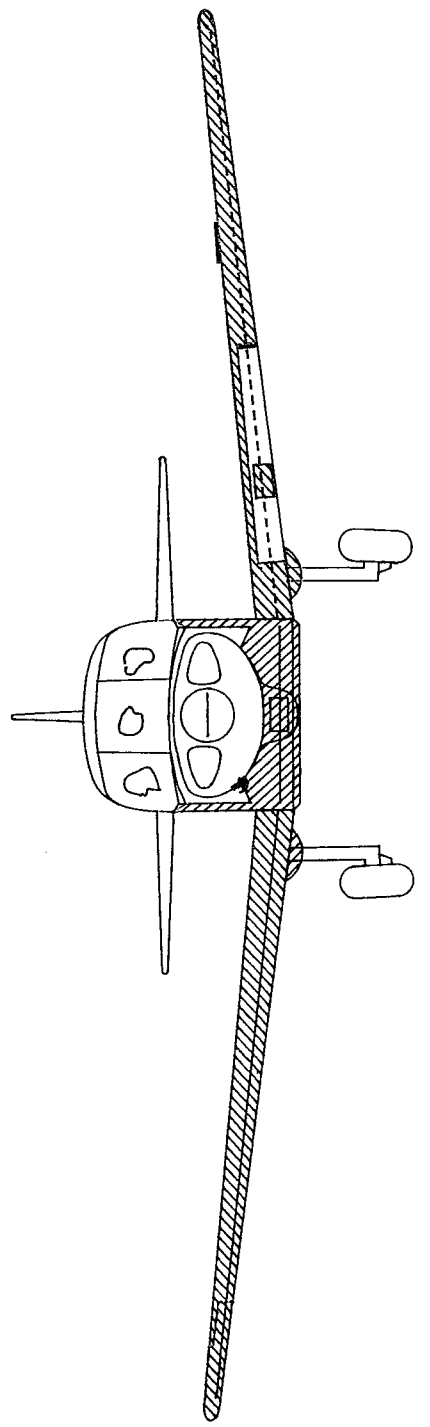
Diagram 2

1.12.4 The extent of the reconstruction of the aircraft is shown at diagram 2. This reconstruction enabled the individual parts found along the wreckage trail to be identified. It is evident that not all the wreckage was recovered. The small size of some of the pieces recovered suggests that significant items were unlikely to have been missed during the search of the pine forest (which involved some 50 searchers): it seems probable that the remaining pieces fell into the native forest beyond.

1.12.5 Examination of the reconstructed wreckage disclosed many glue failures. The nature of these failures varied, but they were due to a number of deficiencies in constructional technique. These were the subject of detailed recommendations to the Amateur Aircraft Constructors' Association. (See Annex A). The principal regions of defective gluing were:

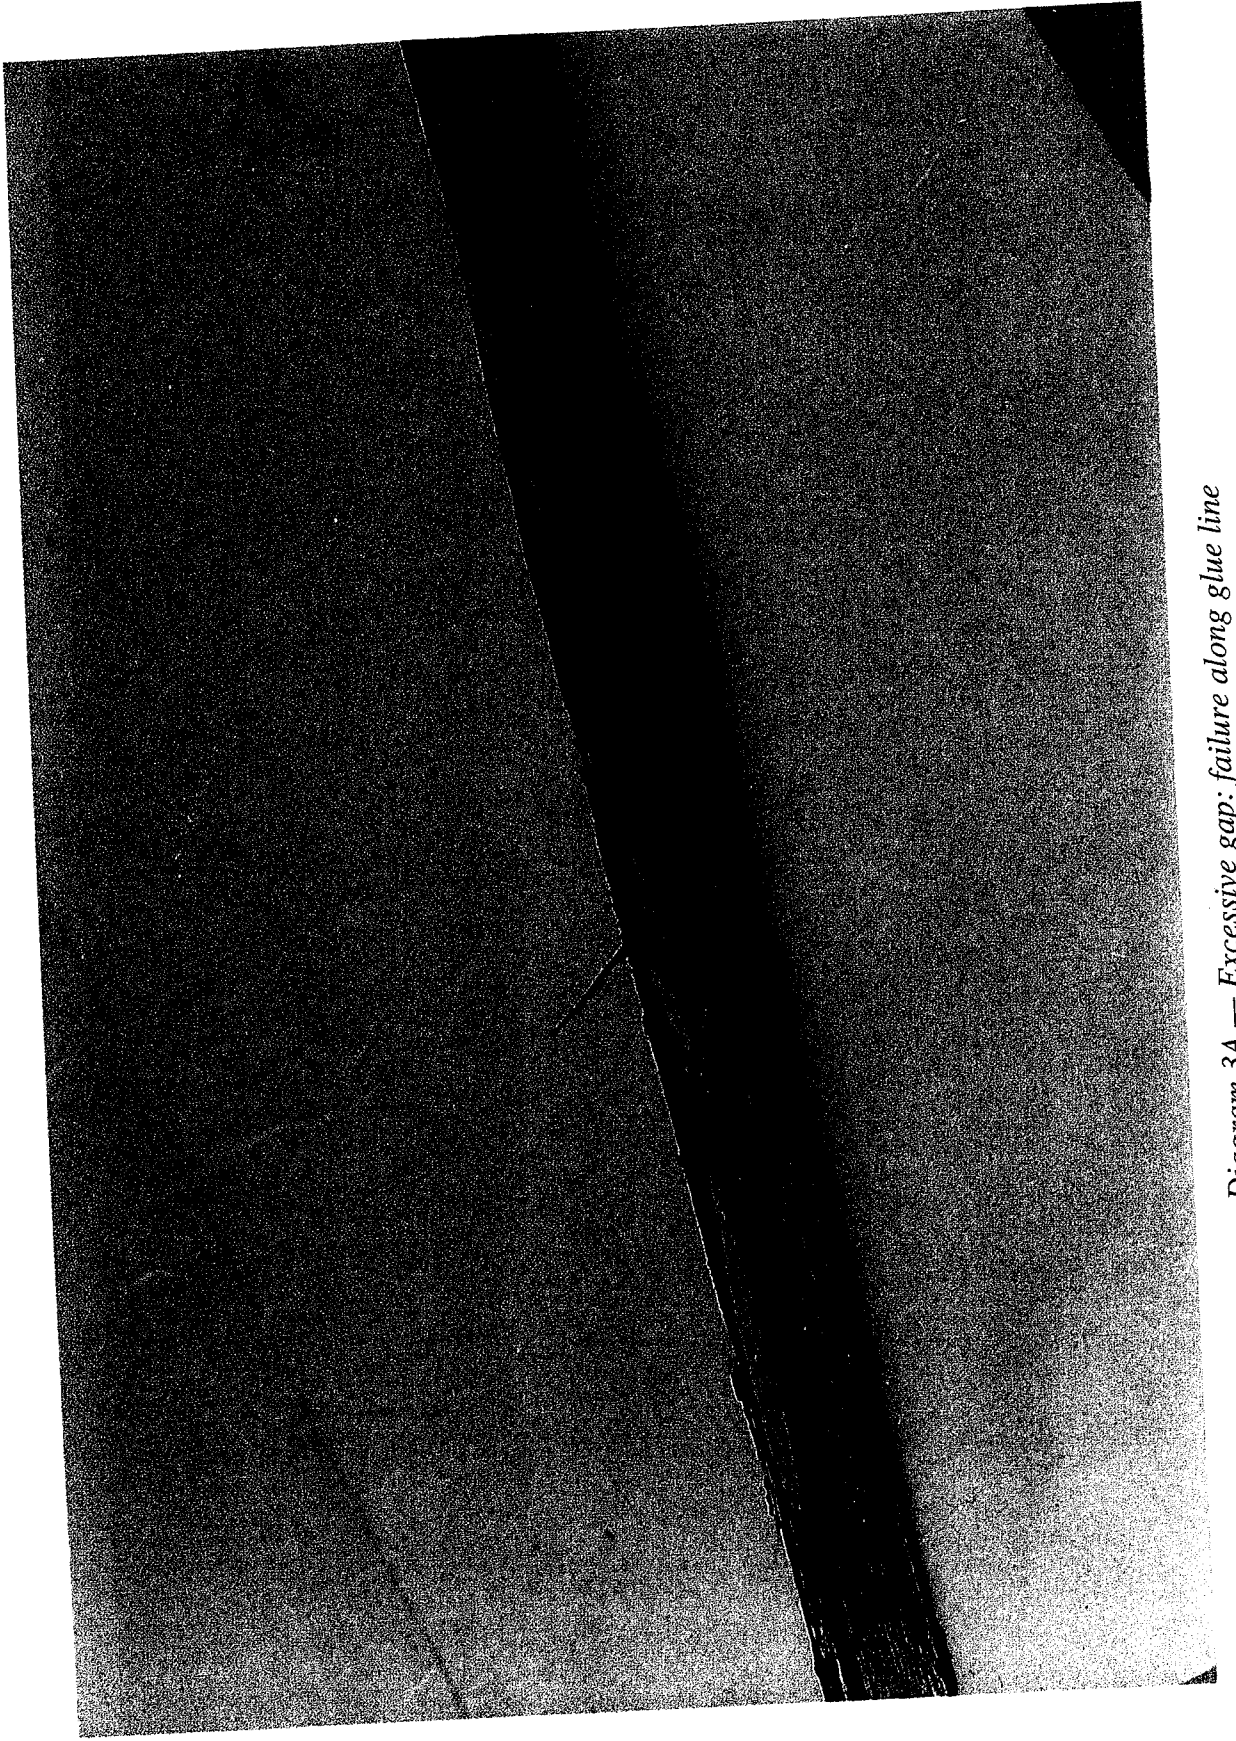
Diagram 3A — Excessive gap: failure along glue line

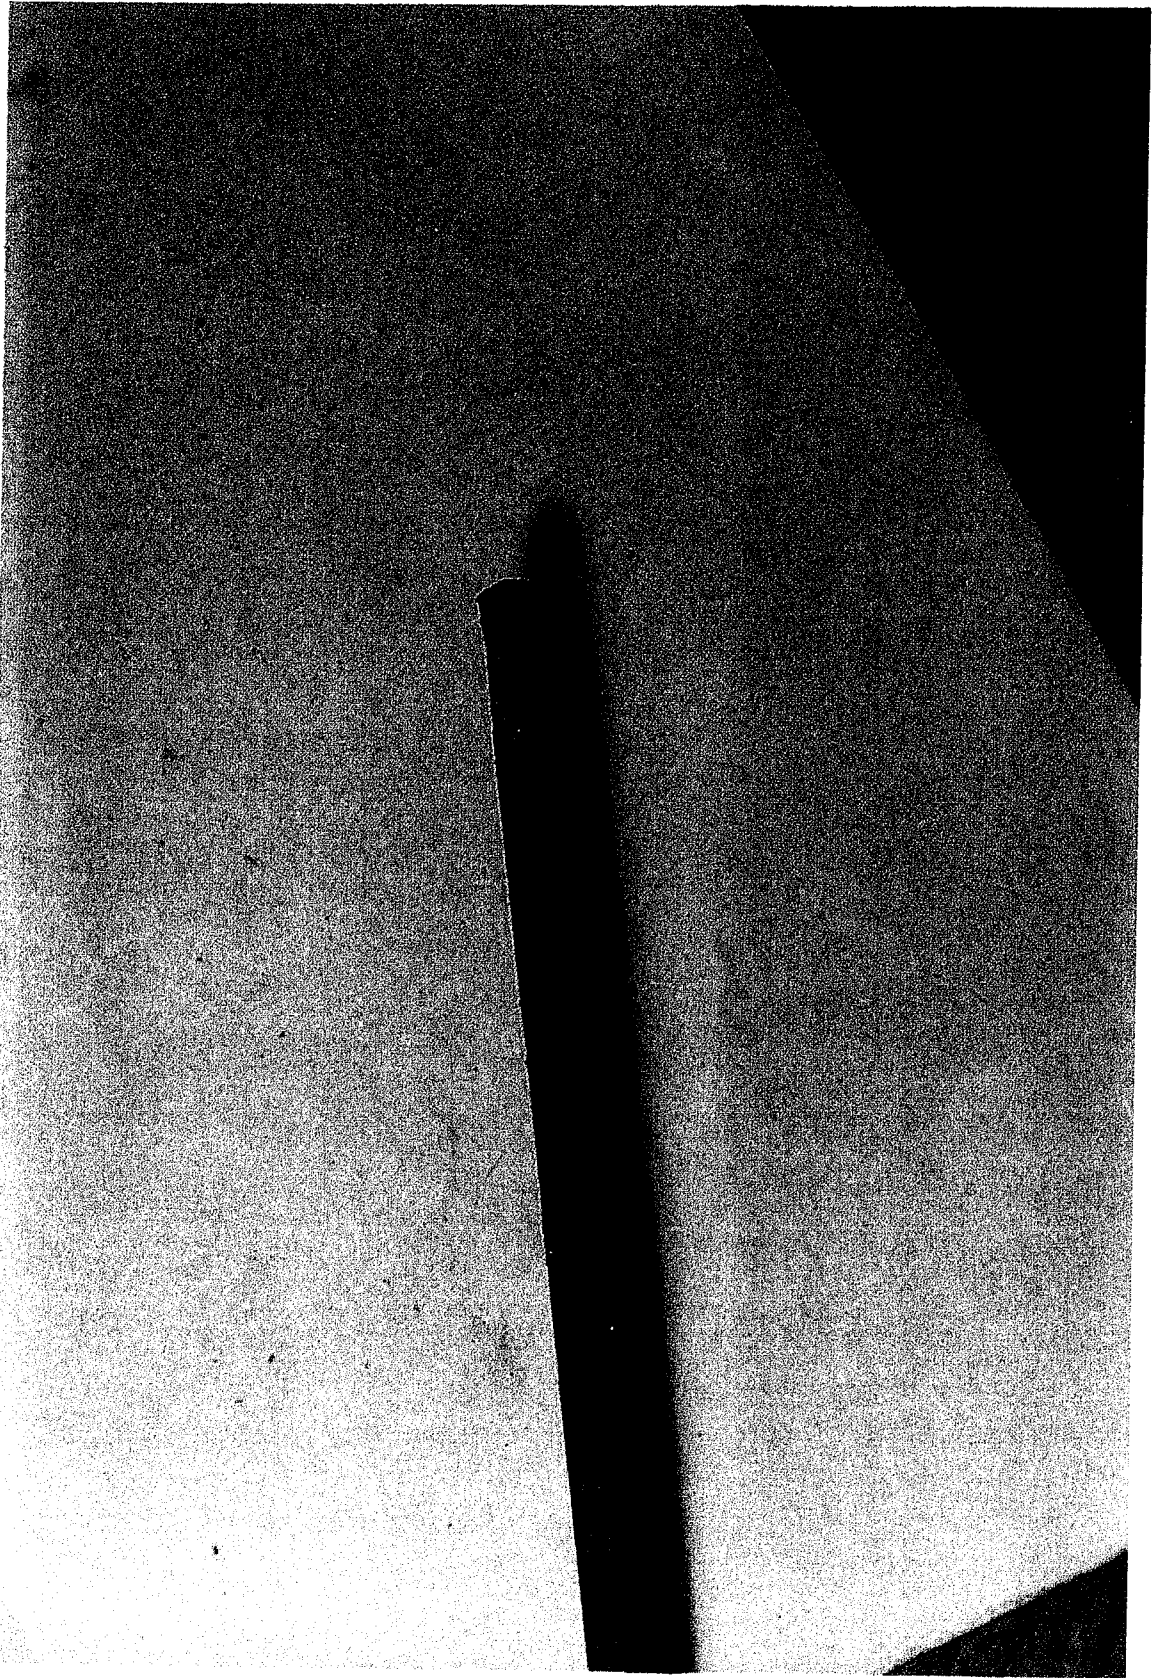
Diagram A4 — Overcramping of Aerodux

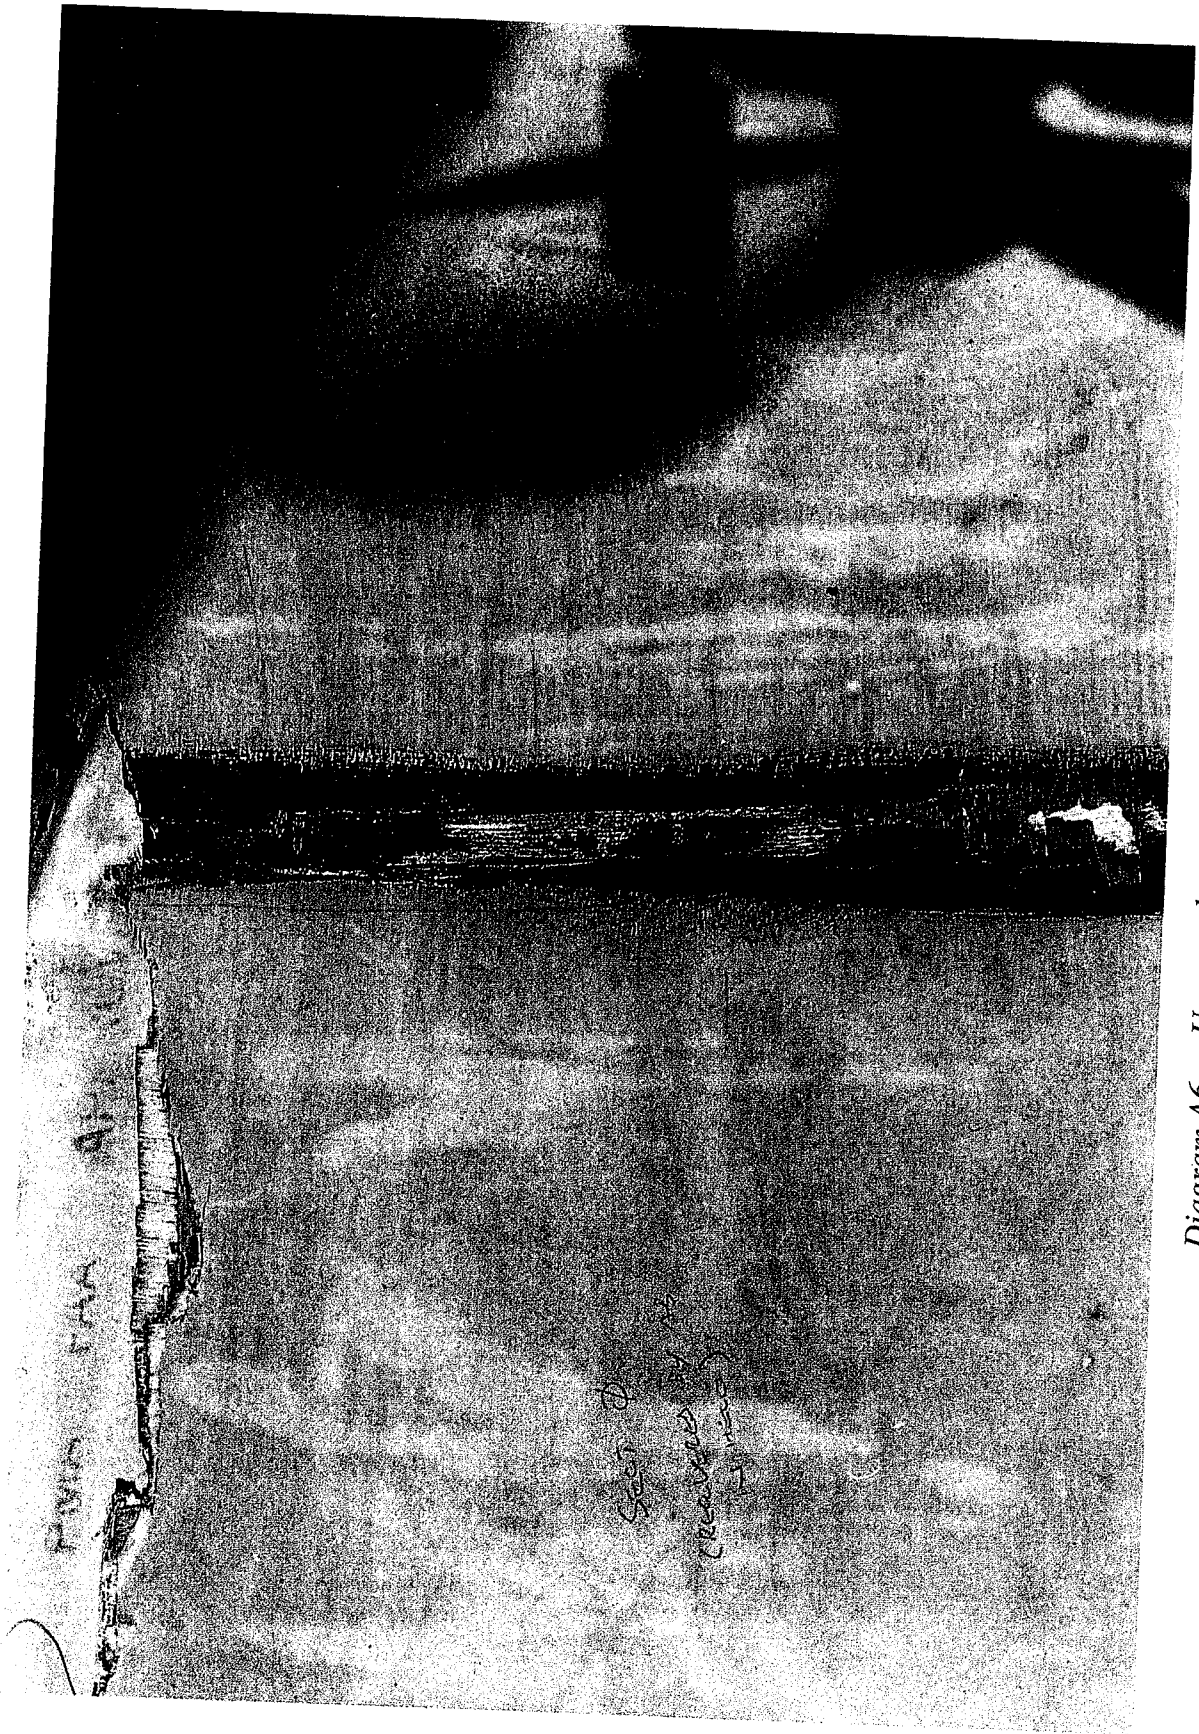
Diagram A6 — Uneven glue application by brushing

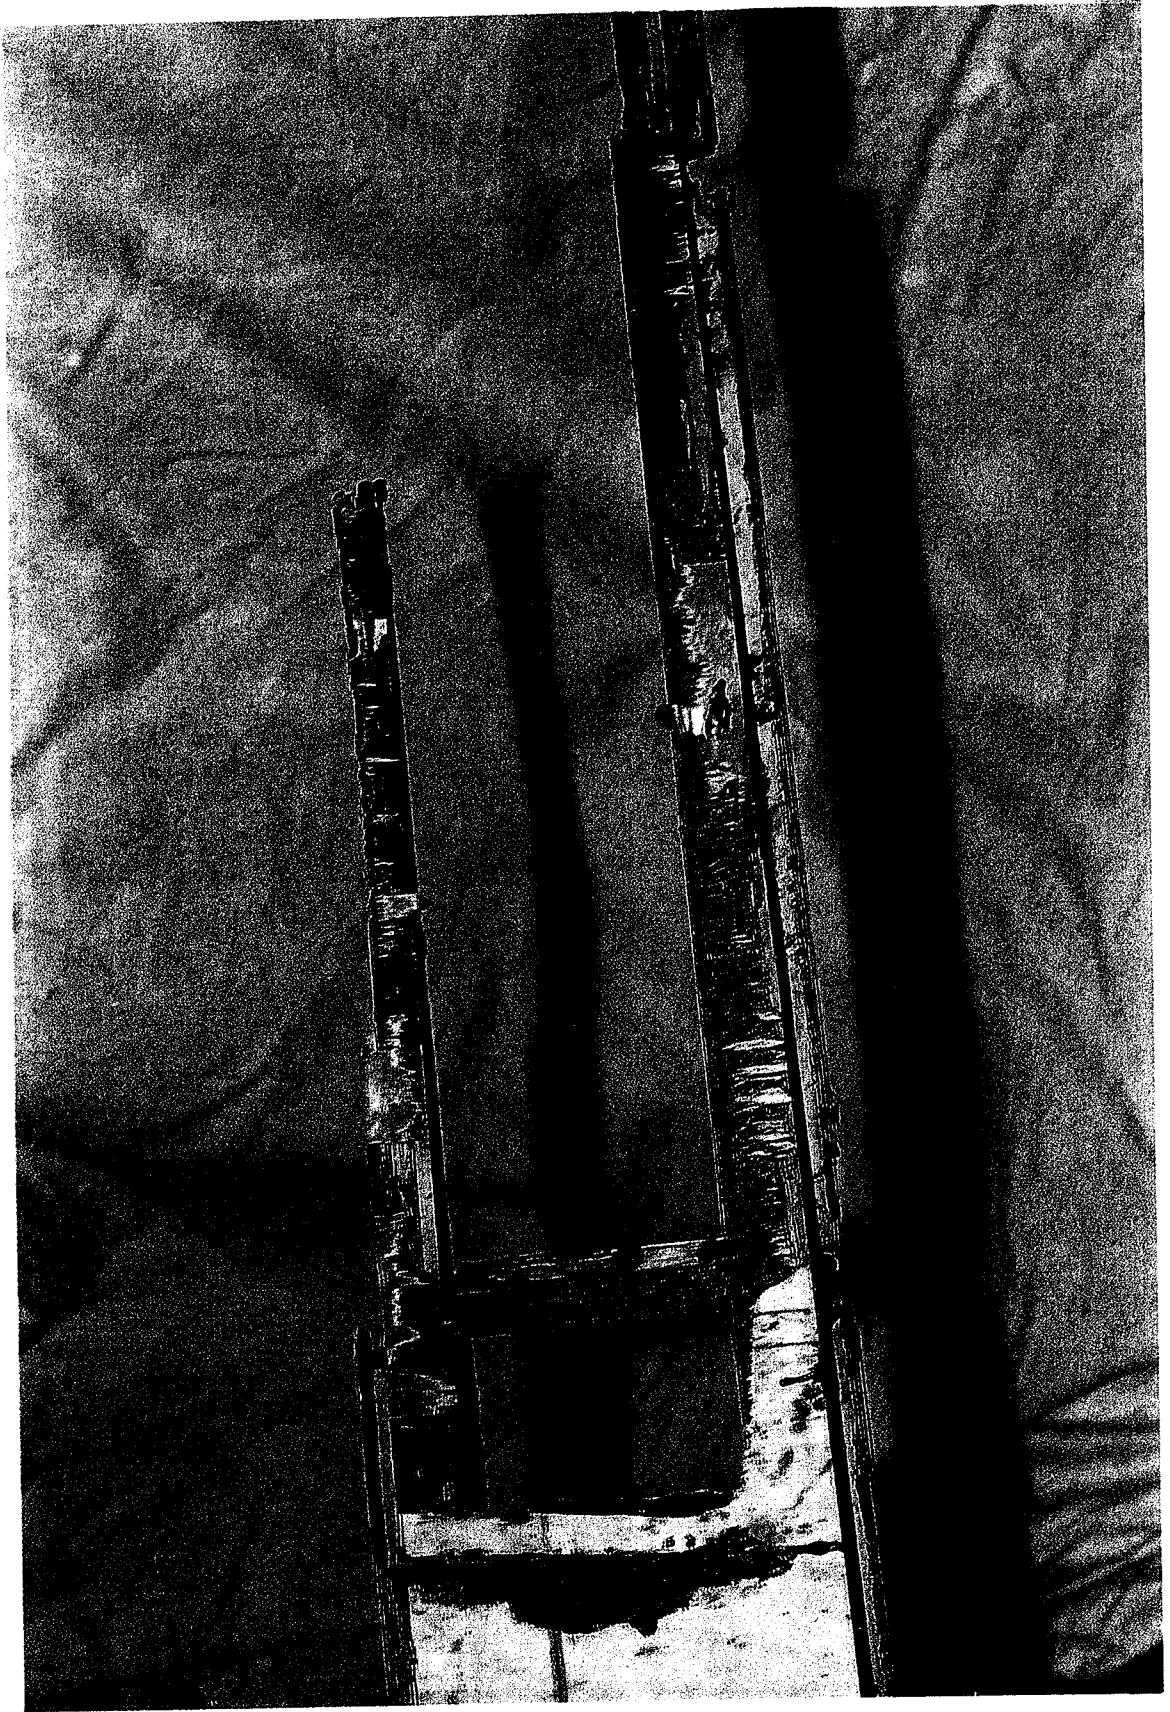
application of glue. Failure to do so will result in an apparently sound joint, but when the joint is broken it will be found that only a few fibres of the wood adhere to the glue line. (See photograph 7).

Diagram A7 — Result of inadequate preparation of plywood

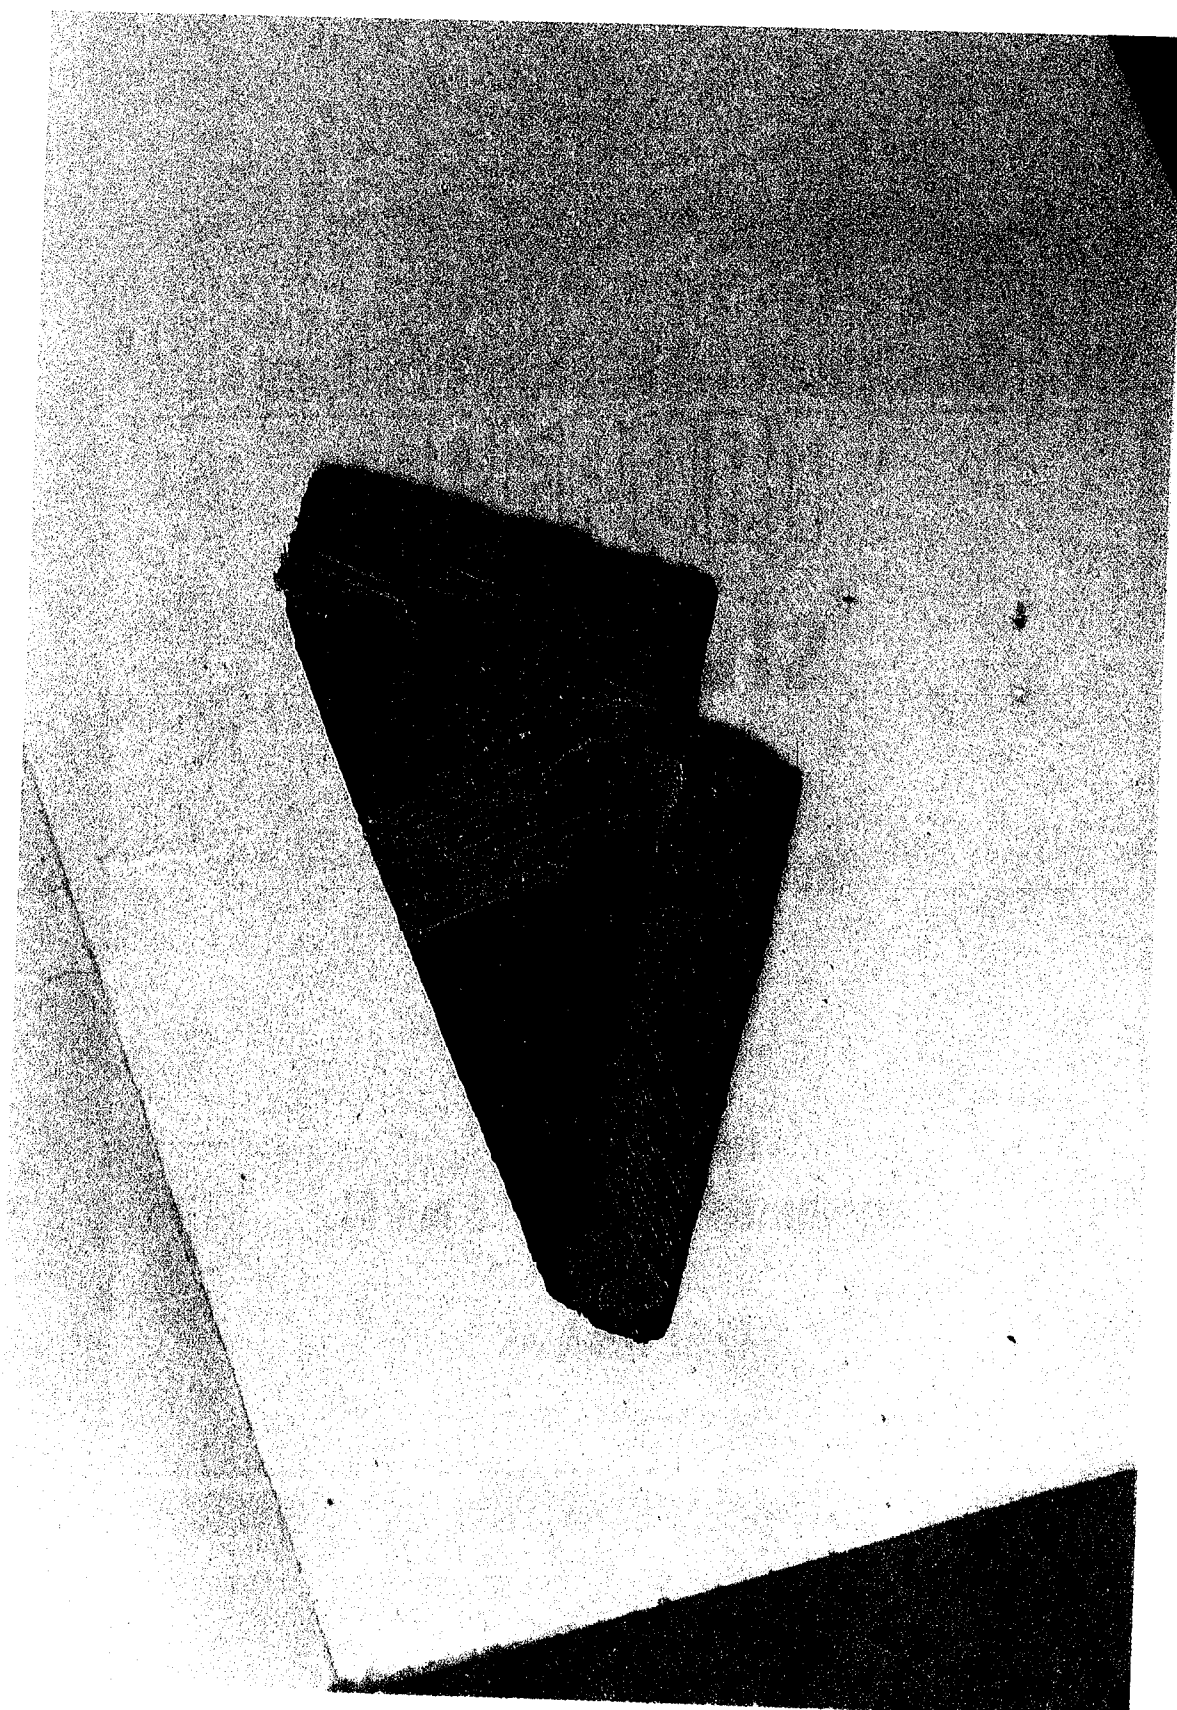
9. When test pieces are broken, the failure should be in the wood, not the glue-line. In the case of plywood, the first veneer should break away. There should be 75% wood break away on a test piece. (See photograph 8). Given the state of the glue joints on ZK-DAG, it is difficult to imagine that test pieces broke with satisfactory results. There should be a stipulation as to when test pieces are required and the existing requirement that they should have to be retained for inspection should be continued when authority for inspection is transferred to the AACA.

Diagram A8 — Satisfactory gluing: 75% wood breakage
