AIRCRAFT ACCIDENT REPORT

No. 91-015

CESSNA 207 ZK-DXG

Mt Tarawera Airstrip

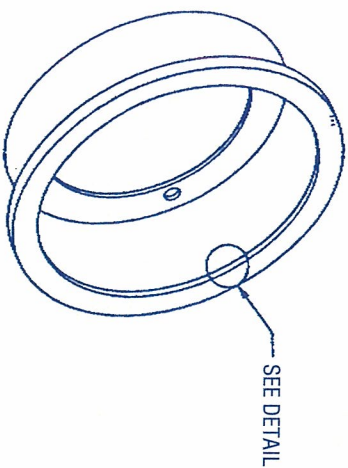
1.1.24 On this occasion the left hand brake unit failed from the same cause.

CLEVELAND DISC BRAKE ASSEMBLIES
Cleveland wheel assemblies P/N 40- series with disc assemblies P/N 164- series installed on, but not limited to, Beech, Bellanca, Cessna, Piper, Maule and Mooney single engined aircraft.

This recommendation is made as a result of an accident involving a Cessna 185 on 1 November 1988. Defect 88-153 (CAIC-AIR 4, February 1989) and Air Accident Brief 88-089 refer.

2.7 The brake unit's disc assembly had been weakened due to corrosion.

To prevent failure of brake disc assembly and possible loss of aircraft control when landing or ground manoeuvring it is strongly recommended that the following is accomplished at intervals not exceeding twelve months:

Remove wheels from aircraft and thoroughly clean and inspect disc assembly in area of the disc to hub weld. It may be necessary to remove assembly from the wheel to adequately inspect. Remove corroded or defective assemblies from service before further flight.
