AIRCRAFT ACCIDENT REPORT

No. 92-007

Pterodactyl Ascender II + 2

ZK-FKF

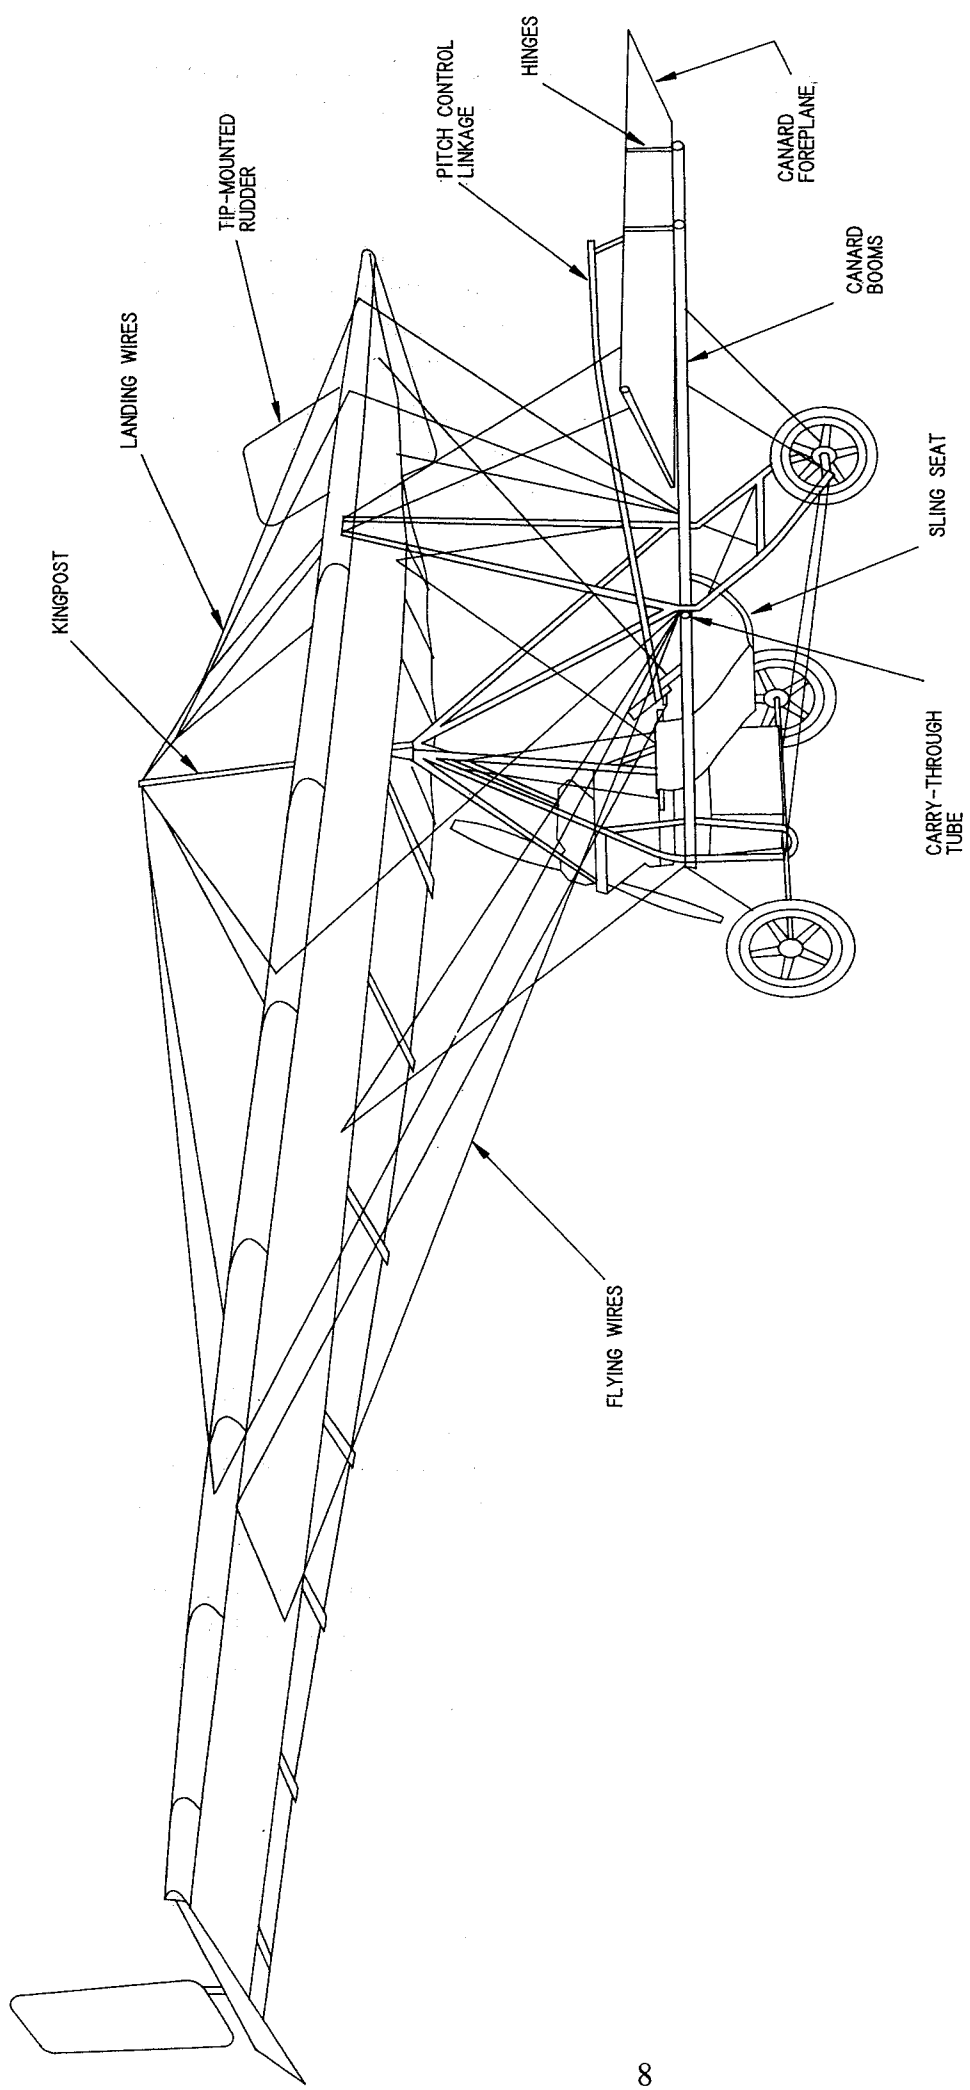
PTERODACTYL ASCENDER II+ - GENERAL ARRANGEMENT DIAGRAM 2
 (SINGLE SEAT VARIANT)

1.12.2 The right wing had broken upwards at the inboard compression strut; the left wing was essentially intact. The canard booms had fractured at the forward carry-through (see diagram 2) and the canard itself was broken in a number of places.

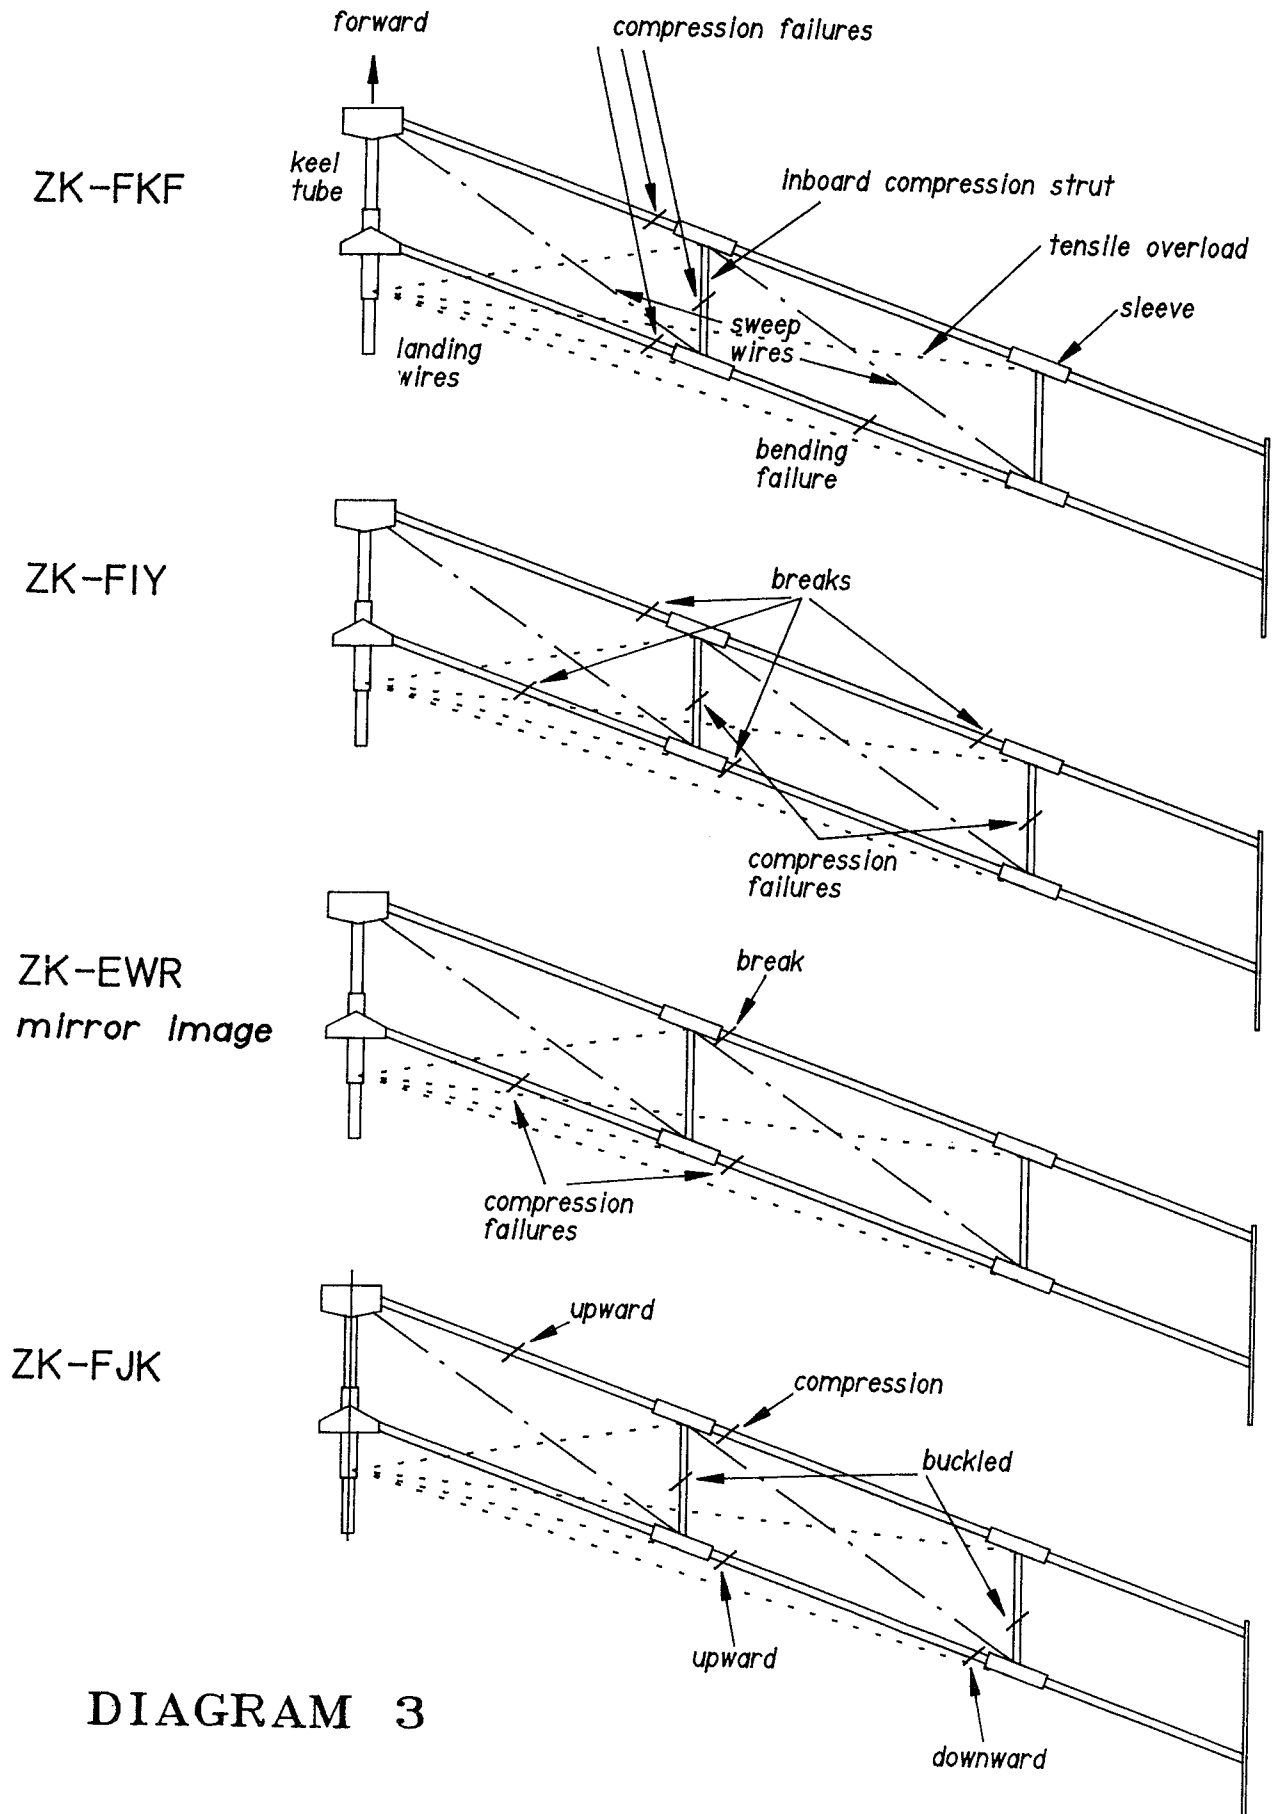
DIAGRAM 3

1.17.5 The wing failures in the New Zealand accidents are shown at Diagram 3. The similarity in the break-up patterns is evident, with breaks in the vicinity of the inboard compression struts, and compression damage to one or both struts. While the exact nature of all the failures was not documented, leading edge compression failures were identified in the cases of ZK-FJK and ZK-FKF. The leading edge broke in the vicinity of the inboard compression strut in every case; so did the trailing edge, and in each case there was an additional break in the trailing edge. Although each accident had a different cause factor attributed to it, it appeared that these might be triggering elements with a similar underlying cause. The video recordings were therefore examined in detail.

2.6.1 The break-up patterns of Ascenders the wings of which have failed in flight in New Zealand (except ZK-FCB, which was not documented) are shown in Diagram 3. The similarities, in terms of breaks in the vicinity of the inboard compression struts, are marked. Where the types of breaks were documented, there were compression failures including leading-edge compression failures. Although different triggering elements were considered likely in each case, in essence these were all the same accident. The only mechanism identified that could produce a leading-edge compression was flutter; in view of the similarity of the break-up patterns it was probable that they all experienced flutter.
