# AIRCRAFT ACCIDENT REPORT

**AIRMISS INCIDENT**

**Boeing 737-200 ZK-NAZ**

**Piper PA38 ZK-PAH**

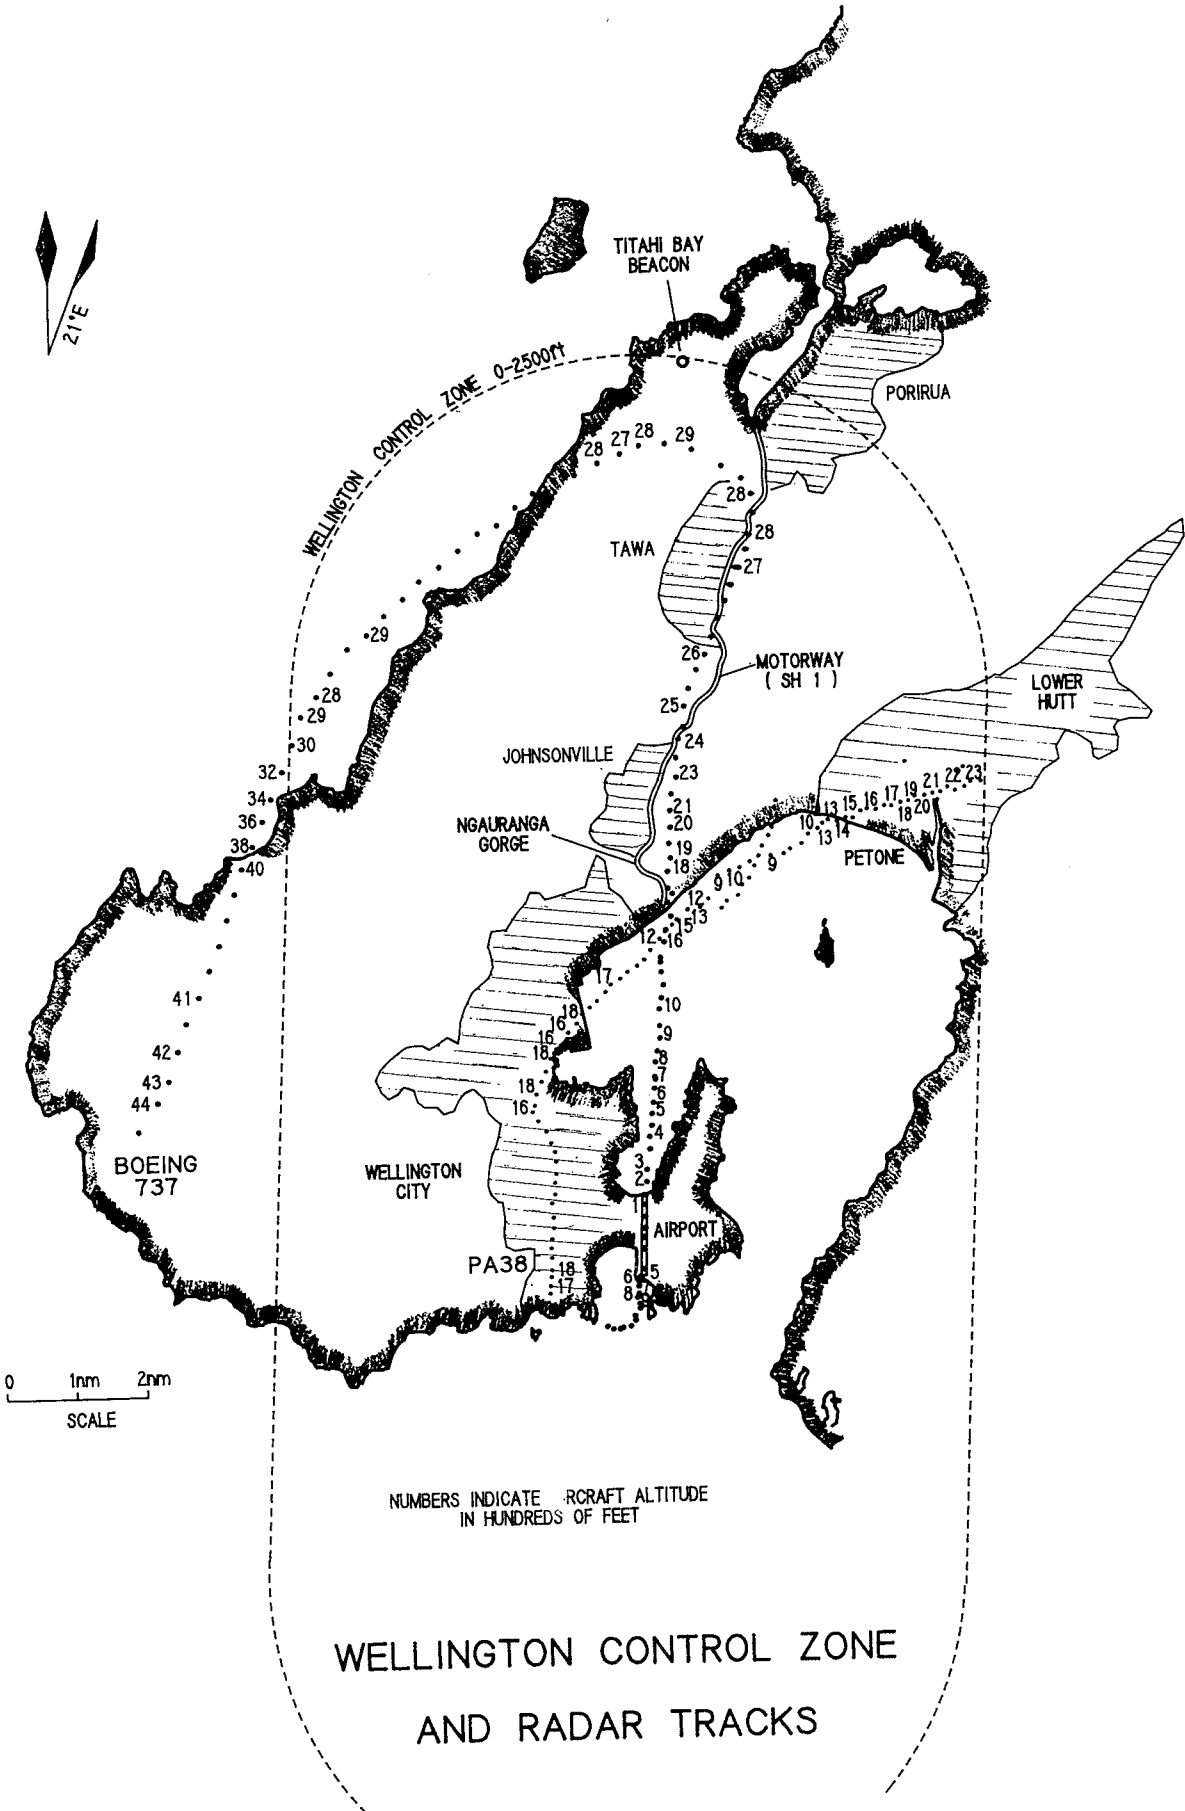
WELLINGTON CONTROL ZONE AND RADAR TRACKS

1.2.2 While NZ410 was on its downwind leg towards Titahi Bay, ZK-PAH had flown towards Ngauranga (see Diagram 1). NZ410 turned short of the Titahi Bay NDB, and joined the ILS approach path so that the ILS could be used to monitor the visual approach. Meanwhile ZK-PAH asked for and was given clearance to proceed to Petone.

1.8.4 The radar tracks of the two aircraft are shown, superimposed on a map of Wellington, at Diagram 1, while an enlargement showing the details of the airmiss, is shown at Diagram 2.

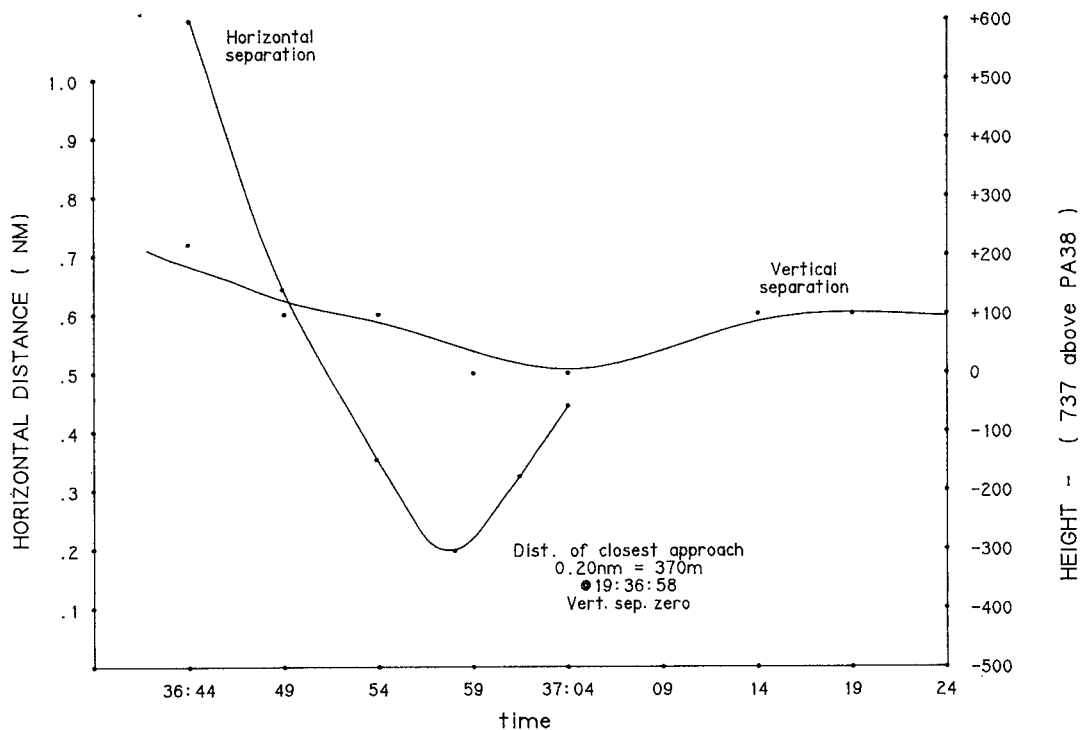
MISS DISTANCE DIAGRAM 3

2.1.1 The PA38 crossed the B737’s projected flight path at 1936:49; at that time the PA38 was 100 feet below the B737, which was at 1600 feet. The B737 was 0.6 nm from the cross-over point and this distance represented 8 seconds at the combined closing speed of the two aircraft. The point of closest approach was found to occur at 1936:58. The horizontal passing distance was recorded as 0.20 nm (370 m); the semi-spans of the B737 and PA38 totalled 20 m so the separation was about 350 m. Both aircraft were then at about the same height. A plot of vertical and horizontal separation against time is shown at Diagram 3.
