AIRCRAFT ACCIDENT REPORT

No. 92-012

Cessna 177B

Great Barrier Aerodrome

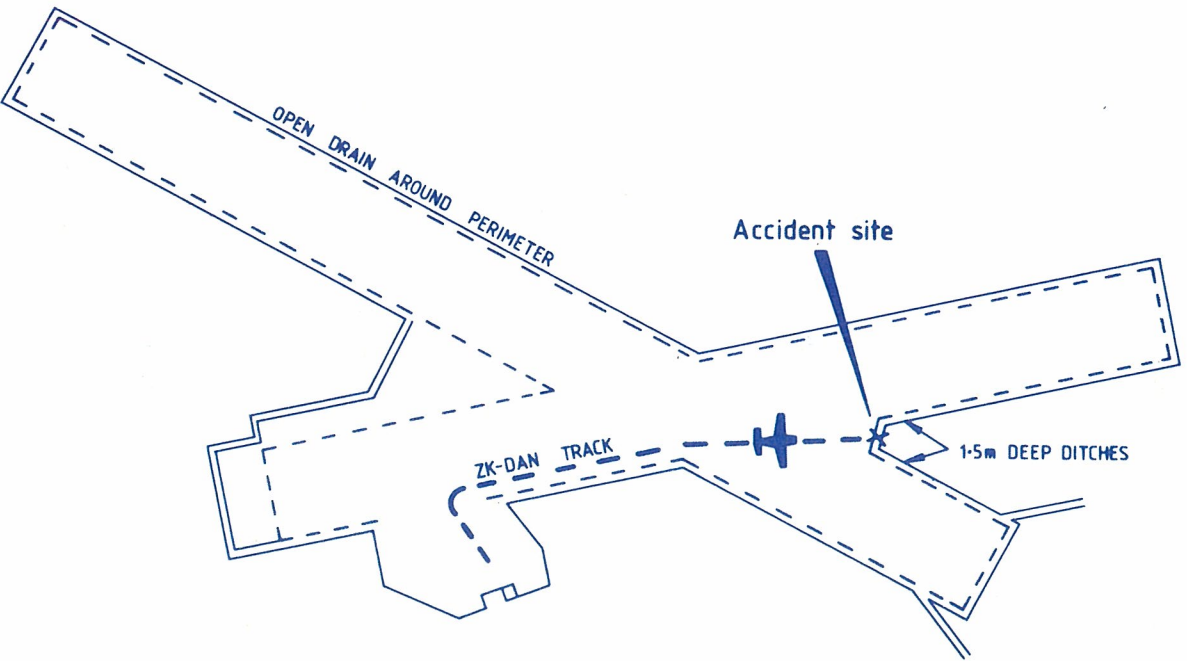
Diagram 1

1.5 As the aircraft crossed the area formed by the intersection with runway 10/28 the aircraft tracked to the right towards a 1.5m deep drainage ditch at right angles to its path. The pilot's first indication of this was the appearance of one of the tyres marking the runway intersection in an unexpected position relative to the aircraft. As soon as she sighted this tyre she braked the aircraft and applied left rudder in an attempt to turn it to the left but it did not change direction and continued into the ditch.
