AIRCRAFT ACCIDENT REPORT

No. 92-017

Thorp T-18

ZK-KID

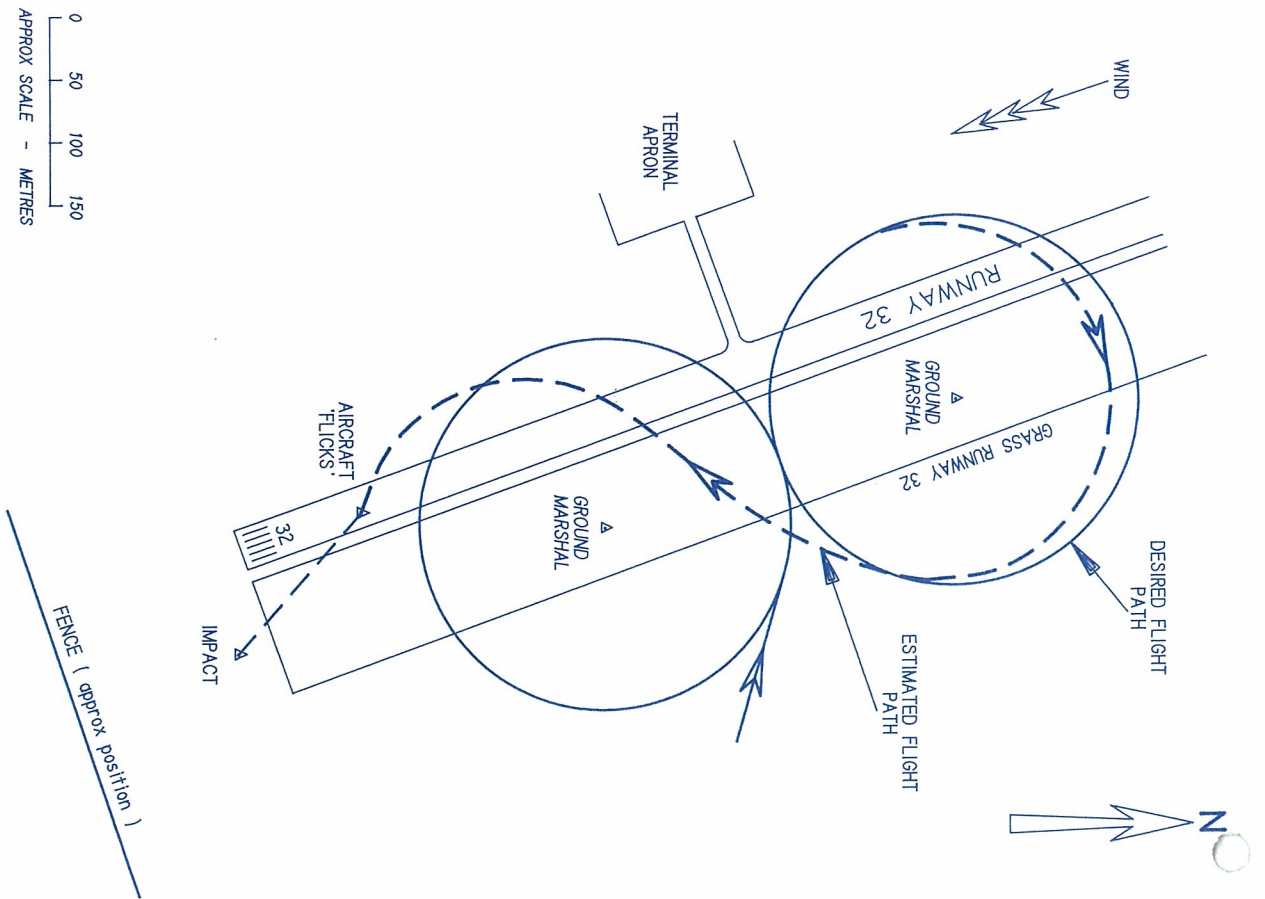
ZK-KID : FIGURE 8 MANOEUVRE

1.8 ZK-KID was taxied out, and after an engine run-up and pre-take-off checks had been completed, was observed to take off without difficulty and climb to 500 feet to carry out the set manoeuvres. The first circuit and into-wind run along the runway edge appeared to be performed normally, after which the aircraft was positioned for the figure-of-eight pattern. The first, or northernmost, half of the manoeuvre was flown to the right, and the direction of turn was reversed at the centre point to fly the second half to the left.

1.9 One witness, a commercial aeroplane and helicopter pilot, observed that the aircraft drifted noticeably during the first half of the eight, and by the time it reached the crossover position, it had drifted "well downwind". As the aircraft was part way round the second lobe of the eight, it appeared to lose height as it turned from a downwind heading to crosswind, at a steep angle of bank. At this point, it "flicked" rapidly into an incipient spin to the right, out of the turn. The pilot appeared to arrest the spin within one rotation, but in an inverted 45° dive. The aircraft was not recovered from this attitude and struck the ground on a south-easterly heading, approximately 60 m east of the threshold of sealed runway 32.
