No 93-011

Boeing 767-200

ZK-NBF

AIRCRAFT ACCIDENT REPORT NO. 93-011

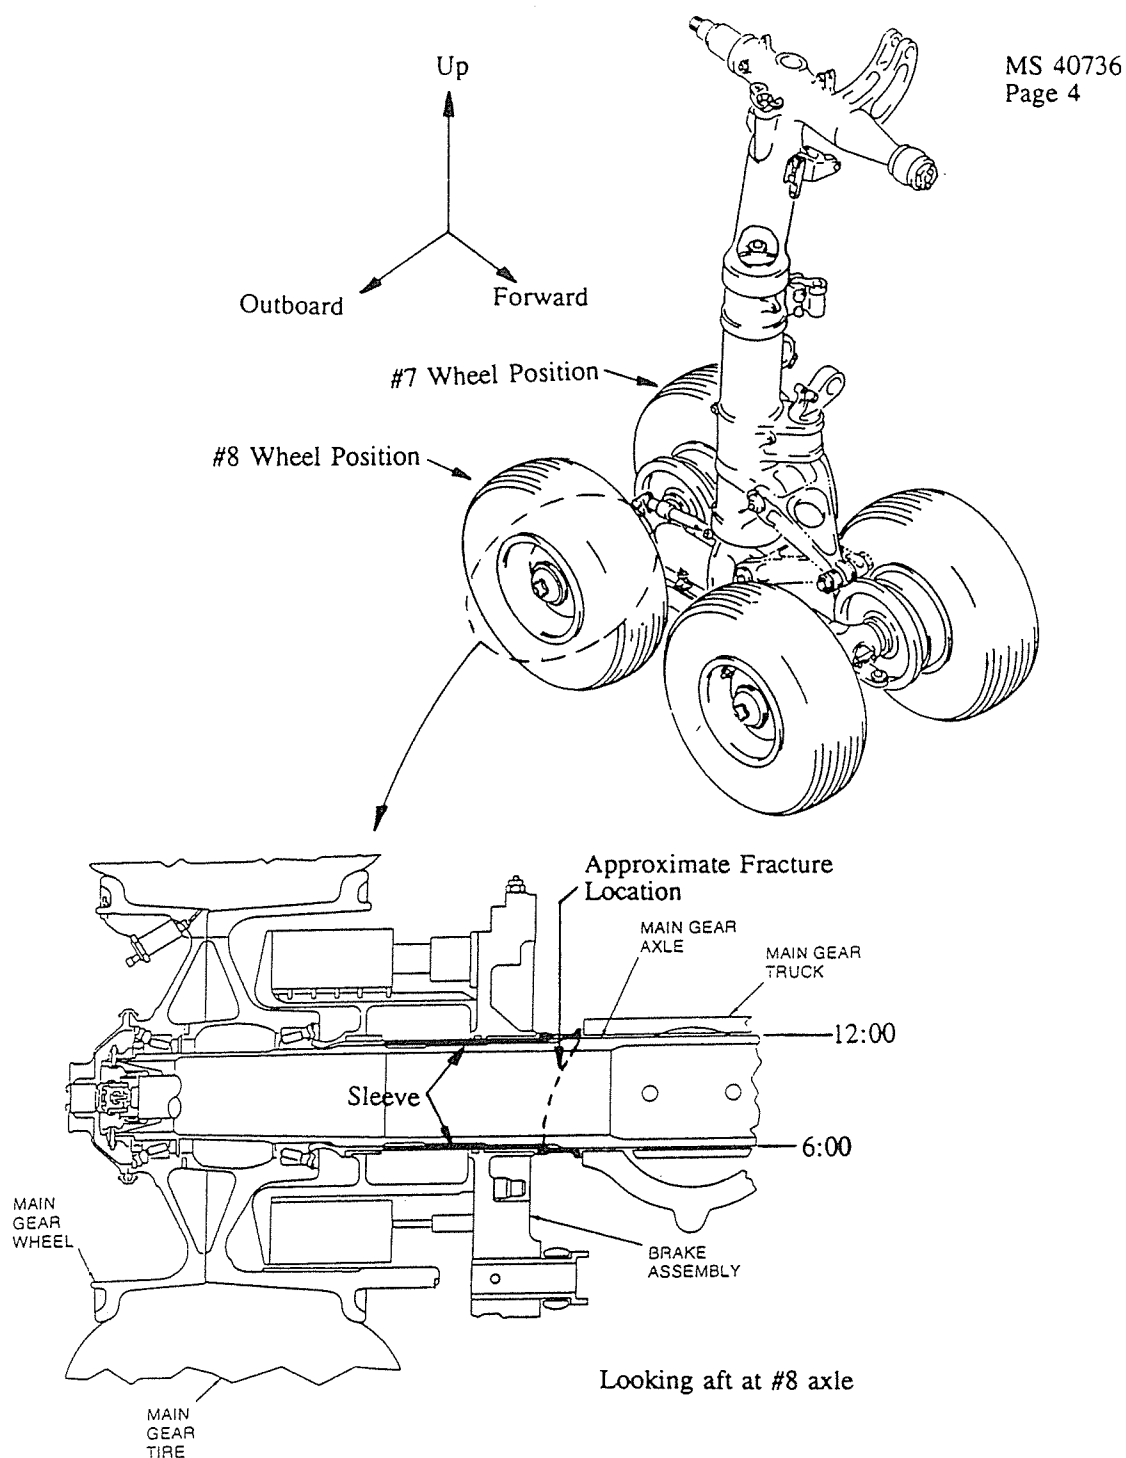
1.3 An investigation revealed that the rear axle (part number 161T1138-4, serial number CPT0166AT) of the right main undercarriage assembly (part number 161T0000-14, serial number 8154) had fractured adjacent to the rear outboard (number eight) wheel. The axle was encased in a sleeve in that area. (See Figure 1).

Figure 1: Illustrations depicting the location of the fracture through the #8 axle on the right hand main landing gear assembly of the model 767 airplane.

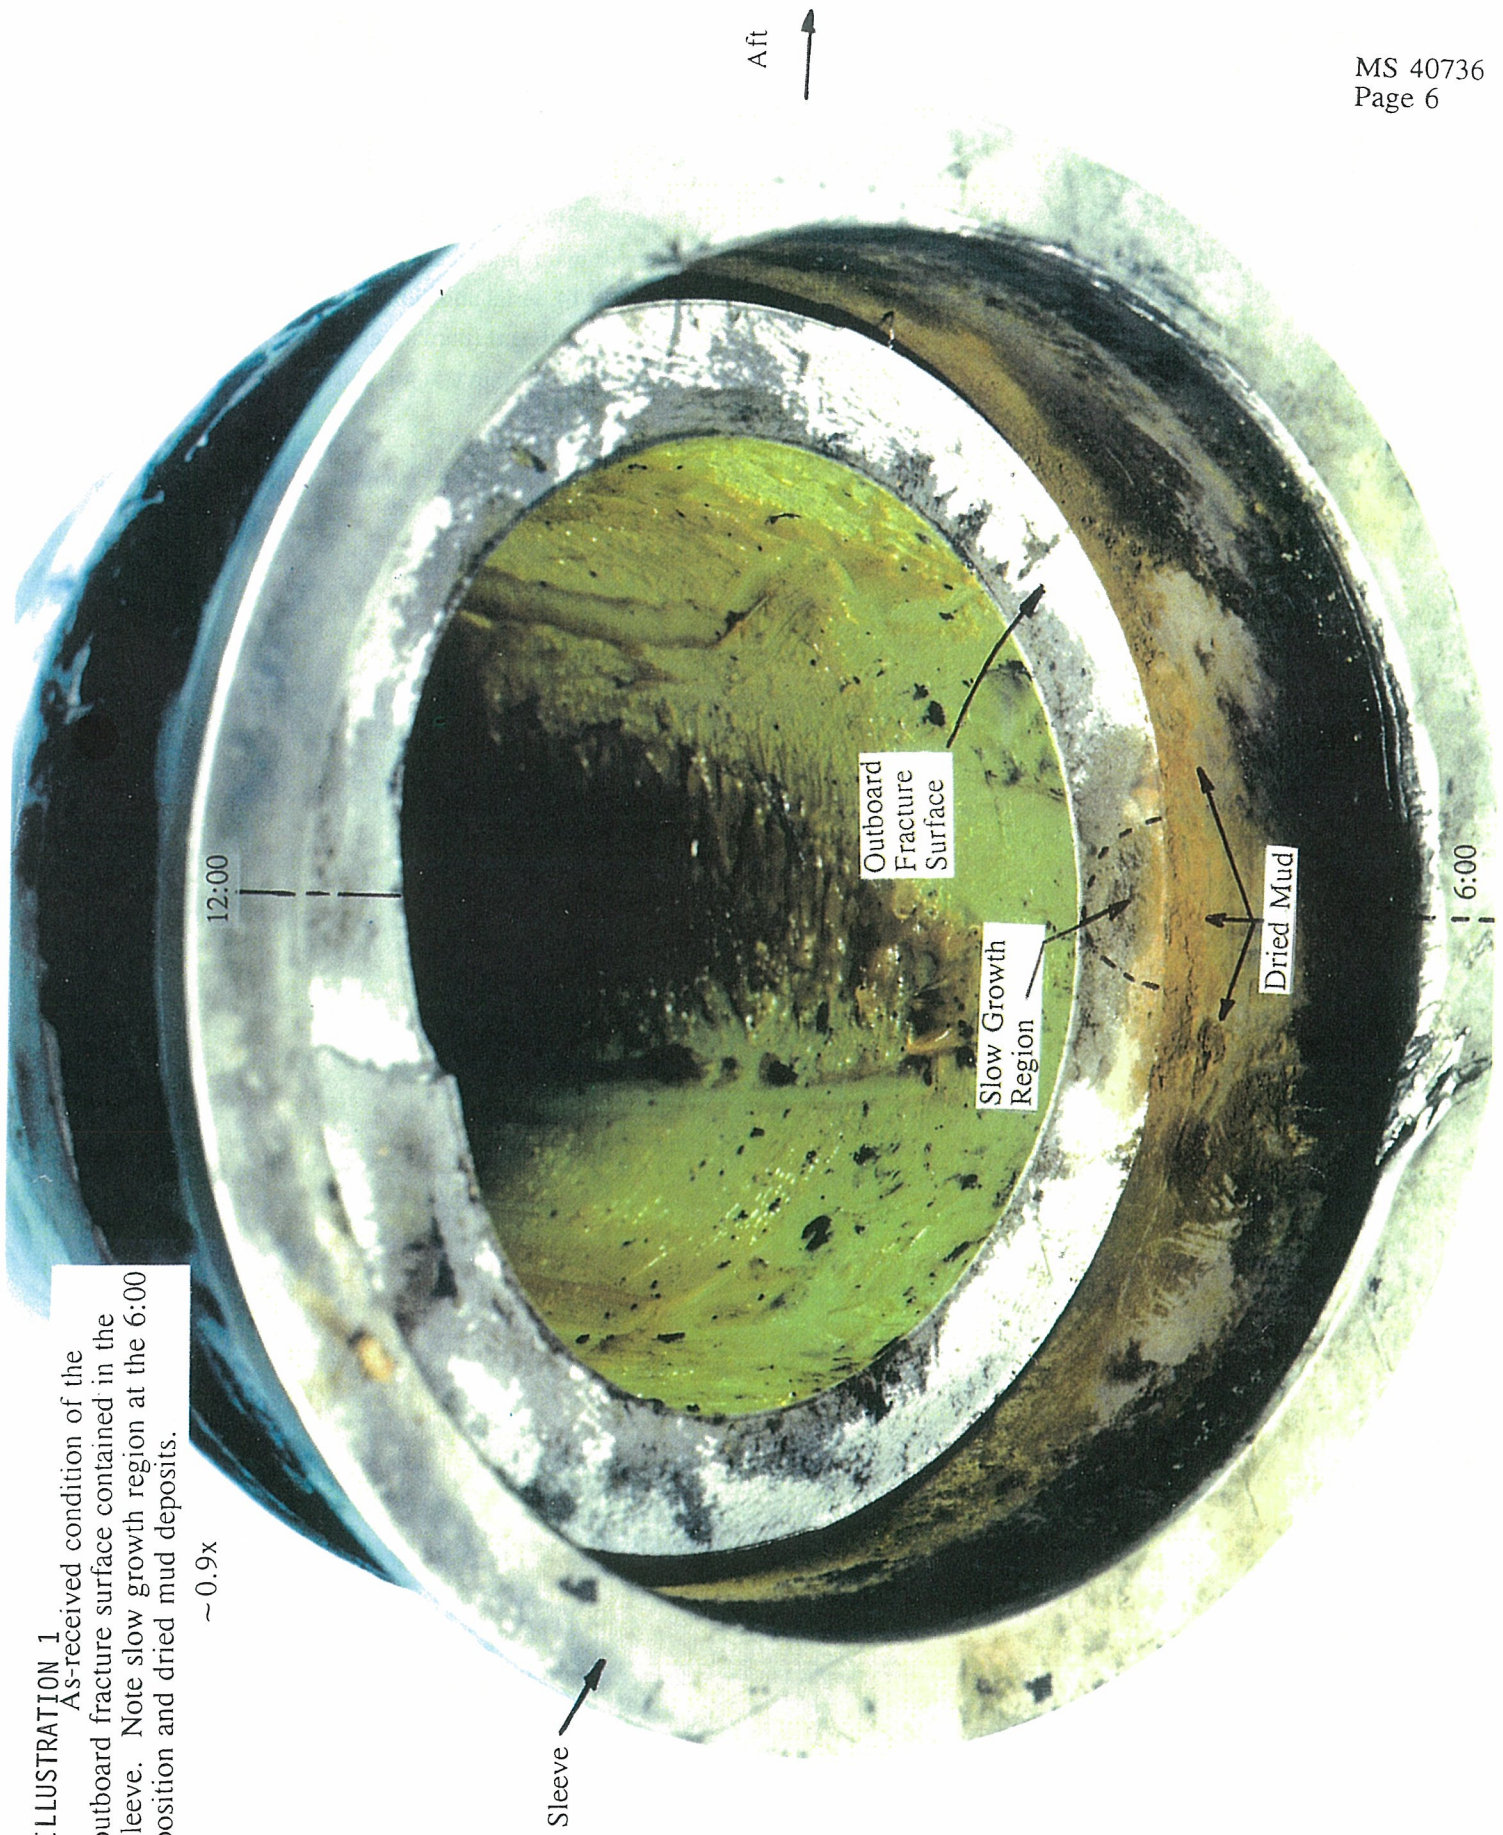
ILLUSTRATION 1
As-received condition of the outboard fracture surface contained in the sleeve. Note slow growth region at the 6:00 position and dried mud deposits.

1.7 A visual inspection of the fracture area while the assembly was in Auckland revealed that a quantity of mud had become trapped outside the axle near the point of origin of the failure and there was no apparent evidence of the protective grease which was intended to be applied to the axle in that area during the assembly of the components. (See Illustration 1).

1.8 The failure initiated from a pit in an area of corrosion on the outer face of the axle on its lower surface beneath the sleeve which surrounded it at this point.

1.13 The point of origin was in a corrosion pit adjacent to a quantity of soil and vegetable matter on the underside of the axle. This foreign matter was trapped in an annular void between the tubular axle and the sleeve fitted to the axle outwards from the point at which it emerged from the main undercarriage truck.

Review the current Maintenance Manual Inspections required for Boeing 767 undercarriage components which have been involved in "hard landings or high drag/side load landing conditions" on unprepared surfaces with a view to ensure the inspections provide for the removal of any foreign matter which may have become lodged between components of the assemblies (064/93), and

"(064/93) Maintenance Manual Chapter 05-51-01 will be revised to read, "any component (landing gear, engine nacelle, etc) which becomes immersed or buried in a contaminant (mud, salt water, etc) should be disassembled, examined and, if necessary, cleaned."

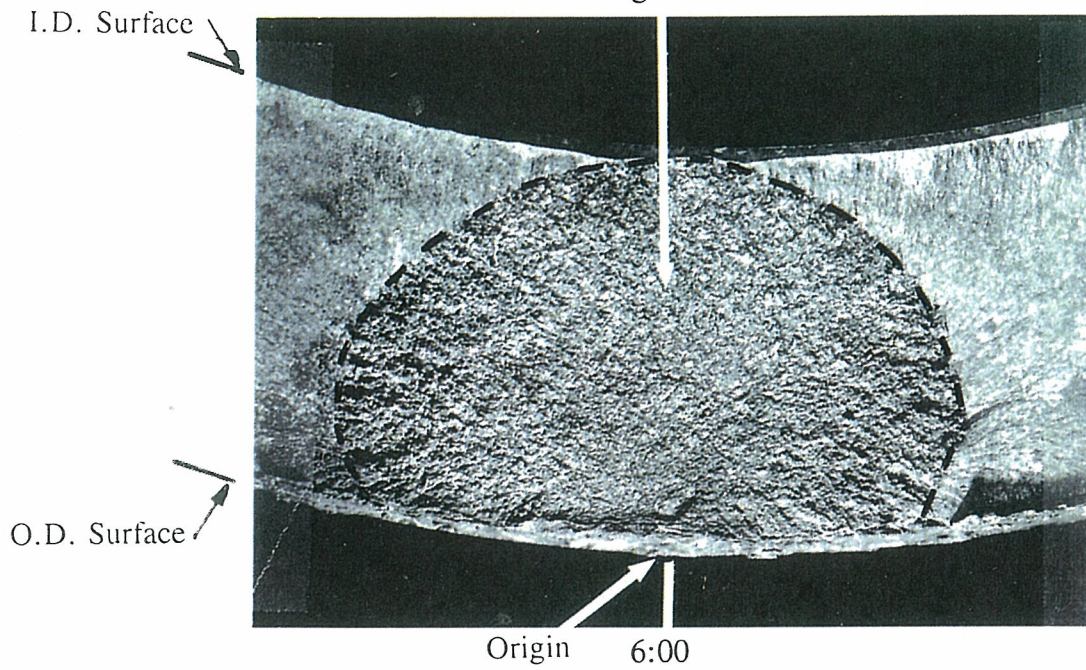
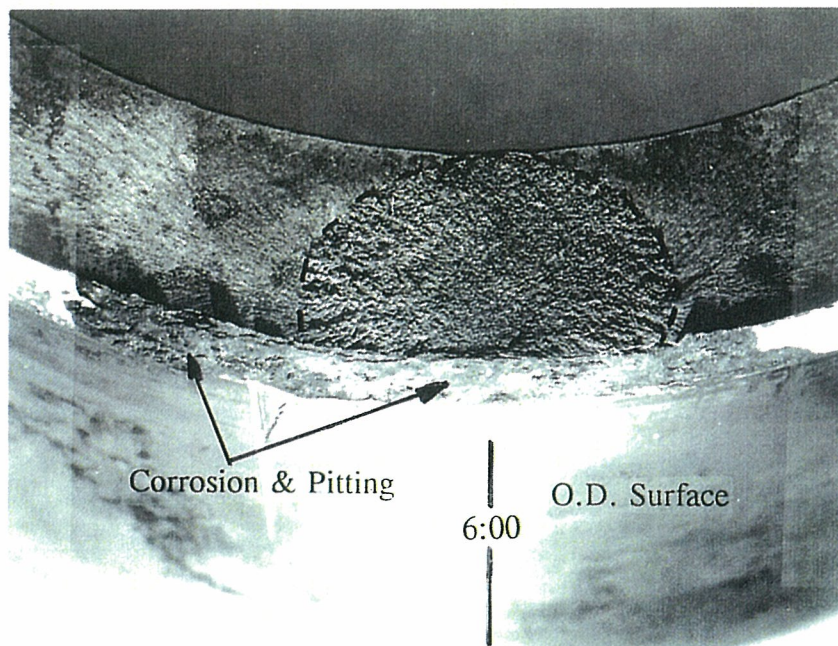
Photographs of the outboard side fracture surface showing the stress corrosion cracking region at the 6:00 position, and the corrosion/pitting on the O.D. surface of the axle.

1.12 The axle failure resulted from a ductile fracture propagating from a pre-existing crack, which had resulted from stress corrosion, through the thickness of the axle wall at the time of final separation. The pre-existing stress corrosion crack formed a semicircular pattern with a base of 23 mm (0.9 inches). (See Illustrations 2 and 3).

1.14 Metallographic cross sections through the origin of the stress corrosion region showed pits into the outer surface of the axle up to 0.055 inches in depth.

Consider the need to advise any B767 operator who has main undercarriage assemblies in service that have been involved in runway excursions onto unprepared surfaces to dismantle such assemblies and test them for evidence of corrosion and/or cracking (065/93), and
