NO. 93-012

FLETCHER FU24-950M

ZK-BHU

AIRCRAFT ACCIDENT REPORT NO. 93-012

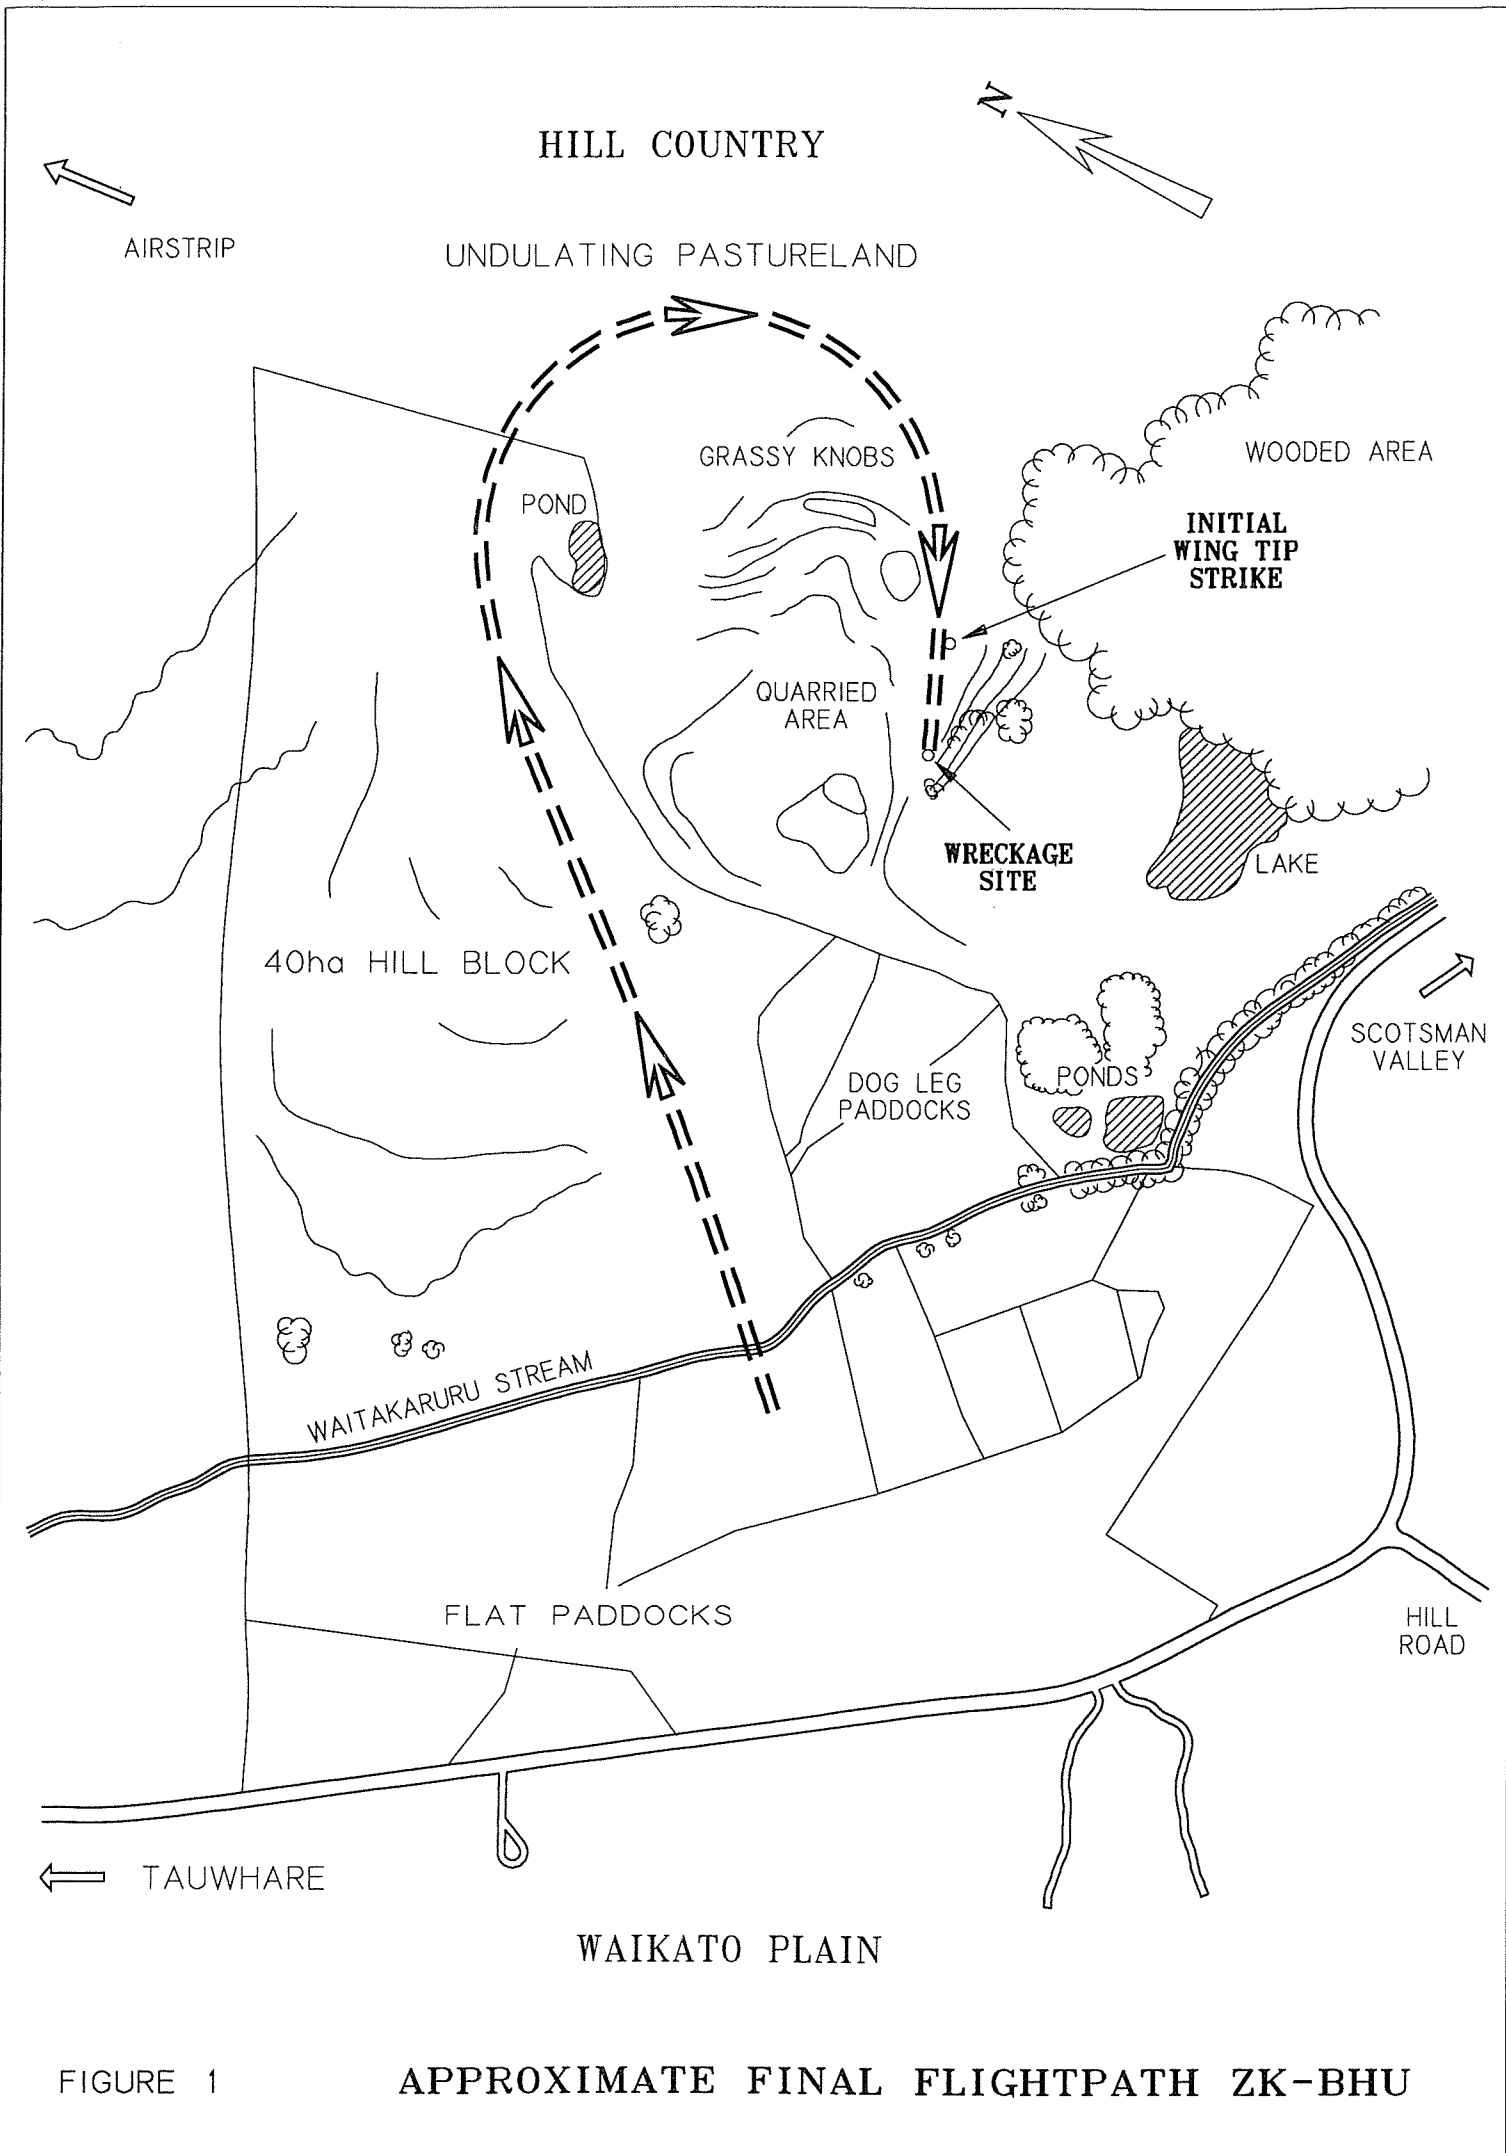
FIGURE 1

APPROXIMATE FINAL FLIGHTPATH ZK-BHU

1.12 The farm covered a total area of 63 hectares, of which 40 hectares were to be topdressed. It was situated on the east side of Scotsman Valley Road about 1 km south-east of Tauwhare, at the edge of the Waikato Plain, and included a number of paddocks at an elevation of about 200 feet amsl. To the east however it comprised gently rolling hill country rising to more than 600 feet amsl. A dog-leg of small flat paddocks bounded by fences and the Waitakaruru Stream lay at the lower level to the south (see Fig. 1).

1.13 The adjacent property on the east side included an abandoned quarry and a narrow gully oriented approximately north-east/south-west which opened towards the lower flat land and the dog-leg area of the property being sown. The required sowing rate was 375 kg to the hectare. Eye witness reports describing the aircraft's flight path, and ground examination to establish the areas which had been covered prior to the accident, suggested that the pilot had followed a sowing pattern corresponding to that shown in Fig. 1.
