NO. 93-013

MIL Mi-8T

YS-1005P

NEAR HOKITIKA

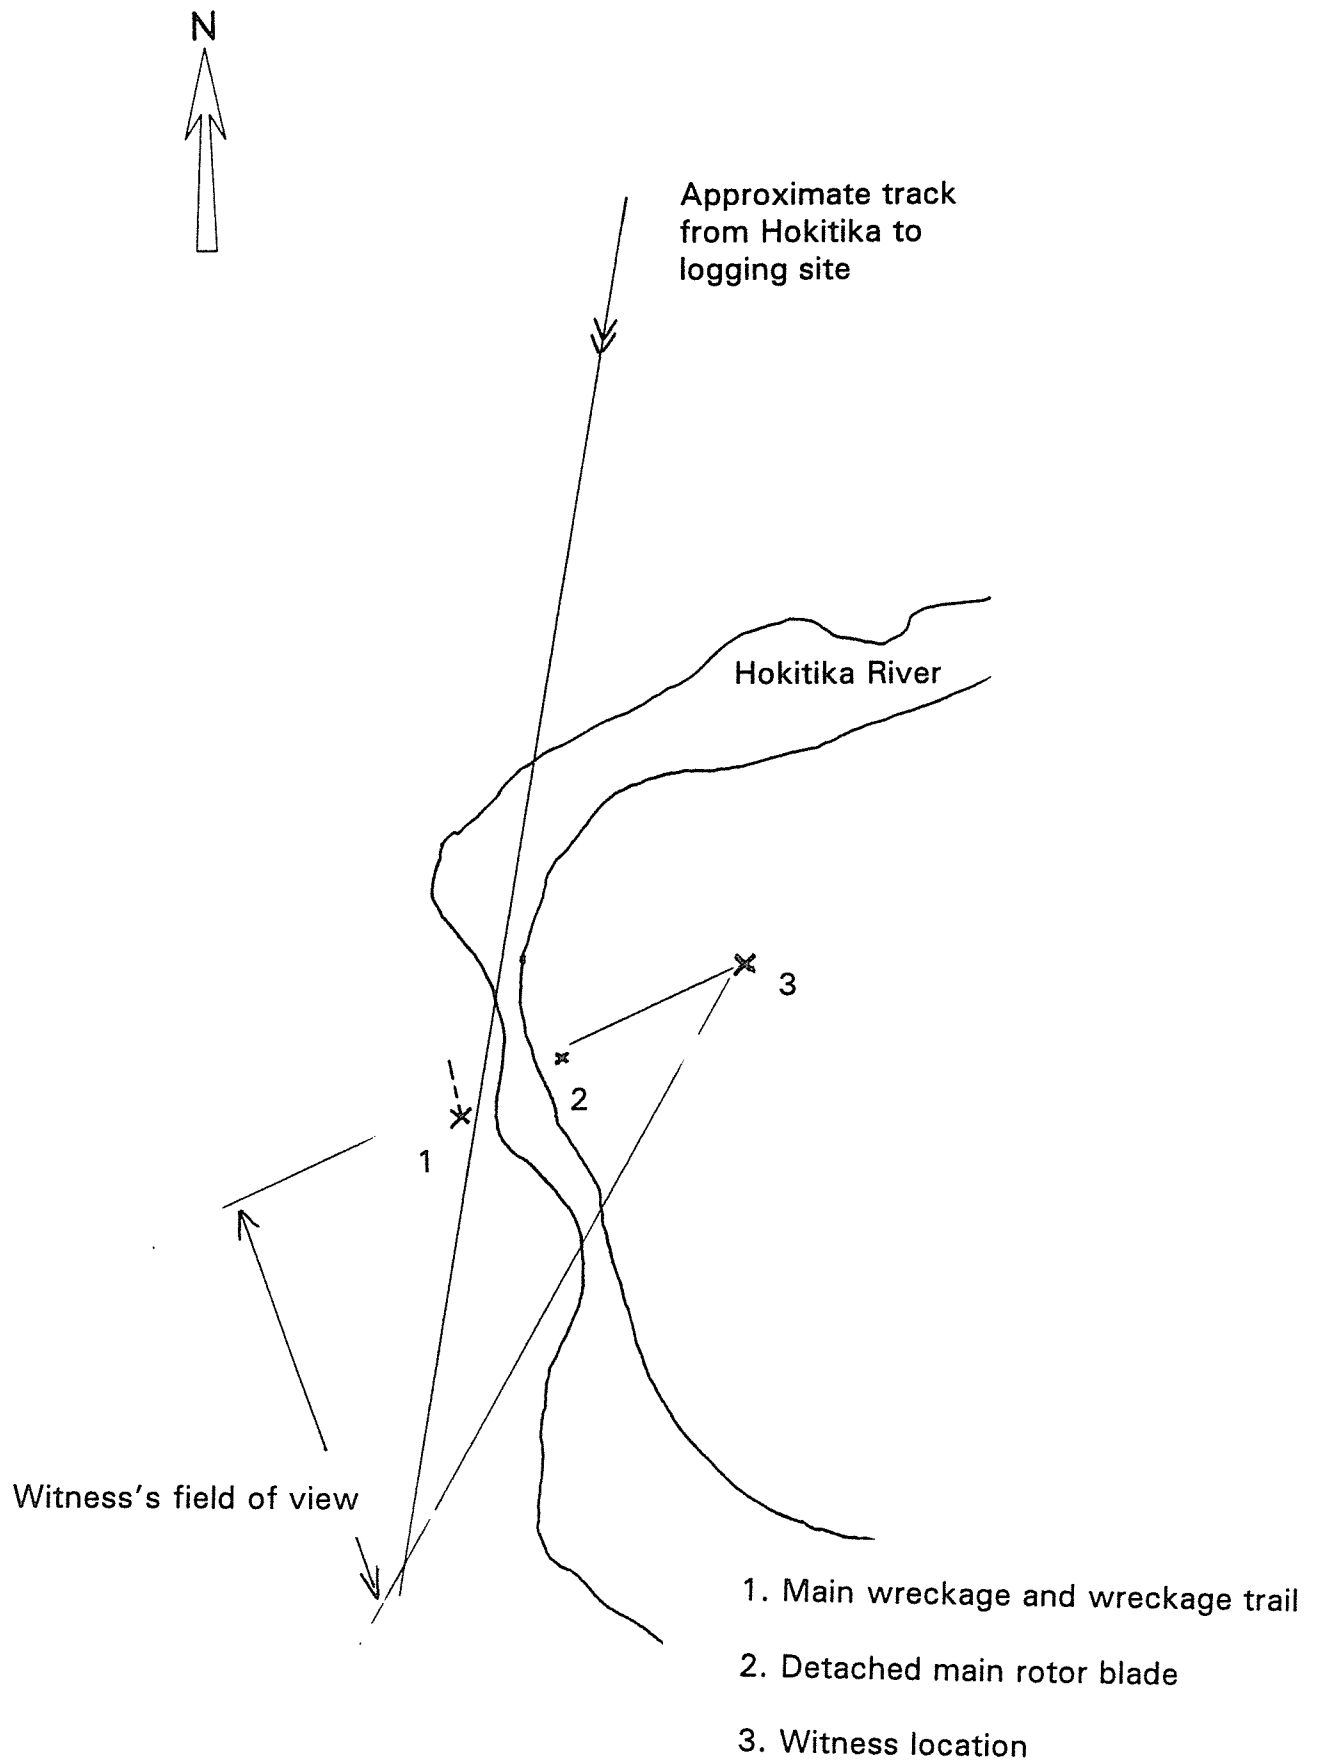
DIAGRAM 1: WRECKAGE LOCATION

1.12.1 The main wreckage, essentially the fuselage minus the tail boom and four main rotor blades, had impacted in an inverted attitude in soft swampy ground amid light scrub. The fuselage had come to rest on a heading of 030° magnetic, but the direction of travel before impact was approximately 145° magnetic. A wreckage trail, consisting mostly of portions of the tail boom, lay generally to the north-north-west of the main wreckage for a distance of approximately 360 m. See Diagram 1.

1.12.2 The main rotor blade seen by the witness landed on the eastern side of the Hokitika river, 750 m from the main wreckage. One blade was with the main wreckage, still partially attached to the rotor hub; the remaining three were scattered to the east, within a 150 m radius. It appeared that these three blades had broken off and been flung to the east of the main wreckage during the impact sequence. The complete tail assembly, comprising the tail rotor, its associated gearboxes and the complete tail pylon, lay in a creek 175 m to the north-east of the main wreckage.

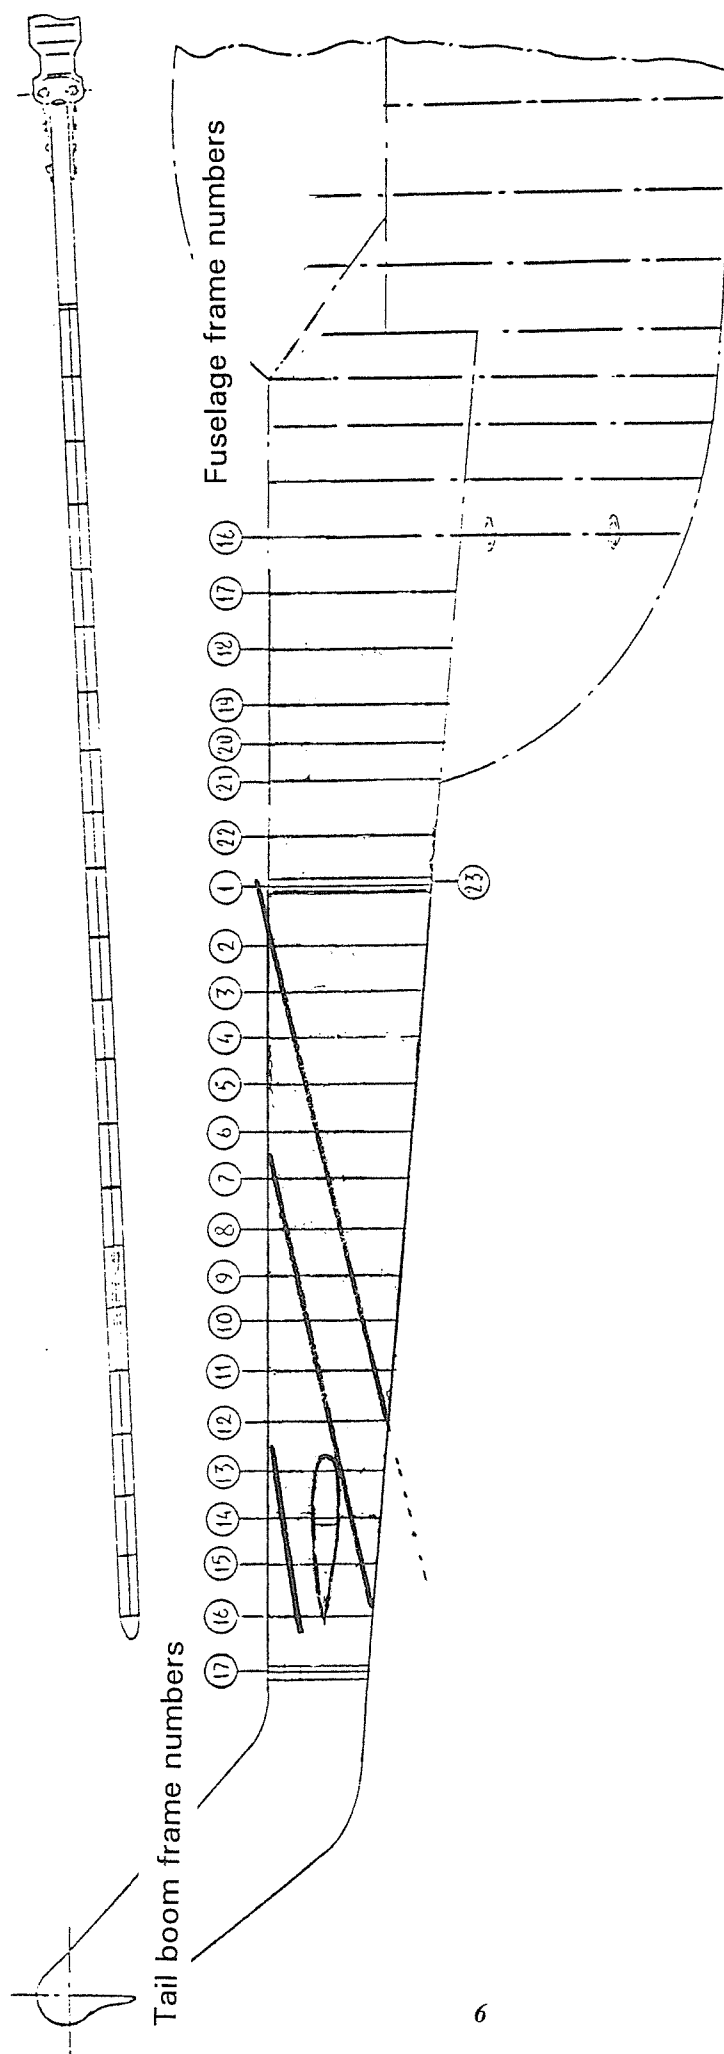
DIAGRAM 2: LOCATION OF MAIN ROTOR BLADE STRIKES

1.12.4 Examination of the rotor blades and the pieces of tail boom showed that the tail boom had been struck and severed by the main rotor. Blade number 4 had detached in flight, and this blade exhibited the most severe damage. This blade was probably the second to strike the boom, severing it. The reactive loads on the blade were sufficient to cause it to fail near the root and be flung a considerable distance. The first strike had occurred above the horizontal stabiliser, but was probably not severe enough to result in the loss of the tail pylon; The second blade strike involved almost the full cross-section of the boom, including the tail rotor driveshaft (see Diagram 2, which shows the position of the first three strikes). The section of the driveshaft from this area was not found.

1.12.6 Severe fragmentation of the tail boom aft of fuselage frame 21 (see Diagram 2) had occurred, but the various portions had fallen in a reasonably straight line and were concentrated within an area of approximately 150 m by 50 m. The largest piece of the boom was from the upper rear, and to which the horizontal stabiliser was still attached. This section showed clear evidence of the angle of strike by the main rotor, as did another distinct “slice” of the boom which had fallen close to the section which included the stabiliser.
