**NO. 93-101**  
**TRAIN 57 SHUNT SERVICE**  
**COLLISION WITH MOTOR VEHICLE**  
**ELTHAM**  
**5 APRIL 1993**

## RAIL ACCIDENT REPORT NO 93-101

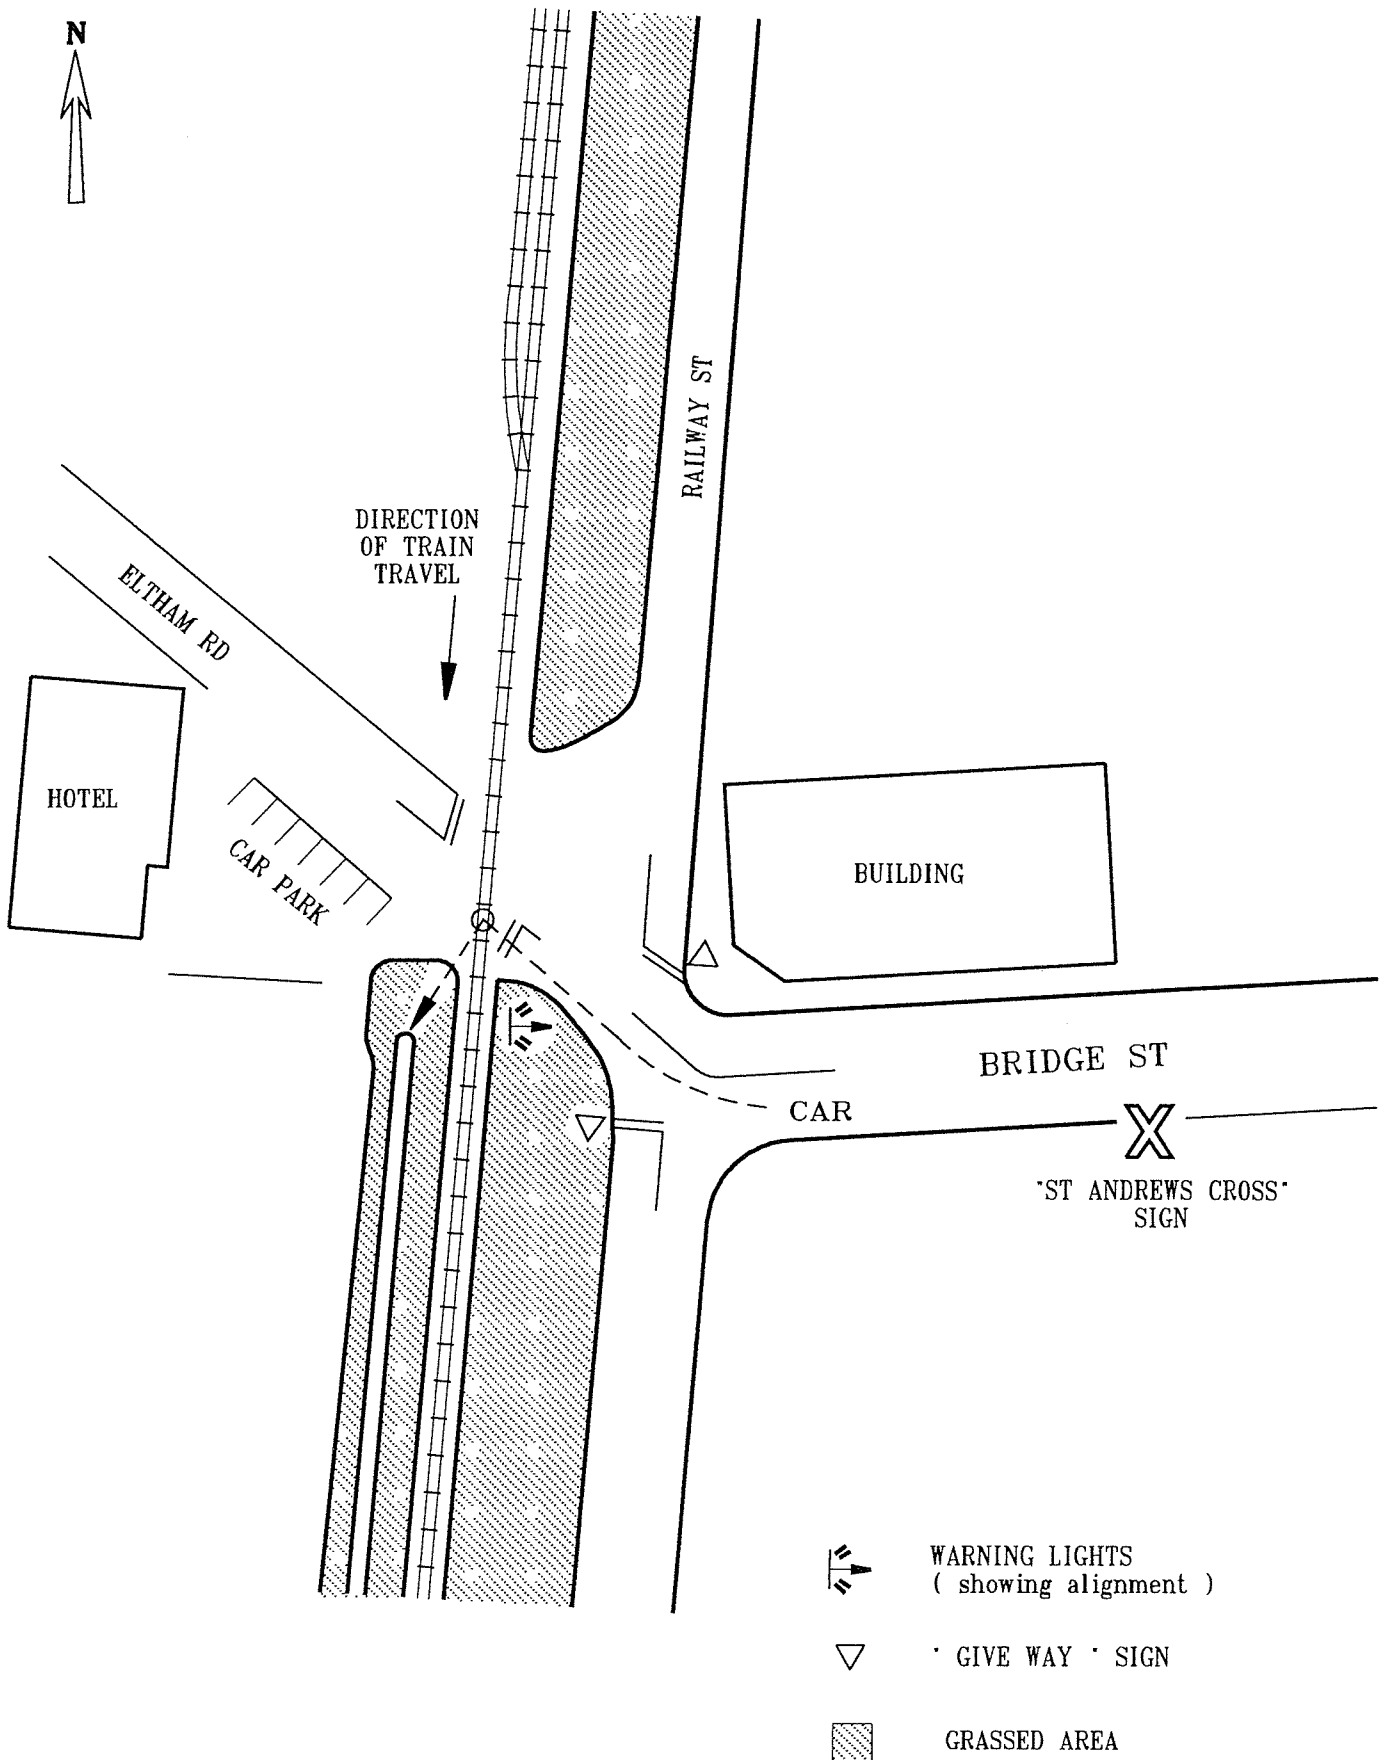
# BRIDGE STREET LEVEL CROSSING , ELTHAM

**1.11** Westbound traffic on Bridge Street had to negotiate a right-hand bend (through 44°) before crossing Railway Street and the railway line (see diagram). Standard warning signs were posted on both approaches to the crossing, the "St Andrews Cross" for westbound traffic being situated on the left-hand side of the street, 75 m before the crossing. Three separate warning light standards served the crossing, with a total of five pairs of warning

lights. One set of warning lights was aligned to face westbound traffic on Bridge Street, and this set was visible from within 190 m of the crossing. The crossing itself was not directly visible to the driver on this approach until he

was within 40 to 50 m of the crossing, owing to the bend in the street and the presence of a building on the north-east corner of Bridge and Railway Streets.
