No 93-105
Train 520
Collision with Motor Vehicle
Near Levin
28 May 1993

This report relates to a collision between a train and a motor vehicle on a level crossing near Levin on 28 May 1993. The driver, the sole occupant of the motor vehicle, was seriously injured. Safety issues discussed in the report are design criteria for level crossings adjacent to main road intersections and the display of warnings to motorists following the disablement of crossing warning devices.

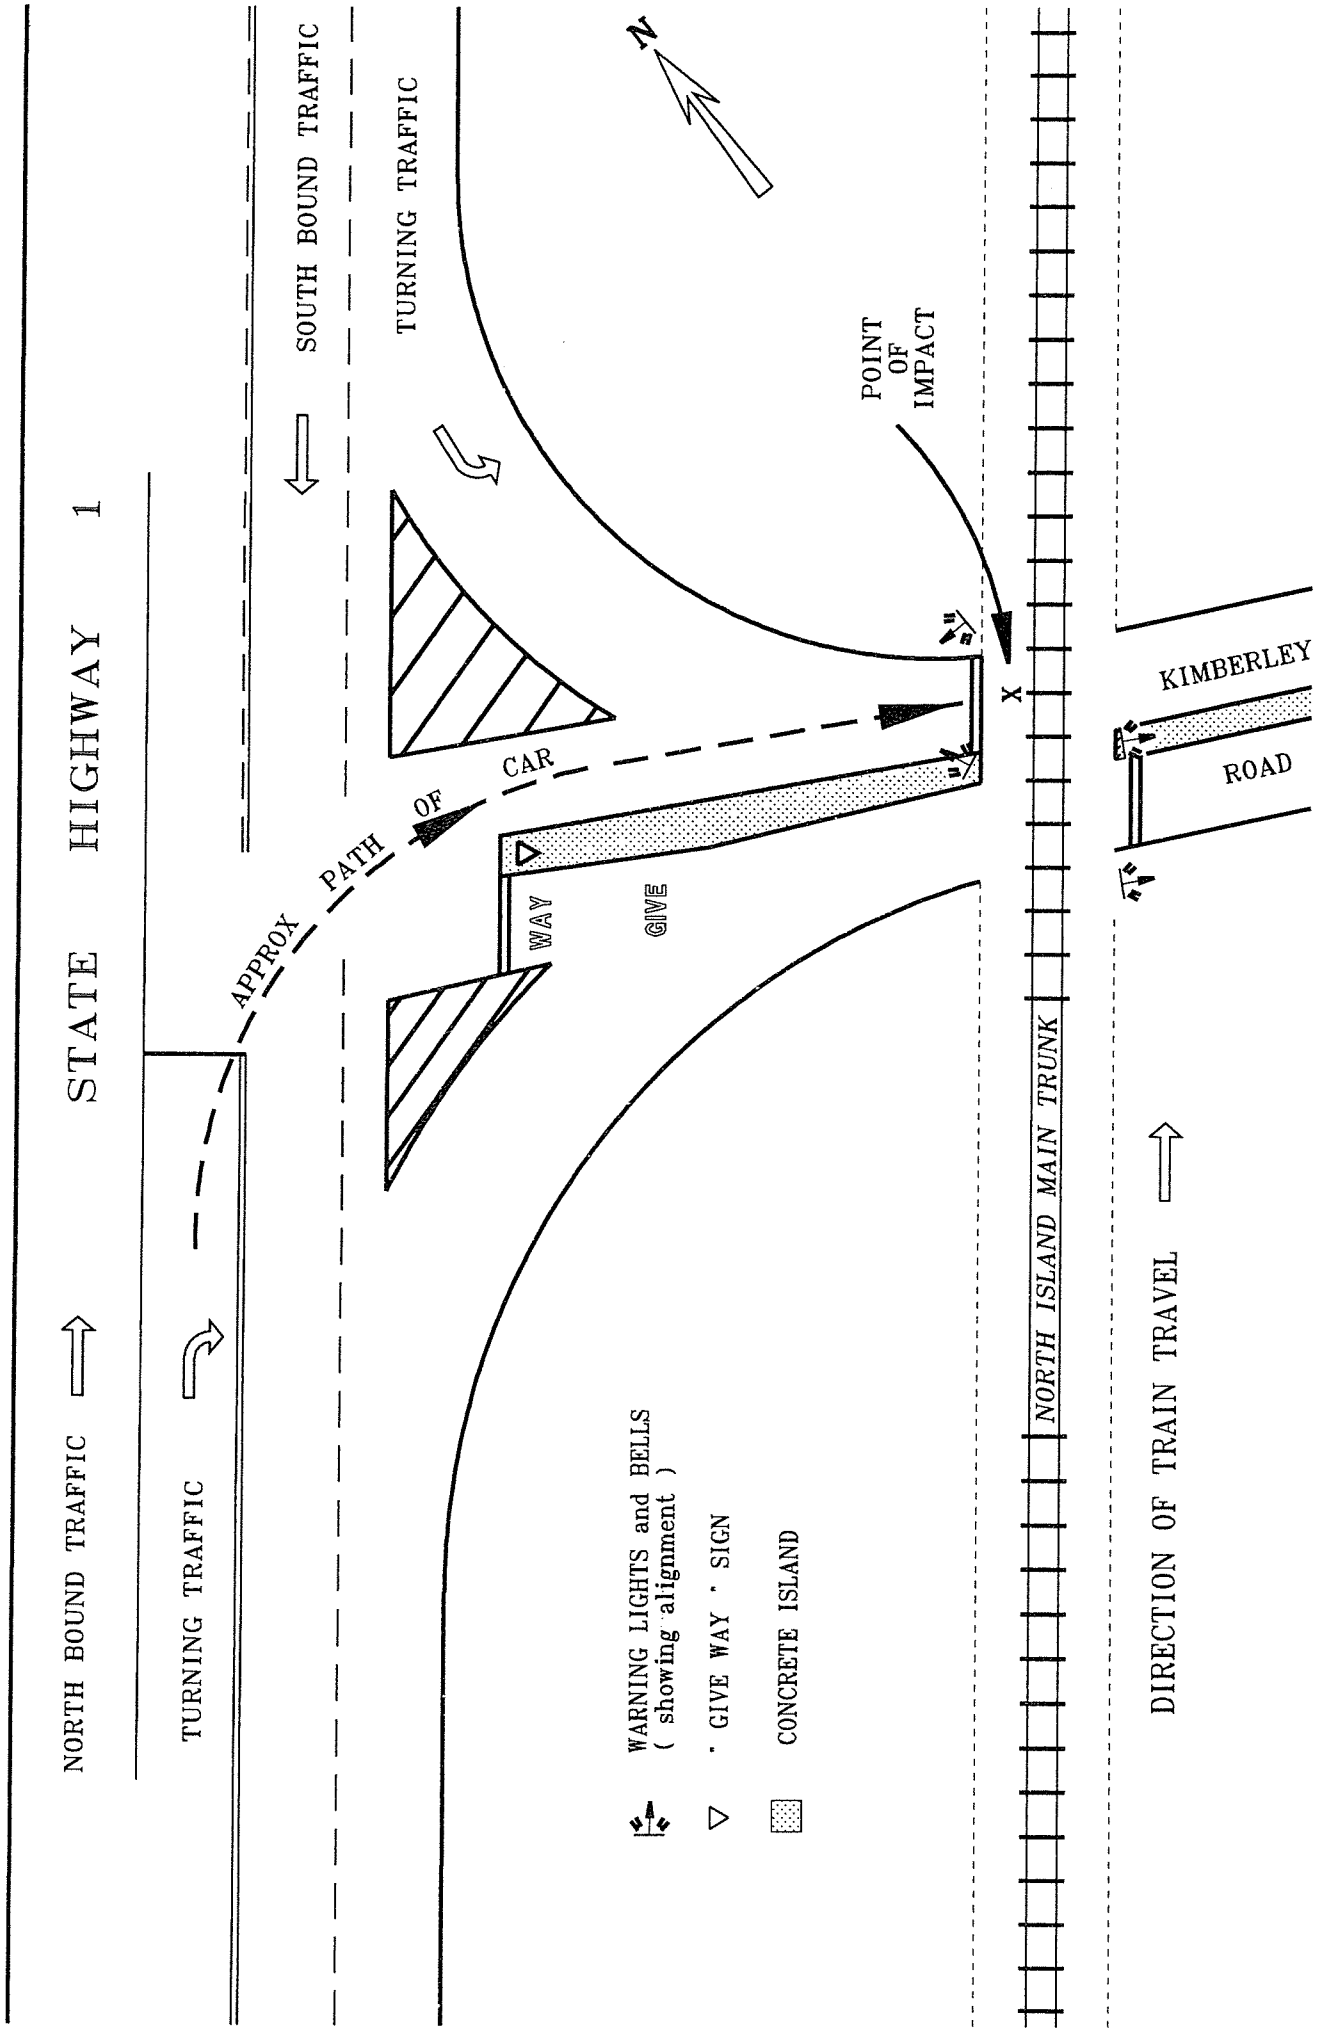
KIMBERLEY ROAD LEVEL CROSSING , LEVIN

1.15 The driver, heading north on State Highway 1 and intending to turn into Kimberley Road, would have entered the area covered by the primary 30° beam of the flashing lights at 25 to 30 m from the turning point at the intersection. The lights would have been visible directly ahead of the driver only after the turn into Kimberley Road was commenced. Sighting of the lights would have been possible from outside of the 30° beam only if the driver had looked directly at them.

2.3 One set of warning lights was aligned towards the approaching motor vehicle driver as he made his turn into Kimberley Road.

2.9 If the driver failed to notice the railway crossing before turning off State Highway 1 into Kimberley Road, he would have little time or distance in which to brake safely.
