No. 93-109
Train 141
Collision with motor vehicle
Te Hana, Northland
19 July 1993

TRANSPORT ACCIDENT INVESTIGATION COMMISSION

RAIL ACCIDENT REPORT NO 93-109

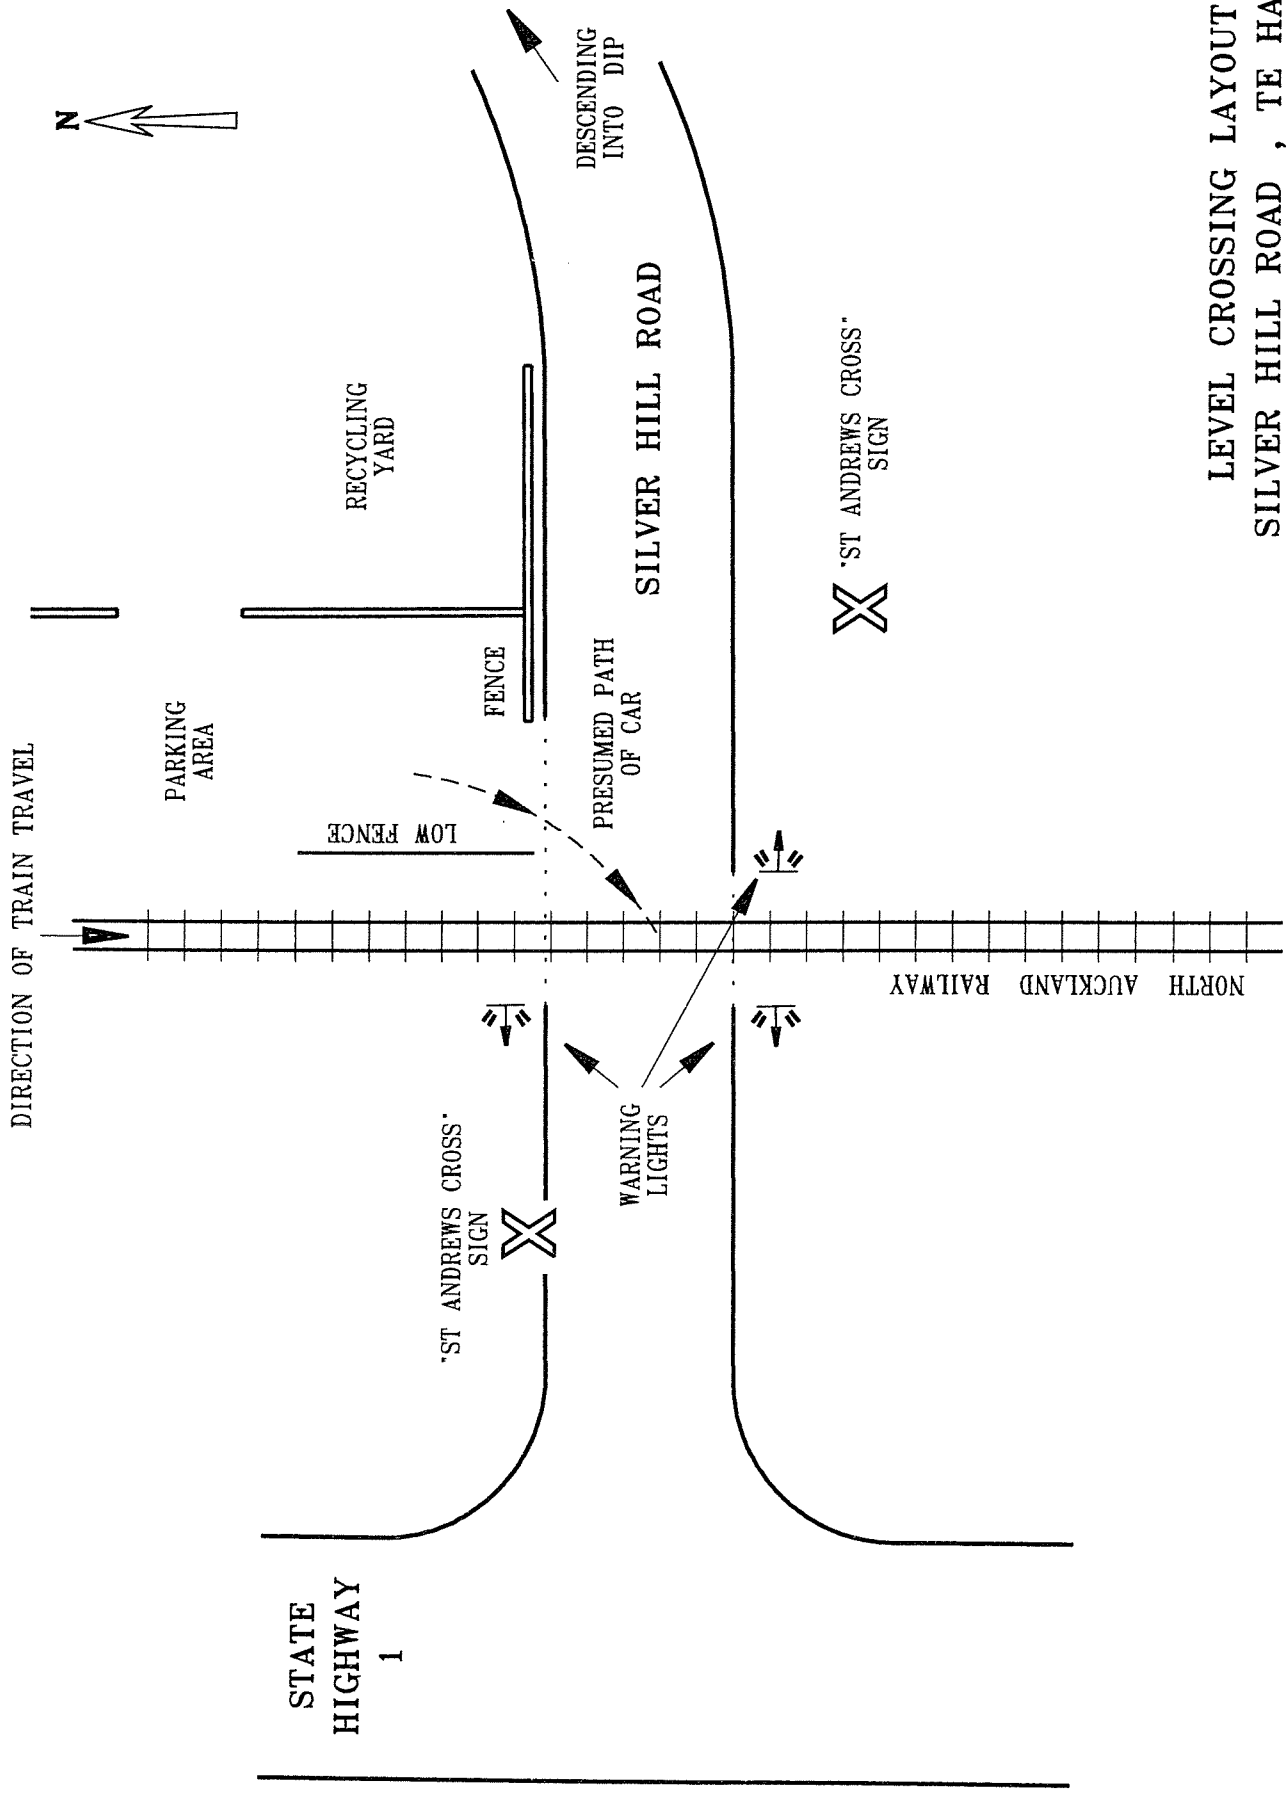
LEVEL CROSSING LAYOUT
SILVER HILL ROAD , TE HANA

1.4 The crossing was protected by flashing lights and bells, the operation of which was confirmed by the staff of the recycling depot and later by a NZRL signals team. Two sets of lights faced the approach from the intersection of State Highway 1, 32 m to the west of the crossing, and one set faced east along Silver Hill Road. The latter set was located on the left-hand, or south side of the road.

1.5 The gateway from which the car had emerged was, at its western extremity, 4.6 m from the centreline of the railway, and about 6 m wide. It appeared that the car had "cut the corner" on exiting from the yard, driving close to the right-hand side (the side nearer to the railway) and entered the crossing at an angle of about 40° to the railway line. As he drove out of the right hand side of the gateway, the driver would not have had a full-on view of the crossing warning lights on the eastern side of the crossing, but rather an almost "edge-on" view of their lenses. It would still have been possible to see if they were operating, but only if the

driver had looked directly at them. At the shallow viewing angle obtained, they would have been unlikely to attract the driver's attention via his peripheral vision.

1.6 The view of the road to the driver's left was restricted by a sharp curve in the road immediately to the east of the yard, and by the road's descent into a dip to cross a stream. Traffic from the east was difficult to see until within about 30 m of the yard exit, and as the driver was familiar with this problem, he may have concentrated his attention on ensuring that the road was clear in that direction before exiting from the yard. The presence of his passenger in the left front seat may have required greater than normal concentration on that approach. The angle of crossing the railway line would have required the driver to look to his "5 o'clock" position to check for the approaching train, as opposed to a look simply to his right, had he approached the crossing at right angles.

Consider mounting a second set of warning lights on the existing installation to the east of the Silver Hill Road level crossing, to face the yard exit on the north side of the road (059/93).
