No 93-112

Train 901

Collision with Motor Vehicle

RAIL ACCIDENT REPORT NO 93-112

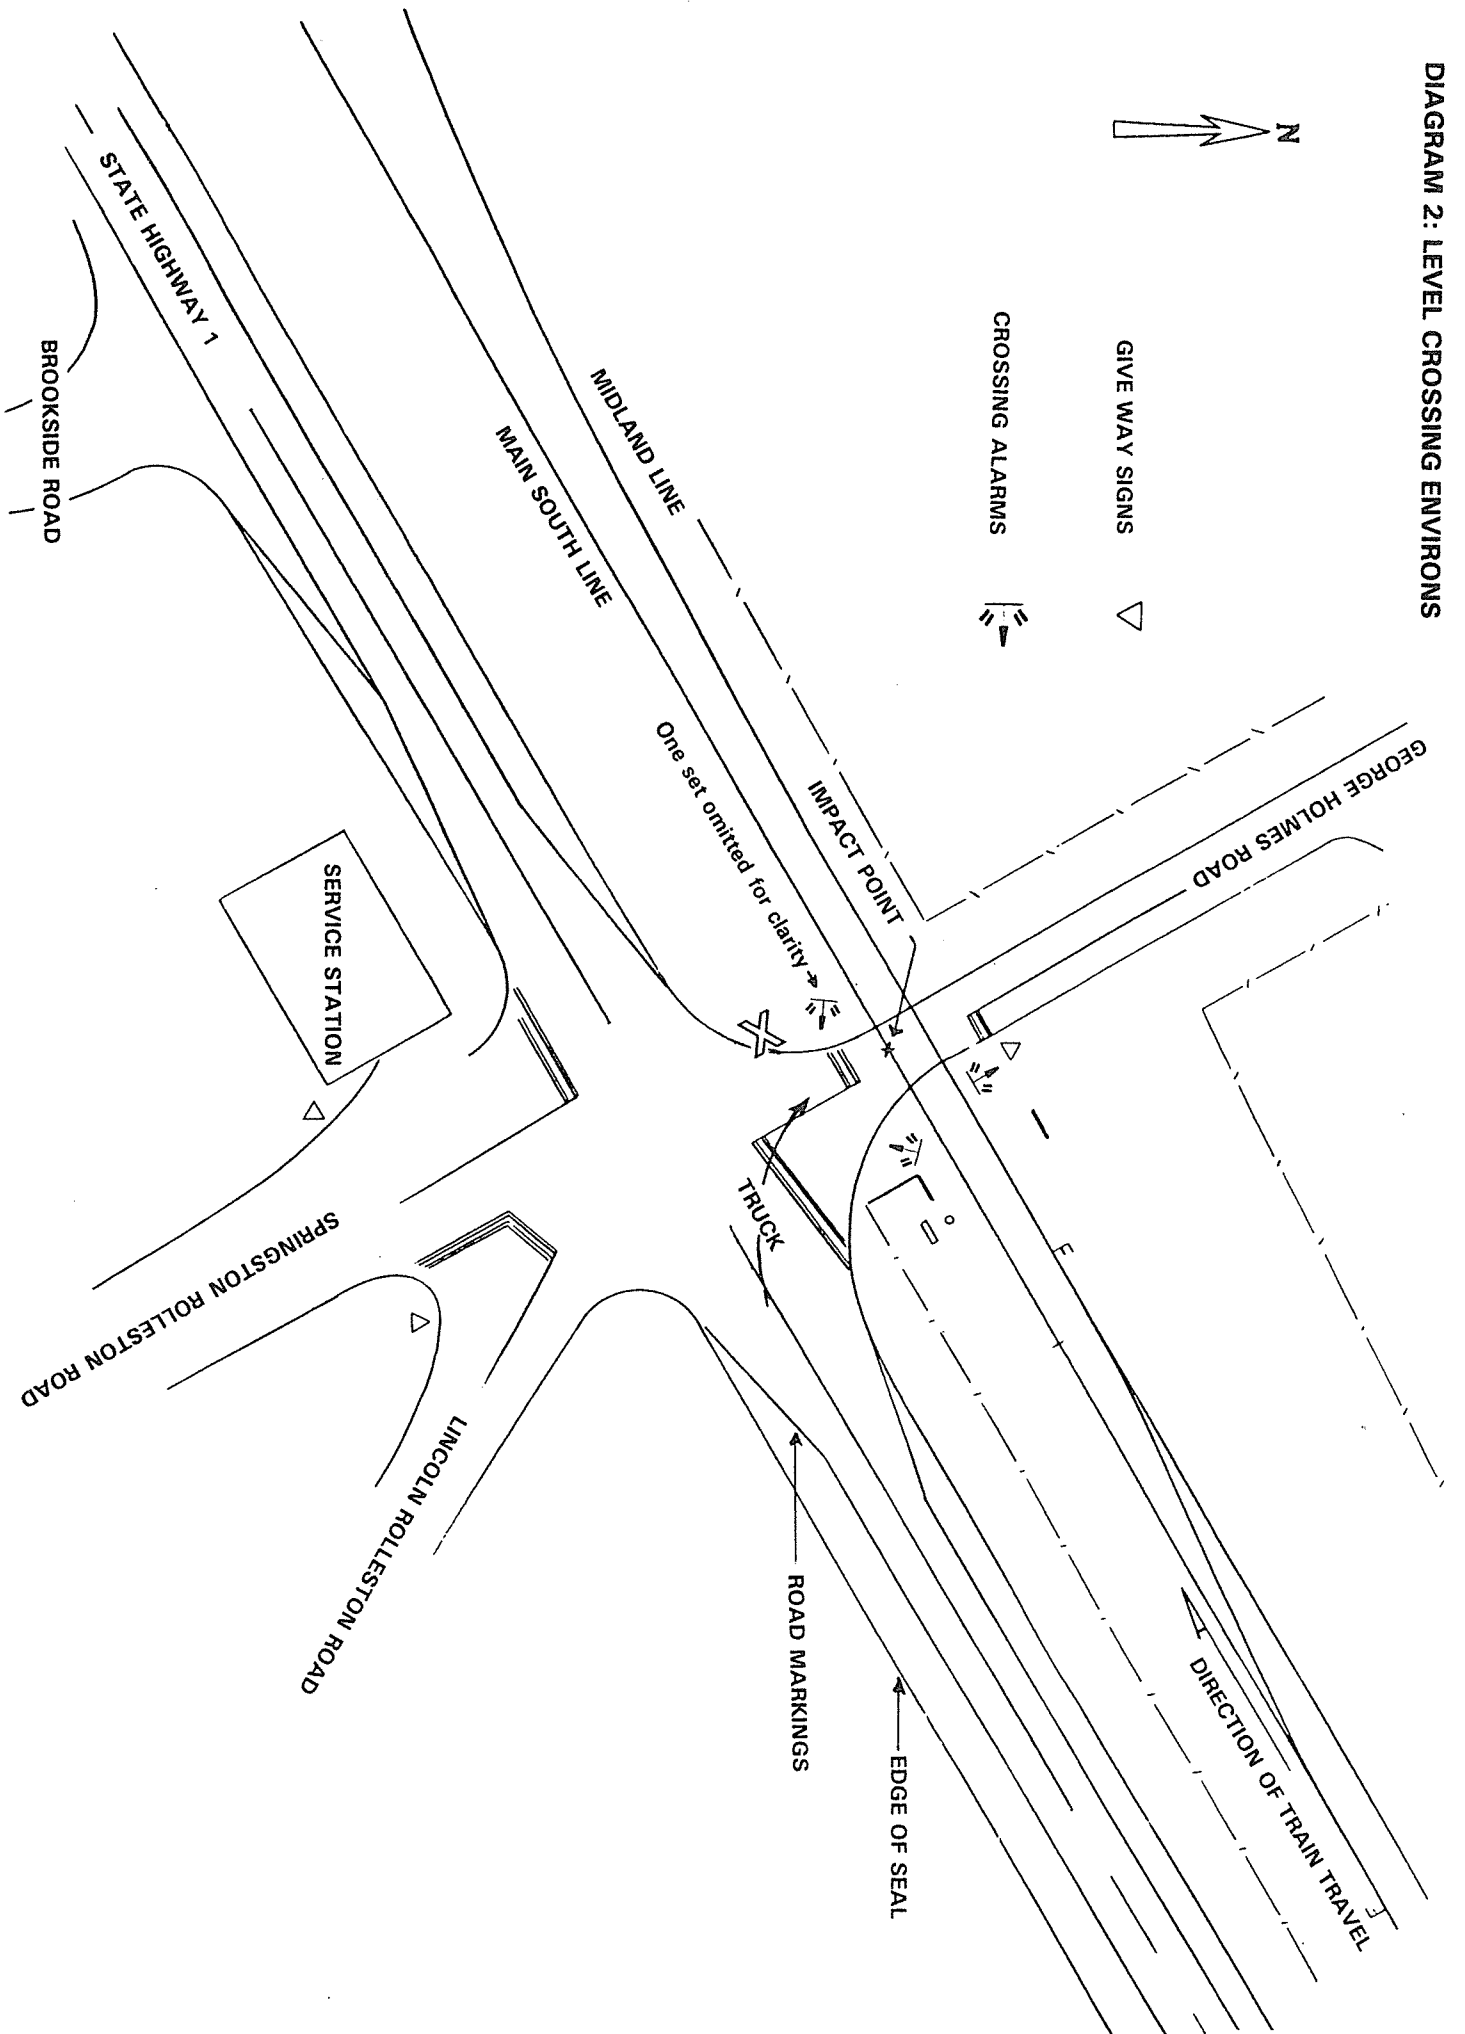
DIAGRAM 2: LEVEL CROSSING ENVIRONS

1.16 It was recognised early in the investigation that the design of the road intersection (see Diagram 2) adjacent to the railway crossing was probably a major factor in the accident. The Commission had investigated a similar type of accident near Levin on 28 May 1993, and found that the main road intersection adjacent to the railway crossing presented a high workload for drivers turning right from the main highway into the side road. The proximity of the railway crossing to the highway intersection gave drivers little recovery time or distance after having turned, in which to recognise that there may be a conflict with rail traffic (see Report 93-105).

1.17 The following significant aspects of the State Highway 1/George Holmes Road intersection were noted:

a. State Highway 1 is only two lanes wide through Rolleston, with no turning or merging lanes. The layout of the intersection dictates that southbound traffic turning right from State Highway 1 into George Holmes Road often forces following traffic to move outside the marked lane onto the (sealed) road shoulder in order to pass. This can be distracting for drivers turning right, especially as the following traffic may not necessarily have slowed to the 70 km/h limit by this point.

b. Two additional side roads form a common intersection with State Highway 1 opposite George Holmes Road, and a third side road joins within 50 m of, and on the same side as these two. Traffic emerging from or turning into these side roads can present an additional distraction.

c. State Highway 1 runs close to the railway line at this point, so that the available stopping distance on George Holmes Road between the highway and the railway line is only 13.7 m. This represents very little distance or time in which to stop if a driver turns into George Holmes Road, and only realises that the level crossing is active after the turn has been completed. Additionally, there is not sufficient space for a truck and trailer unit, after entering George Holmes Road, to stop clear of the railway line without obstructing the highway, or conversely, on emerging from George Holmes Road, to stop clear of State Highway 1 without the rear of the combination sitting foul of the railway line.
