Train No. 36

Collision with Motor Vehicle

TRANSPORT ACCIDENT INVESTIGATION COMMISSION

RAIL ACCIDENT REPORT NO. 93-117

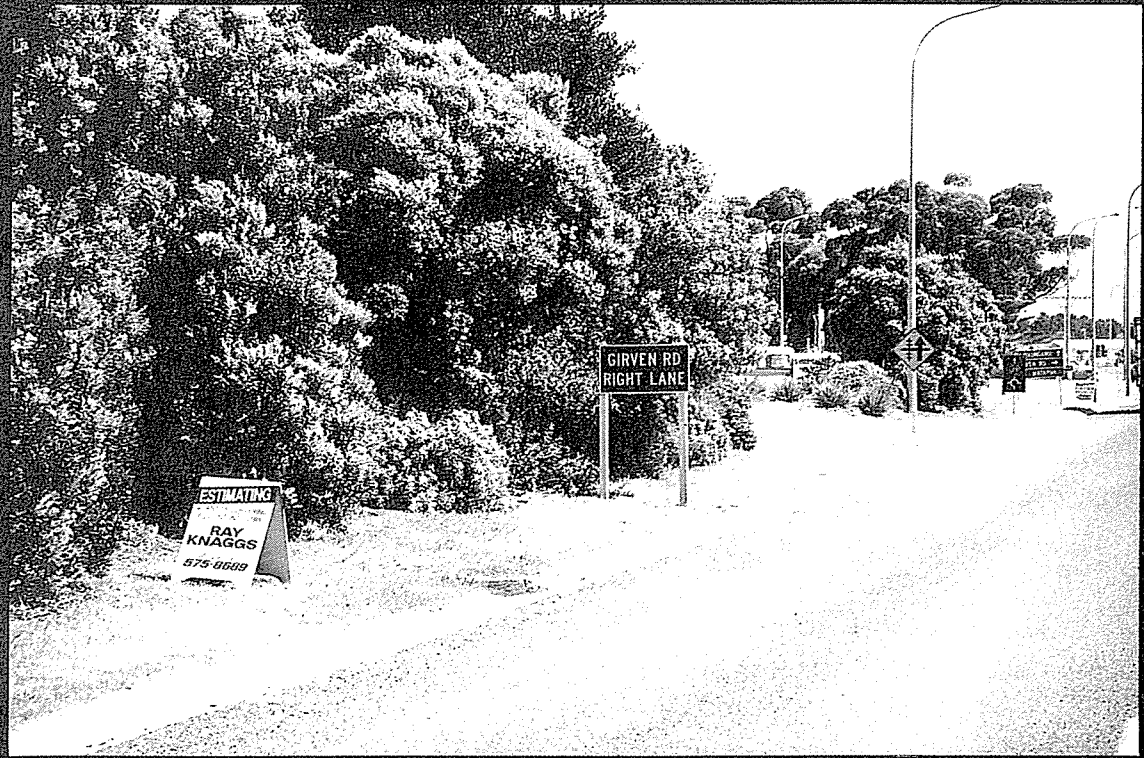
FIG. 1

Approaching the Matapihi Road intersection along Maunganui Road. The number of signs can be seen, but the crossing and the alarms are not visible.

2.5 There was an excessive number of passive signs along the roadside leading up to the intersection. Two of the signs were commercial advertising, and were unauthorised.

3.2.1 They reduce the number of road signs in the vicinity of the Maunganui Road/Matapihi Road intersection to the minimum necessary to convey information to drivers effectively. (071/93).

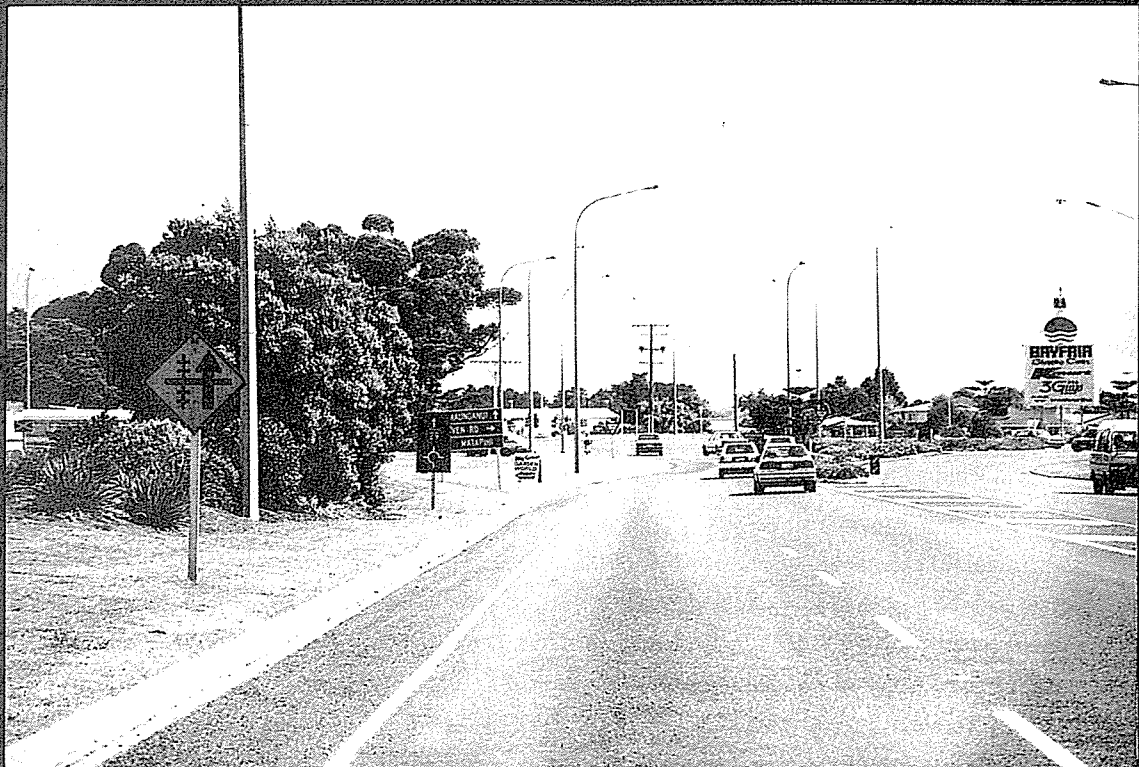
FIG. 2

This photograph was taken closer to the crossing than Fig. 1. The roundabout is visible, but the crossing and the alarms are still out of sight, obscured by the largest bushes and two of the road signs. The inconsistency of the information given by the nearest two road signs is also apparent.

2.6 The authorised road signs were inconsistent in the information they gave about the intersection ahead and the location of the level crossing.

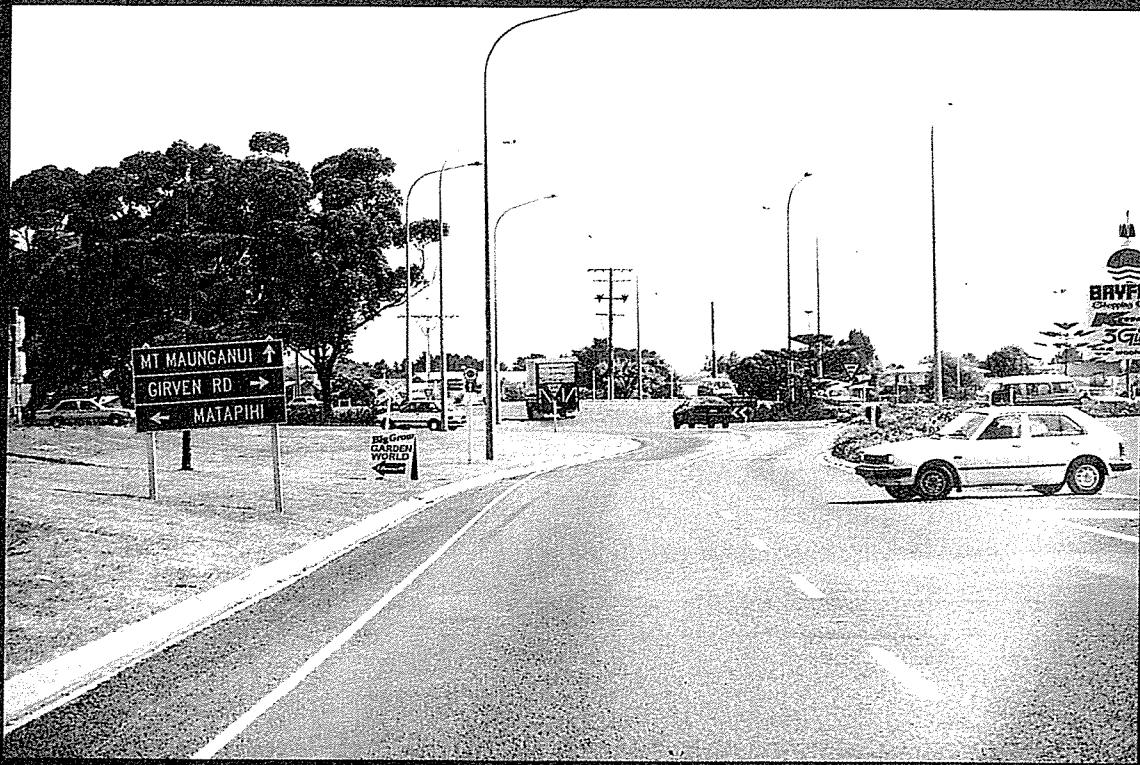
FIG. 3

1.22 The first point was at a distance of 40 m from the roundabout, when the view of the flashing lights was completely obscured by the large information sign referred to in paragraph 1.14 (d). The zone of obstructed vision lasted for several metres. Although this zone was outside the cone of focus of the light beam, it was still an area in which the driver of the car might have looked towards the level crossing and noticed the flashing lights prior to concentrating on the roundabout and the traffic on the right.

Closer still to the roundabout, the crossing alarms are completely obscured by the large destination sign. (The car on the right of the photograph is making an unusual (but not illegal) U-turn.)

3.2.2 They alter the location of road signs at the Maunganui Road/Matapihi Road intersection to reduce or eliminate obstruction of the view of the level crossing alarms from Maunganui Road. (072/93).

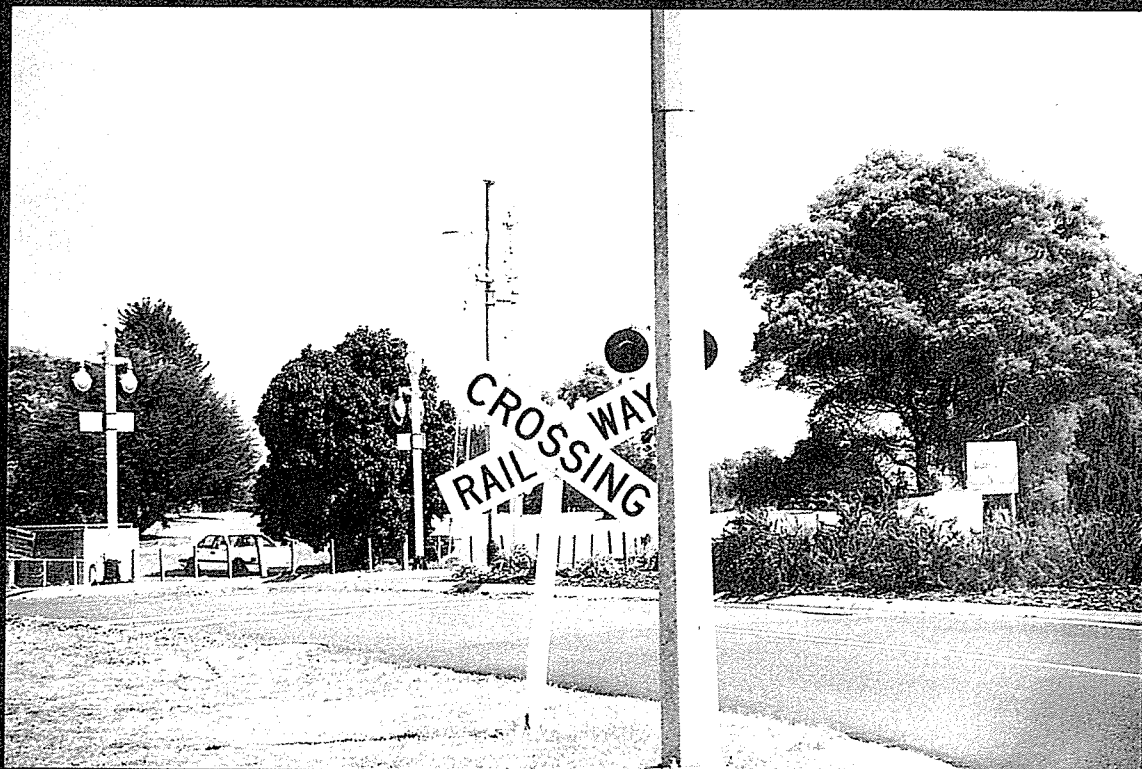
FIG. 4

1.23 The second point at which the view of the flashing lights was obstructed was much closer to the roundabout, approximately five metres along Maunganui Road. The driver had his view of the flashing lights obstructed over a short zone by the St Andrew's cross sign and a closely adjacent lamppost.

Close to the crossing, but still in Maunganui Road at the edge of the roundabout. The photographer was standing up. The motorist in his car would have had a lower viewing height, and the St Andrews Cross would have blocked his view of the alarms.

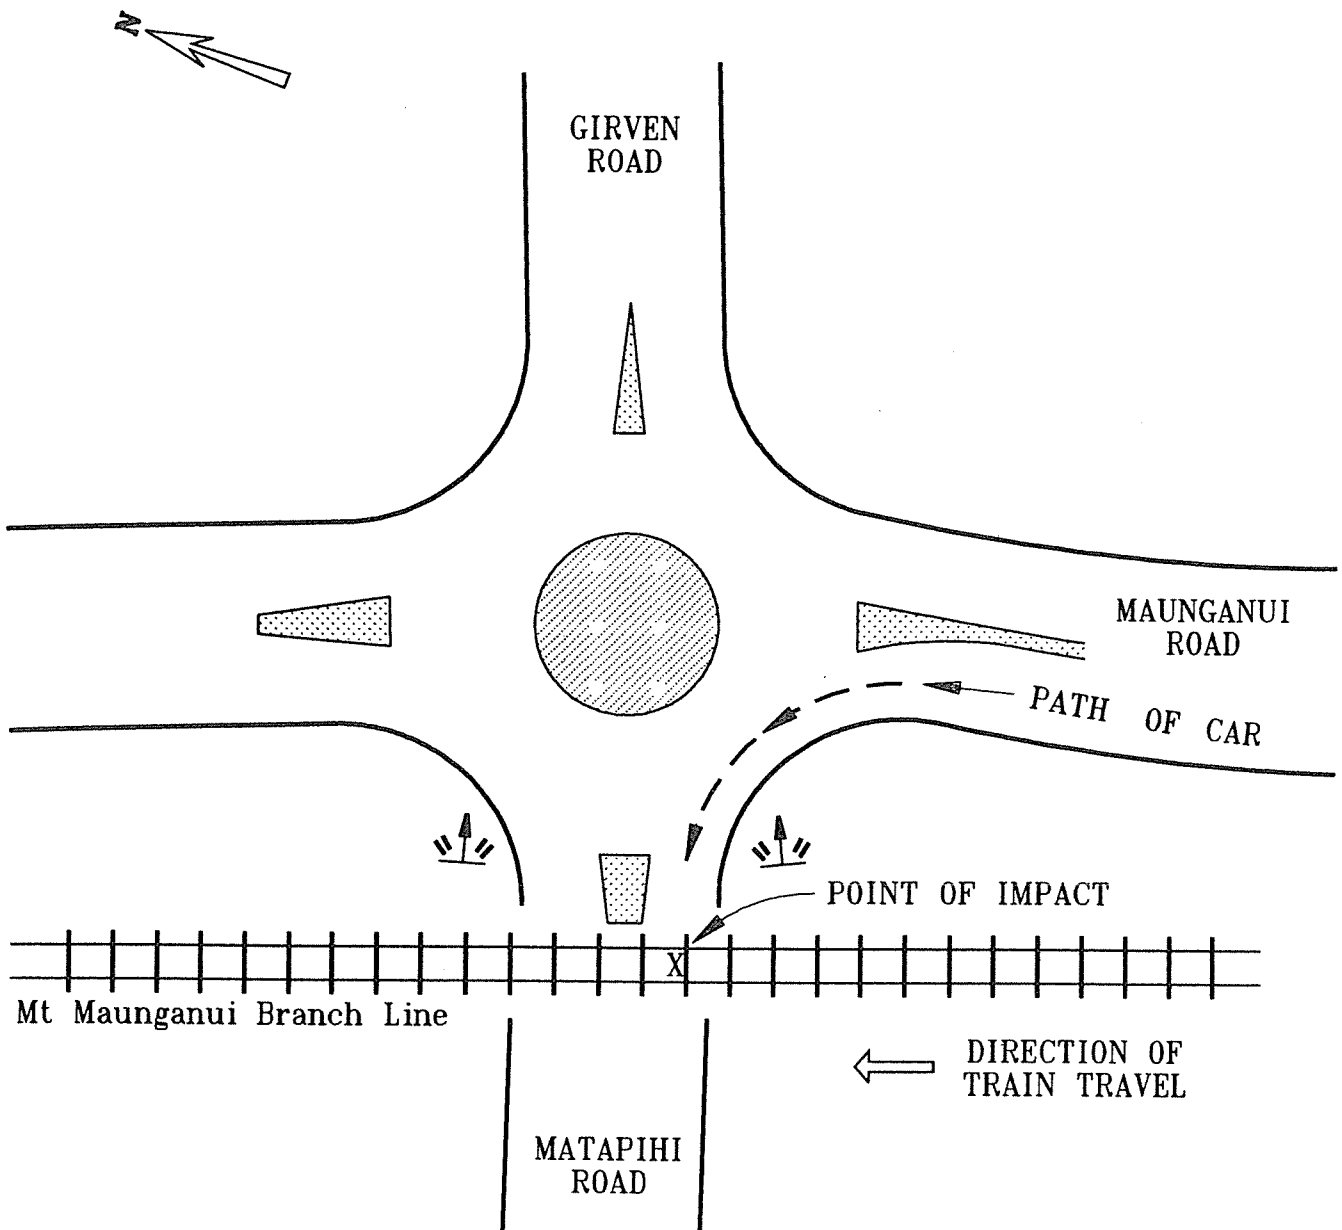
LEVEL CROSSING LAYOUT
MAUNGANUI RD / MATAPIHI RD INTERSECTION

1.18 The railway crossing was also protected by flashing lights and bells. There were two masts each carrying a pair of flashing lights directed towards the Maunganui Road side of the crossing. One was directed across the roundabout towards Girven Road, and could not be seen clearly from Maunganui Road while approaching the intersection. The other was directed at the outside edge of the roundabout where the two left hand lanes of Maunganui Road joined it. This pair of flashing lights was the only active warning given to traffic in Maunganui Road that a train was approaching.

3.3.1 They examine the possibility of incorporating a further pair of flashing lights into the crossing alarms directed to be visible as far along Maunganui Road towards Te Maunga as is practicable with a view to attracting the attention of drivers before they become occupied by traffic in the roundabout. (074/93)
